Joint Inspection Report of 5 MLD STP Shuklaganj

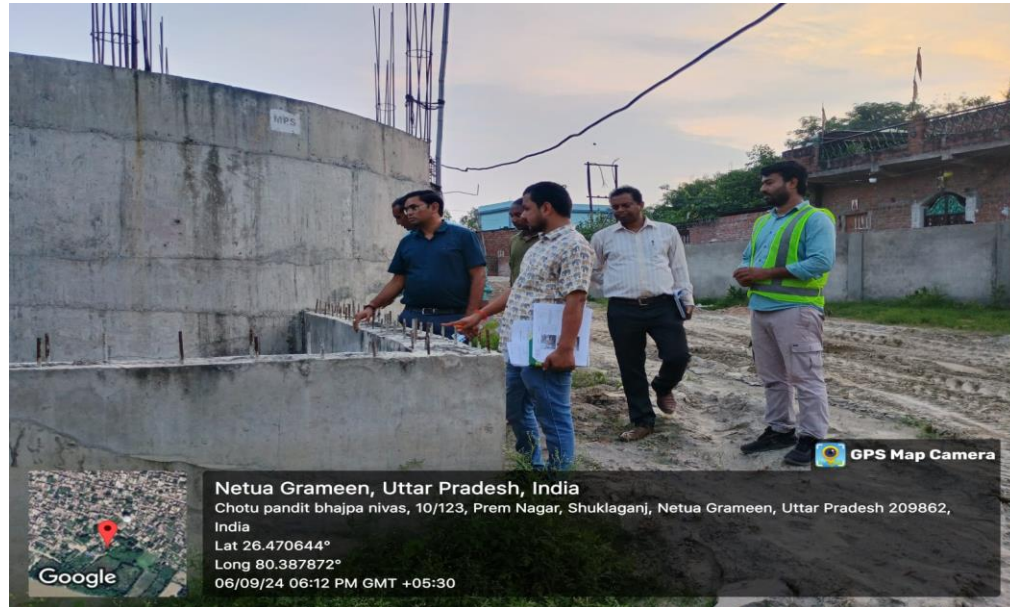
B MPS- At inlet chamber step arrangement and proper footrest have not been provided. Column, beam and slab work is still pending. KRMPL needs to do hydro

testing with clear water as per CEPHEEO MANUAL and IS code 3370 in presence of UPJN & STC. EE UPJN advice to increase the manpower and finish the work quickly. It was also advice to clean the open steel bar and coat with cement slurry.

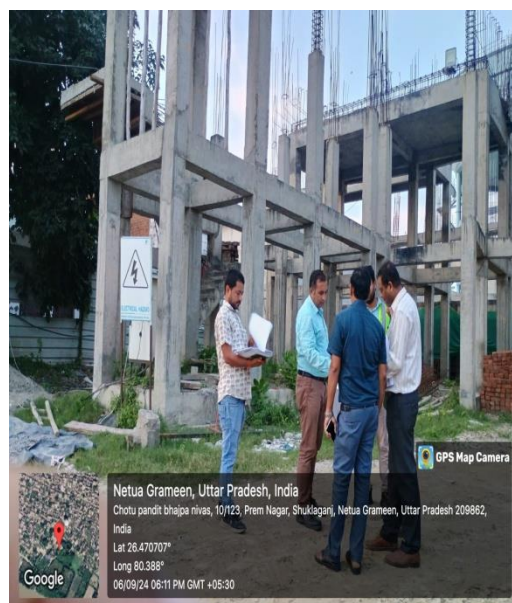
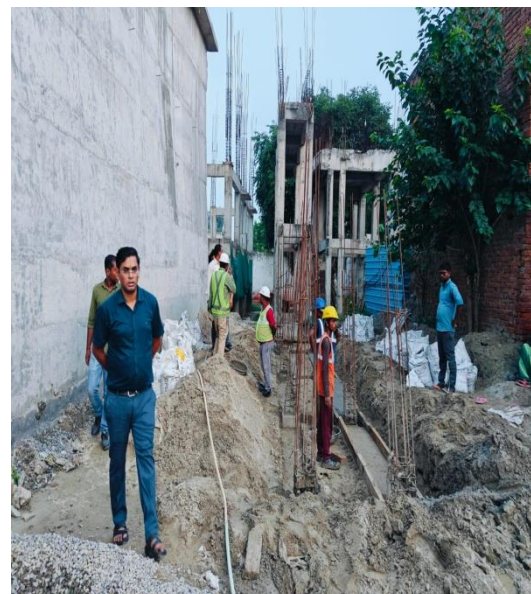
c PTU- Most of Steel found corroded. PTU, Column work completed and slab shuttering and reinforcement work is in progress. In Inlet chamber area finishing work, hydro test is pending. In Grit chamber and parshall flume RCC wall & slab, walk way, platform and hydro test pending. Stair costing done and connecting channel column on progress.

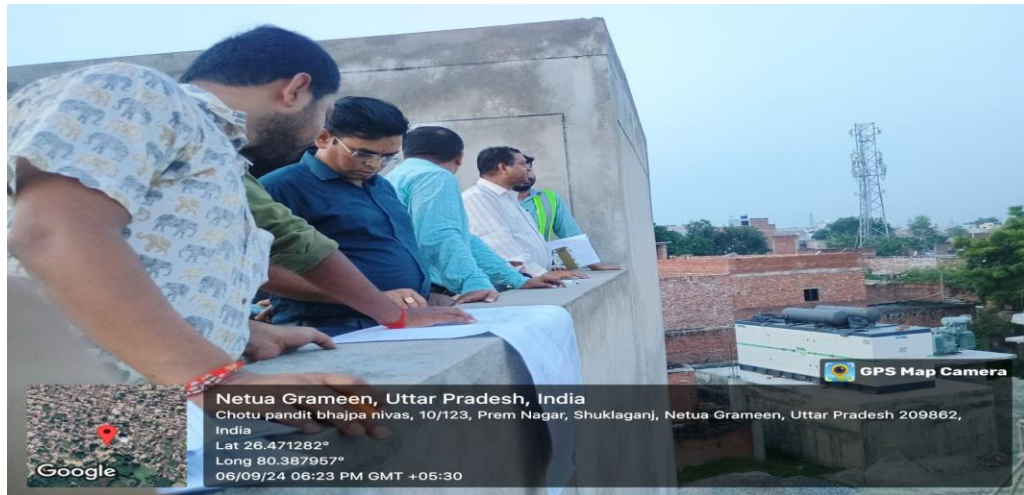
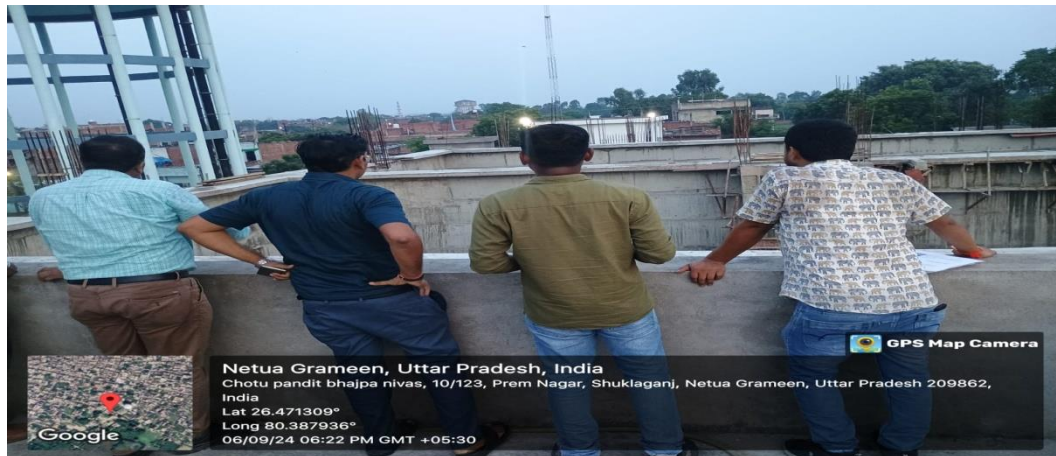
- B. SBR-** In SBR connecting channel, supporting column, walkway platform, RAS & WAS pump platform column, decanter foundation, finishing hydro test are pending. Selector zone wall pipe support beam reinforcement on progress.

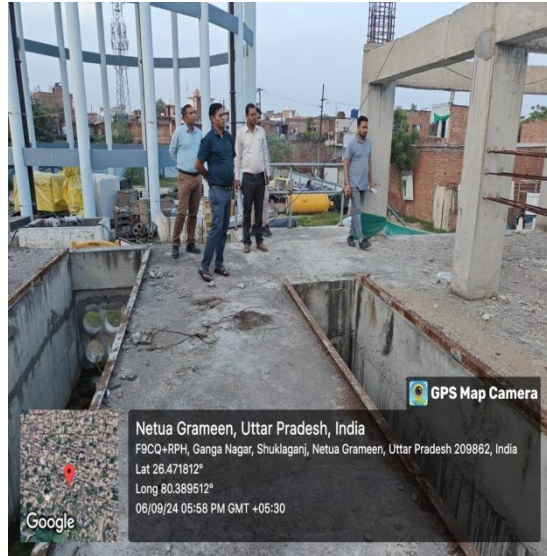
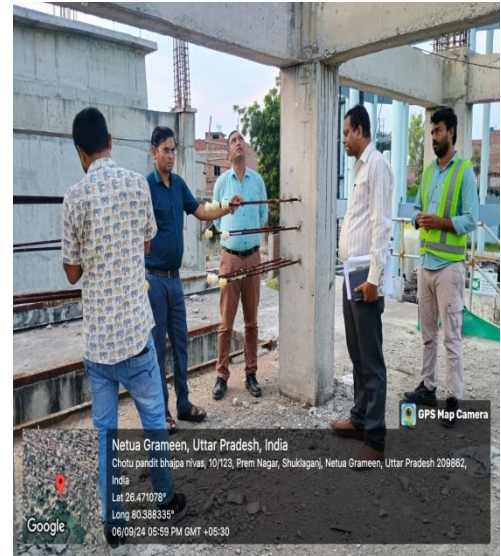
Admin building cum Blower room- In admin building room first floor and second floor slab work pending, brick work IPS flooring, electrification, sanitary fitting & plumbing, beam, column works are pending. In blower room roof slab, brick work, IPS flooring, roof treatment & finishing works are pending. EE UPJN advice to clean the open steel bar and coat with cement slurry, also advised for better housekeeping.

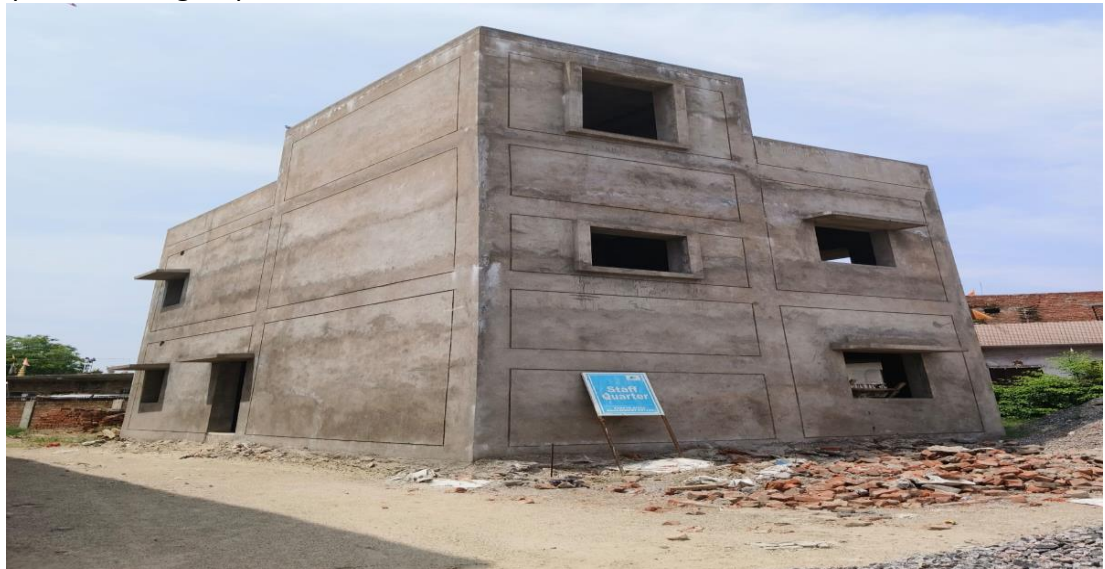
- C. Staff quarter-** Electric work, plumbing, sanitary fittings, floor, roof treatment, drainage, finishing and painting works are pending. There is no manpower on staff quarter during inspection.

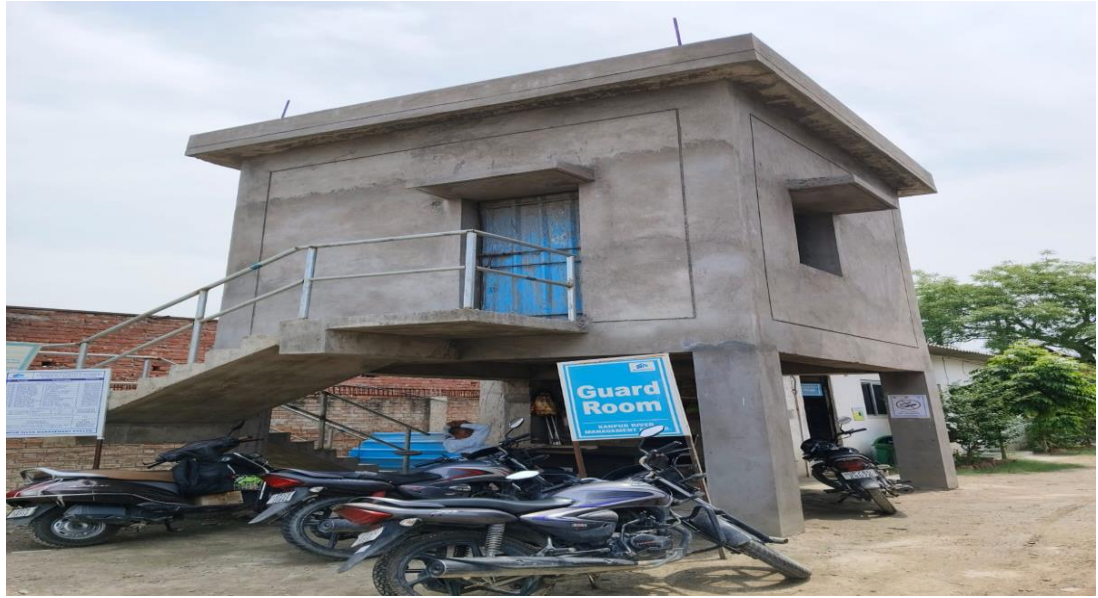
- D. Guard Room-** Electric work, plumbing, sanitary fittings, floor, roof treatment, drainage, finishing and painting works are pending. There is no manpower on staff quarter during inspection.

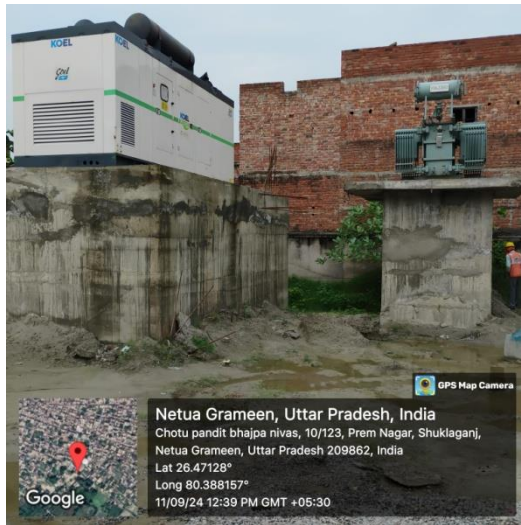
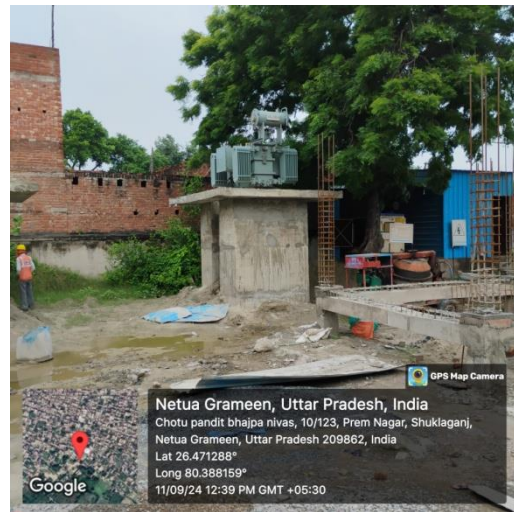
- E. Transformer & DG Yard-** Staircase, finishing, approach and painting works are pending.

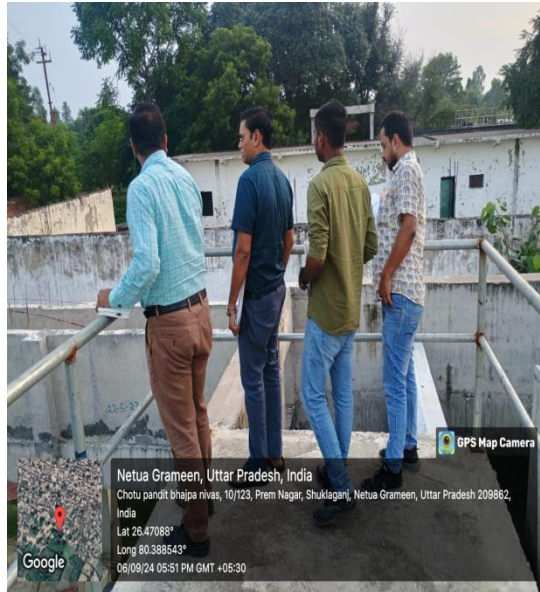
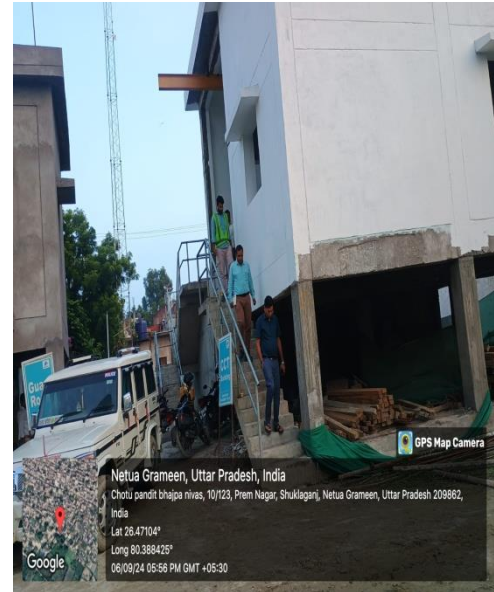
- F. CCT & Chlorination building** - In CCT outlet channel work, finishing of outlet chamber, grinding, finishing and painting works are pending. In building foundation of tonner, Electric work, plumbing, floor, finishing and painting works are pending. Putty work on progress. Booster pump and fitting pump can be install. EE UPJN advice for better housekeeping. And also to advice to complete the casting of toner foundation quickly.

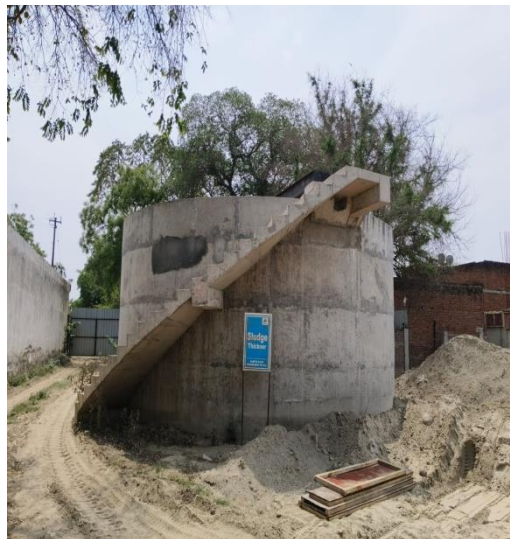
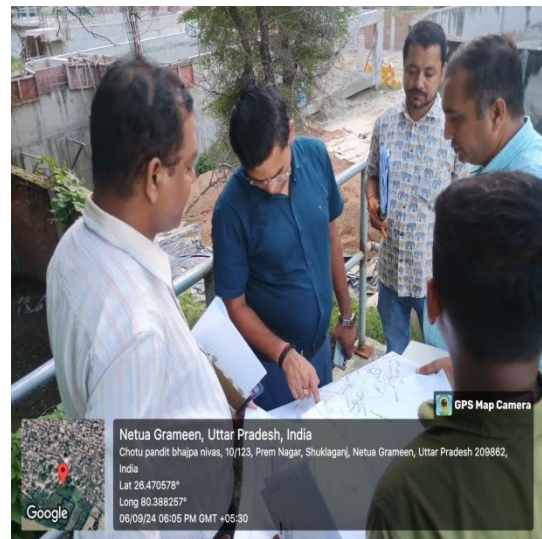
G. Sludge Thickner & Supernatant Pump- finishing, painting and hydro testing are pending. Scrapper in thickener and pump in supernatant can be install as there is no hindrance.

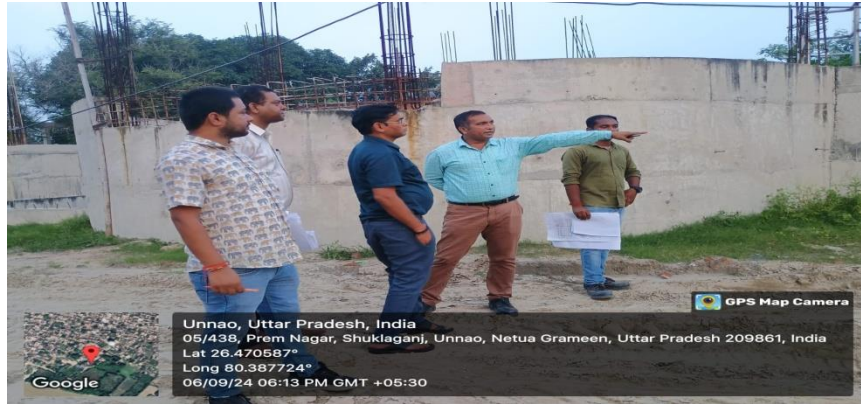
H. Centrifuge Building- First and second floor slab work is pending, column and beam work is in progress. Cracks found in the beam.

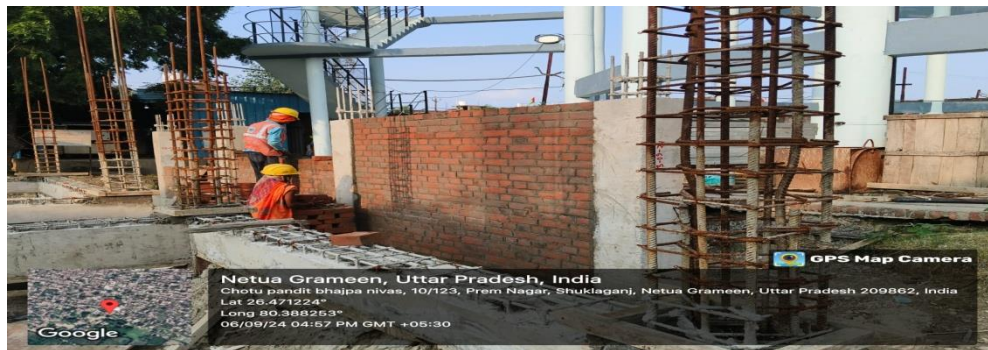
- I. Boundary wall-** 70% work of boundary wall completed. Plaster work of boundary wall is in progress.

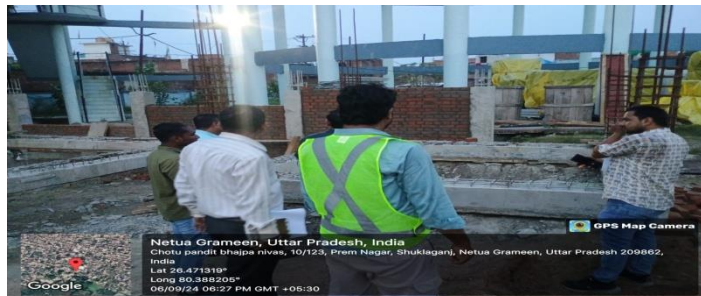
- M. HT panel & metering room-** Plinth beam work completed. Column, brick work and slab works are pending.
