National Mission for Clean Ganga- Development, Rehabilitation with
Operation & Maintenance of STPs at Kanpur under Hybrid Annuity based
PPP mode

Shah Technical Consultants Private Limited

Sub: HAM KANPUR: Inspection Report of 130 MLD IPS and STP Jajmau facilities Phase I, Inspection done on 02.03.2022.

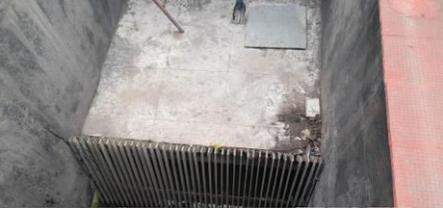
3	Screen Chamber	1. Garbages was available.

<ol style="list-style-type: none"> 1. Garbage cleaning work need to be compulsory. 2. Garbages Trolly need to be available at site. 	23.11.2021		Pending
4	Receiving Chamber 1	Overflow condition found since handover

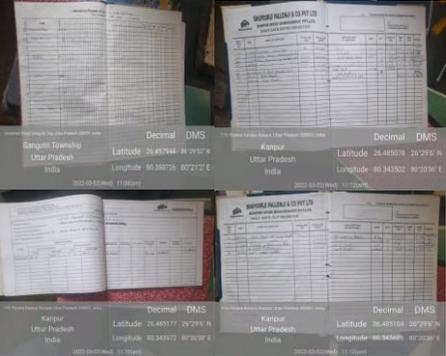
<ol style="list-style-type: none"> 1. Inside and outside painting work done by KRMPL under renovation. 2. Replacement of damaged Door,window,louvers and ventilators. 2. Panel Volt meters and Ammeters need to be replaced. 3. All Phase Indicator need to be replaced. 	23.11.2021		Pending
10	Logbook	Log book of pump house 01 and pump house no. 02 has not maintained by KRMPL properly

<p>119, Purania Kanpur, Kanpur, Uttar Pradesh 208001, India</p> <p>Decimal DMS Latitude 26.485284 26°29'7" N Longitude 80.344053 80°20'38" E</p> <p>2022-03-02(Wed) 11:00(am)</p>	<ol style="list-style-type: none"> 1. Log book of pumps and DG set are not being maintained by KRMPL. 2. KRMPL has not arranged adequate number of staff (Operators, Sweepers and relieves) for proper O&M of IPS and attendance register manipulated staff details. Operators are non technical person. They are not understanding the Pump Capacity, Flow of Discharge, Peak Flow and maintain the records. 3. KRMPL need to maintain Visitor Register. 4. Security guard need to be deploy. 5. No labour available by KRMPL for renovation work. 	23.07.2021		Pending

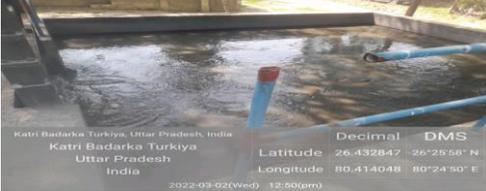
S. No.	Equipment	Assessment of Current Condition	Assessment of Current Condition Photo	Current defects and Corrective Action Suggested by STC, PE	Original Date of Issue	Proposed Date to Resolve by KRMPL	Current Status of Compliance
A	Collection Chamber	Renovation work need to be done by KRMPL.

<p>Katri Badarka Turkiya, Uttar Pradesh, India Decimal DMS Latitude 26.432847 26°25'58" N Longitude 80.414048 80°24'50" E 2022-03-02(Wed) 12:30(pm)</p>	<ol style="list-style-type: none"> All gates to be repalced. Repairing work of free board of this chamber found very poor this must be repaired. Renovation to be completed without getting approval ,testing & commissioning. Handrailing need to be replaced. 	01.03.2021		Pending
1	Inlet Chamber (Civil)	Needs to be renovated in all respects.

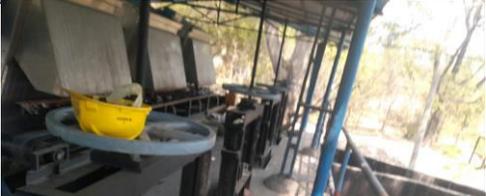
S. No.	Equipment	Assessment of Current Condition	Assessment of Current Condition Photo	Current defects and Corrective Action Suggested by STC, PE	Original Date of Issue	Proposed Date to Resolve by KRMPL	Current Status of Compliance
5	Mechanical Fine Screen no. 2	unavailability of DG set Mechanical screen found Non-Operational.

<ol style="list-style-type: none"> Mechanical screen of teeth are damaged , KRMPL has not been repaired. Mechanical Fine Screen are need to be installed as per approved drawing. Screen needs to be clean periodically depends on the sewage. Mechanical Screen is not working with auto system and without sensor .Need to be fixed the auto system immediately. New Cables should be laid properly in cable trays. Autosystem and level sensor meter has not been installed by KRMPL till date. 	23.11.2021		Pending
6	Mechanical Fine Screen no. 3	operated

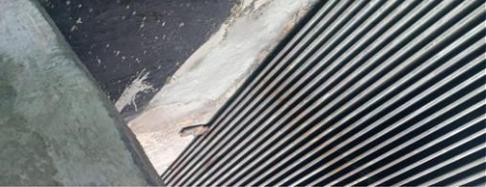
7	Manual Screen no. 1	Operated

<ol style="list-style-type: none"> KRMPL has been installed GI anchor fashners in submergence condition for screen. Need to be reaplced SS316/SS304 anchor fashaner. KRMPL without getting approval for shut down and charging the Raw sewage for the same work. KRMPL has not been submitted any approval. 	23.11.2021		Pending

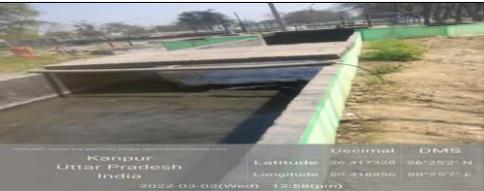
D	Parshall flume and flow meter						
16	Parshall Flume and Flow Channel (Civil)	Structure renovation work done

<ol style="list-style-type: none"> 1. Painting procedure has not been submitted by KRMPL. 2. Channel renovation work done but hydrotest of this channel is pending. 3. Level scale need to be installed for proper flow measurement. 	23.11.2021		Pending
18	Flow meter	Operational

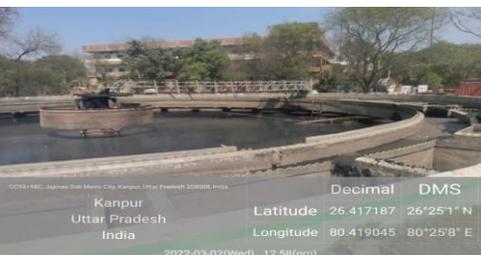
<ol style="list-style-type: none"> Operational wheel found missing ad needs to install for proper operation of the gates. Damaged precast salbs need to be replaced. All Sluice gate need to be replaced. 	01.03.2021		Long Pending
F	Primary Sedimentation tank

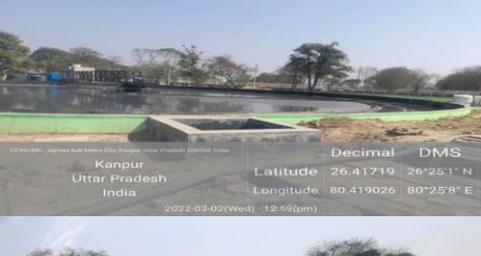
22	Primary Sedimentation tank-2	Due to electric fault in 33/11KV substation at Jajmau form 01.03.2022 and unavailability of DG set Primary sedimentation tank 02 found Non-Operational.

<ol style="list-style-type: none"> KRMPL need to arrange proper power backup to operate the Primary sedimentation tank 02. PST commisioned 29.01.2022 and bioremediation started from after commisioned. 	01.03.2021		
23	Primary Sedimentation tank-3	Due to electric fault in 33/11KV substation at Jajmau form 01.03.2022 and unavailability of DG set Primary sedimentation tank 02 found Non-Operational.

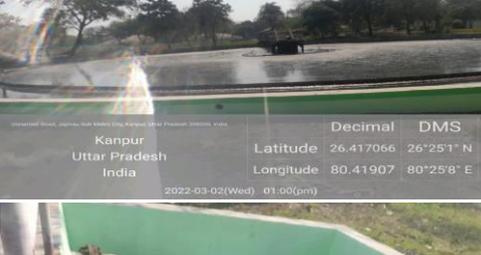
<ol style="list-style-type: none"> KRMPL need to arrange proper power backup to operate the Primary sedimentation tank 03 Plastering and finishing work to be done at PST-3. Weir plate to be replaced at damaged portion. PST-3 mechanism to be replaced and install. Remote system to be installed for PST-3. Cable to be laid in cable tray. Log Book need to be maintained. Bioremediation started form 28.01.2022 	01.03.2021		Long Pending

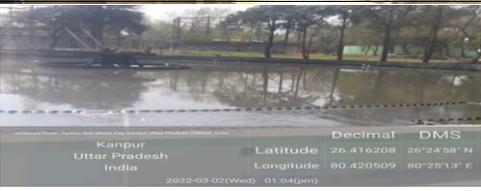
S. No.	Equipment	Assessment of Current Condition	Assessment of Current Condition Photo	Current defects and Corrective Action Suggested by STC, PE	Original Date of Issue	Proposed Date to Resolve by KRMPL	Current Status of Compliance
51	Final Sedimentation Tank no.3	Due to electric fault in 33/11KV substation at Jajmau form 01.03.2022 and unavailability of DG set,Final sedimentation tank 02 found Non-Operational.

<ol style="list-style-type: none"> 1.KRMPL need to arrange sufficient power backup to operational Final sedimentation tank 02. 2. Plastering and finishing work to be done at FST-3. 3.FST 03 equipments need to be replaced. 4.LPBS system to be installed for FST-3. 5.Cable need to be laid in cable tray. 6. E&M materials has not supplied by KRMPL for renovation work. 	01.03.2021		Long Pending
K	Treated Effluent Pump House	Due to electric fault in 33/11KV substation at Jajmau form 01.03.2022 and unavailability of DG set,only 5 Nos TEPH pumps found Operational.

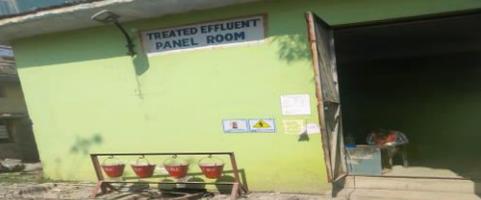
<ol style="list-style-type: none"> 1. KRMPL need to arrange sufficient power backup to operate all TEPH pumps. 2. New Treated effluent pump house has already been proposed in CA and needs to keep this pump house in working condition till the renovation period. 3. Civil Drawing of pump foundation not submitted by KRMPL for Renovation work. 4.Out of 11 pumps only 4 Nos.pump has been supplied at site and 2 Nos. Pump with motor has been installed . 5. Log Book need to be maintained. 	01.03.2021		Long Pending

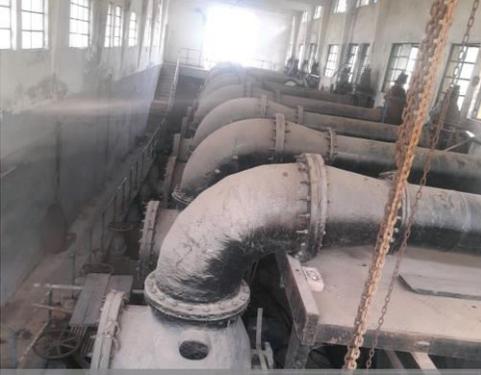
<ol style="list-style-type: none"> 1.New TEPH cum Sump has already been proposed in CA and needs to keep this sump in working condition till the renovation period. 	01.03.2021		Long Pending
53	Treated Effluent Pump House (Civil)	Structure is in bad condition.

<ol style="list-style-type: none"> 1.New TEPH cum Sump has already been proposed in CA and needs to keep Pump house in working condition till the renovation period. 2.Pump foundation are found in damaged condition. 3.Hand railing to be repaired and installed. 	01.03.2021		Long Pending
54	TEPH Pump no.1	Operational

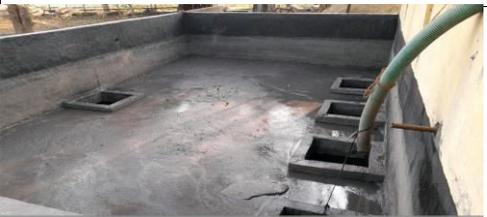
S. No.	Equipment	Assessment of Current Condition	Assessment of Current Condition Photo	Current defects and Corrective Action Suggested by STC, PE	Original Date of Issue	Proposed Date to Resolve by KRMPL	Current Status of Compliance
L	Return Sludge Pump House						
65	Return sludge Sump (Civil)	Needs rehabilitation

<ol style="list-style-type: none"> Sludge cleaning work done by KRMPL only top of slab. Renovation work done by KRMPL only slab top. KRMPL need to clean sump from bottom of slab. 	01.03.2021		Long Pending
66	Return Sludge Pump House (Civil)	Needs rehabilitation

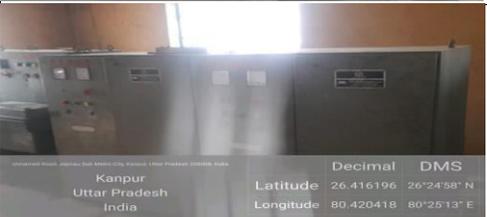
<ol style="list-style-type: none"> Only outer face painting work partially done by KRMPL. Dewatering arrangement need to be arrange. Foundation of pumps need to be renovate. KRMPL need to submit Civil drawing of foundation for renovation work. Renovation work of internal wall need to be done. Lighting arrangement and Cable to be laid in cable tray. LPBS system to be install at site Cable need to be dressed properly All Indoor Light to be replace immediately Log Book need to be maintained. 	01.03.2021		Long Pending

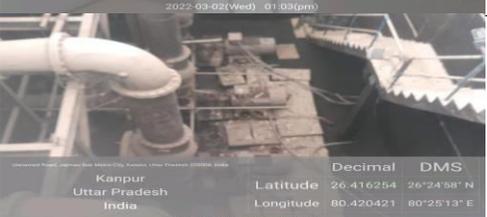
67	Return Sludge Pump no. 1	Due to electric fault in 33/11KV substation at Jajmau form 01.03.2022 and unavailability of DG set, all pumps found Non-Operational.

<ol style="list-style-type: none"> KRMPL need to arrange sufficient power backup during any breakdown from Keso. Cables to be arranged in proper manner and should be laid in cable tray. Leakage has been detected in the pipes connecting to the Pumps. All panel found non-operational. 2 Nos new pumps has been installed by KRMPL without get any prior approval from UPJN/PE and KRMPL has not submitted any erection procedure as per CA schedule 11. Erection and commissioning of pumps have been done by KRMPL. KRMPL has not complied the compliance raised by PE officials. Thermometer and vibration meter should be at site. Vibration and Temperature reading has not mention in the daily log book. 	10.12.2021		Pending
68	Return Sludge Pump no. 2

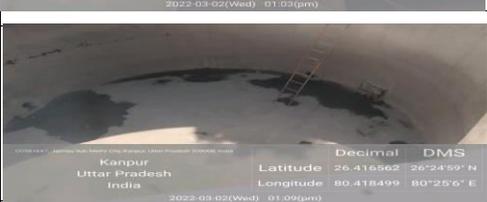
69	Return Sludge Pump no. 3						
70	Return Sludge Pump no. 4						
M	Blending Tank						
71	Civil works	Belding tank found partially renovate

<ol style="list-style-type: none"> Sludge disposal work done from dated 04.02.2022 to 22.02.2022 from common sludge chamber. Cleaning work need to be done. Sewages should be removed from site after cleaning of chamber. Interconnection of sludge pipe line for Inlet and Outlet cleaing is pending. Cracks should be treated by Pressure grouting. Structure should be strength and visible bars to be covered with concrete. 	01.03.2021		Long Pending
	Blending Tank Agitator	New Replacement as per BEPI

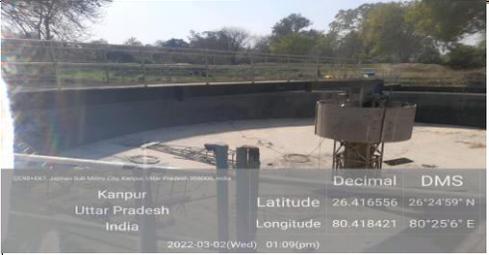
S. No.	Equipment	Assessment of Current Condition	Assessment of Current Condition Photo	Current defects and Corrective Action Suggested by STC, PE	Original Date of Issue	Proposed Date to Resolve by KRMPL	Current Status of Compliance
73	Gravity Sludge Thickener no. 1	Not functional

<ol style="list-style-type: none"> Mechanical bridge has installed of sludge thickener No. 02 on 26.02.22 and balance equipments commissioning work is in progress. Renovation need to be done for interconnection pipe line of inlet and outlet of this chamber. Repair and Rehabilitate done for wall of sludge thickener. Plastering and finishing work done. Make structure free from the Cracks. Remote system to be installed for GST-1. Cable to be laid in cable tray. 	01.03.2021		Long Pending
74	Gravity Sludge Thickener no. 2	Non-Operational

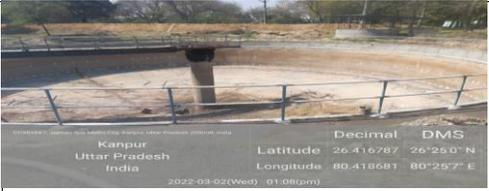
<ol style="list-style-type: none"> Sludge Thickener found is under renovation. Sludge removal work of Sludge Thickener from 03.02.22 to 22.02.22 and Dismantled the scraper system done on 23.02.22 and 24.02.22 respectively. Civil structure to be repaired and make it free from any structural defects & deficiencies. Plastering and finishing works to be done. New Gravity Sludge Thickener equipments drawings have been vatted by PE / UPJN but KRMPL has not supplied as same. Remote system to be installed for GST-2. Cable to be laid in cable tray. Sludge thickener no. 2 is to be replaced. Hand railing to be replace . 	01.03.2021		Long Pending

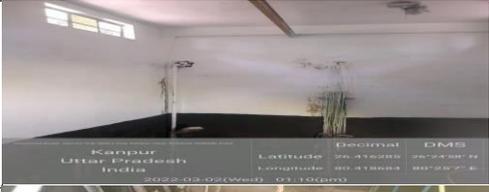
0	Thickened Sludge Pump House						
75	Thickened sludge Pump House cum Sump (Civil works)	Structure needs rehabilitation

<ol style="list-style-type: none"> Cleaning work of roof slab is in progress by KRMPL. Sump to be clean and rehabilitate. Precast cover slabs of Sump to be replaced . Pump house structure needs plastering and finishing works. Cracks should be treated with proper technique. Remote system to be installed for TSPH. Cable to be laid in cable tray. All Thickened sludge pumps to be replaced as per CA. Dewatering pump to be installed for removing extra water. EOT crane /lighting /exhaust fan to be installed . Log Book need to be maintained. 	10.12.2021		Pending
76	Thickened Sludge Pump no.1	Not operated

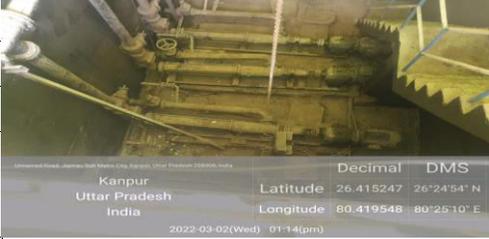
1. Need to be replaced	27.11.2021		Pending
77	Thickened Sludge Pump no.2	Not operated		1. Need to be replaced			
78	Thickened Sludge Pump no.3	Not operated		1. Need to be replaced

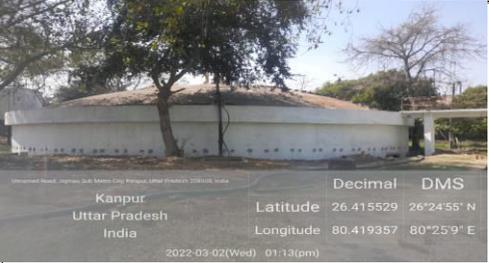
S. No.	Equipment	Assessment of Current Condition	Assessment of Current Condition Photo	Current defects and Corrective Action Suggested by STC, PE	Original Date of Issue	Proposed Date to Resolve by KRMPL	Current Status of Compliance
80	Primary Sludge Digester no. 1	Under maintenance

Decimal DMS Kanpur Uttar Pradesh India Latitude 26.415529 26°24'55" N Longitude 80.419357 80°25'9" E 2022-03-02(Wed) 01:13(pm)	<ol style="list-style-type: none"> Cleaning work of digester done partially by KRMPL. Outer face cracks repair work and painting work is in progress by KRMPL. Removal of centrally located sludge mixing shaft from Primary Digester 1. Gate to be overhaul Civil Structure of the Digester to be renovate and cracks to be treated. Leakage to be Arrested in the Digester. Installation of the Railing at the boundary of the dome. 	01.03.2021		Long Pending
81	Primary Sludge Digester no. 2	Not operational

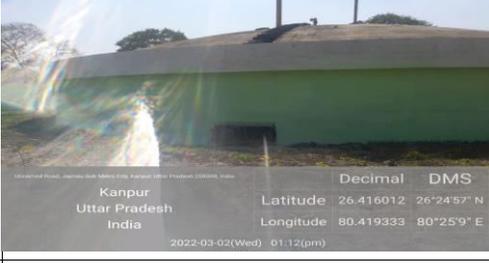
Decimal DMS Kanpur Uttar Pradesh India Latitude 26.416012 26°24'57" N Longitude 80.419333 80°25'9" E 2022-03-02(Wed) 01:12(pm)	<ol style="list-style-type: none"> Cleaning work of Primary digester done partially. Outer face cracks repair and painting work is in progress by KRMPL. Gate to be overhaul Civil Structure of the Digester to be renovate and cracks to be treated. Leakage to be Arrested in the Digester. Installation of the Railing at the boundary of the dome. 	01.03.2021		Long Pending

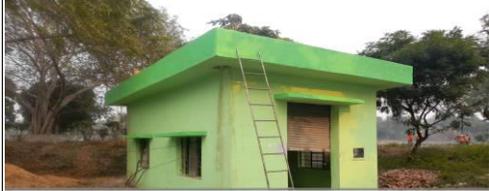
<ol style="list-style-type: none"> Outer face cracks repair and painting work done by KRMPL. Polymer concete work done under renovation work. Gate to be overhaul Civil Structure of the Digester to be renovate and cracks to be treated with all respect. Leakage to be Arrested in the Digester. Installation of the Railing at the boundary of the dome. Finishing work to be done. 	01.03.2021		Long Pending
R	Digested Sludge Pump House						
83	Digested Sludge Pump House cum Sump (Civil works)	Need to be renovated

<ol style="list-style-type: none"> Sump to be clean and renovate. Installation of the railing on the boundary of the sump. Precast cover to be replaced or constructed on the sump. Stairs at the pump house to be renovate. Plastering work and finshing work to be done in the pump house. Foundation of the pumps to be repaired. Railing to be repair in the Pump house. LPBS System to be installed for GST-1. Cable need to be laid in cable tray. Dewatering pump to be installed. Log Book need to be maintained. 	01.03.2021		Long Pending

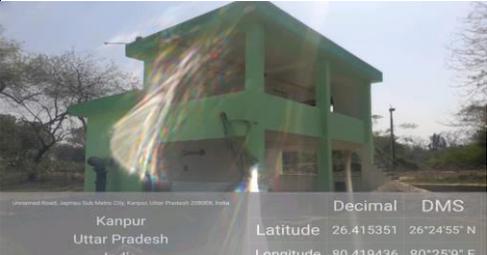
S. No.	Equipment	Assessment of Current Condition	Assessment of Current Condition Photo	Current defects and Corrective Action Suggested by STC, PE	Original Date of Issue	Proposed Date to Resolve by KRMPL	Current Status of Compliance
5	Centrifuge						
88	Centrifuge Building (Civil Works)	Not operational

<ol style="list-style-type: none"> 1. Plastering and finishing work of the Centrifuge building and centrate Pump house. 2. Railing and steel ladder to be repaired or replaced as per site condition. 3. Housekeeping to be done. 4. Sign boards are required. 5. No approach road found at site to get on thsi unit/component. 6. Proper lighting arrangement to be required at site. 7. All centrate pump 4 no. to be replace. <p style="text-align: center;">7.As per CA centrifuge to be repaired.</p>	01.03.2021		Long Pending
89	Centrifuge Pump no.1	All centrifuge were in dilapidated condition and dismantling work is completed

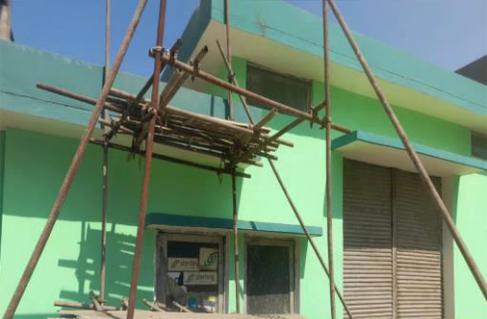
STC				SITE INSPECTION REPORT			Jajmau STP - 130 MLD	
S. No.	Equipment	Assessment of Current Condition	Assessment of Current Condition Photo	Current defects and Corrective Action Suggested by STC, PE	Original Date of Issue	Proposed Date to Resolve by KRMPL	Current Status of Compliance	
W1	Compressor panel room	Renovation work is in progress

<ol style="list-style-type: none"> 1. Roof slab cleaning work is in progress. 2. KRMPL is doing surface roof treatment for compressor panel room slab while KRMPL didn't submit any methodology, Work process and Work Plan. 3. Outer face plaster work is in progress by KRMPL with mortar (1:3) cement:sand ratio. 4. Plaster work should be proper thickness, verticality and smoothness but KRMPL is not doing same as per CA specification. 5. Cracks repairing work in ceiling slab is in progress by KRMPL. 6. KRMPL has engaged 9 Nos of labour for civil work. 	10.12.2021		Pending

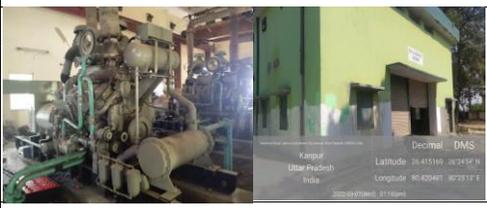
111	DFG no.1	not oprated						
112	DFG no.2	Operated						
113	DFG no.3	Operated			<ol style="list-style-type: none"> 1. Proper lighting arrangement to be required at site. 2. DFG to be replaced as per CA and BEP. 3. Derating of DFG calculation need to be of 2 DFG for plant operation 	01.03.2021		Long Pending
114	DFG no.4	not oprated						
115	DFG no.5	not oprated						
Z	Filtrate Pump

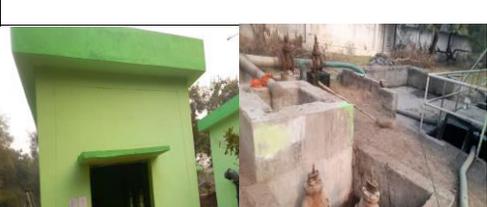
116	Filtrate pump cum Sump (Civil works)			<ol style="list-style-type: none"> 1. Civil structure needs finishing work to be done. 	01.03.2021		Long pending	
117	Filtrate Pump no.1	Not working			<ol style="list-style-type: none"> 1. As per CA, Filtrate pump to be replaced. 2. KRMPL has not submitted design, drawing for approval till date 	01.03.2021		Long pending
118	Filtrate Pump no.2	Not working
