SITE INSPECTION REPORT FOR 42 MLD Sajari STP

Date:
07.03.2022

INSPECTED BY:
STC Team:
1) Dr. Giridhar Prabhu Kumar (TL) 2.
Mr. L.K.Rao (Safety Expert)
3) Mr. Rohit Suman (Supp. Engr.
Mechanical)
4) Mr. Pankaj Rawat (Supp. Sup. Civil)

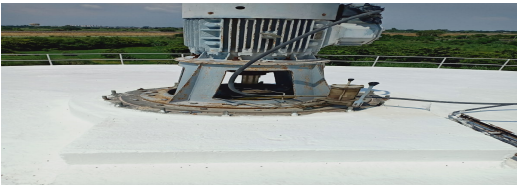
3	Thickened sludge pump 1	Operational						
4	Thickened sludge pump 2	Operational						
5	Sludge digester-01	Operational

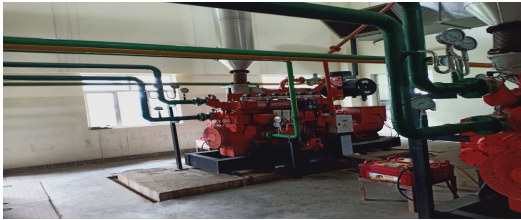
Must be rectified at the earliest		18.11.2021	28.02.2022	LONG PENDING
8	Gas engine -1	Operational
