National Mission for Clean Ganga- Development, Rehabilitation with
Operation & Maintenance of STPs at Kanpur under Hybrid Annuity based PPP mode

Sub: HAM KANPUR: Inspection Report of 43 MLD IPS and STP Jajmau facilities Phase II, Inspection done on 15.03.2022

SITE INSPECTION OF JAJMAU ASSOCIATED IPS REPORT				Parmiya IPS - 3.5 MLD	Date: 15.03.2022	INSPECTED BY: UPJN Team 1. Mr. Ajeet Singh, J.En Civil 2. Mr. Ankit Singh, J.En E&M 3. Mr. Ashish Seyal, J.En E&M STC-Team 1. Dr. Girdhar Prabhukumar, Team Leader cum Waste water Expert. 2. Mr Anuj Kushwaha(Support Engineer Civil) 3. Mr Ajay Goyal (Support Engineer- Mechanical) KRMLP-Team 1. Mr Satyam Bharati, Process Engineer

SITE INSPECTION REPORT FOR 43 MLD JAJMAU PHASE-II STP

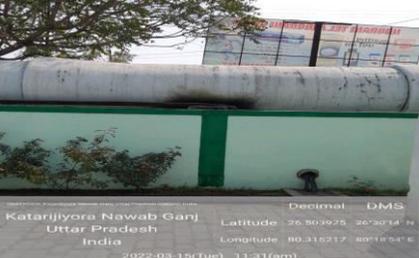
<p>Decimal DMS Katarjiyora Nawab Ganj Uttar Pradesh India Latitude 26.503025 26°30'12" N Longitude 80.315217 80°18'54" E 2022-03-15(Tue) 11:31(am)</p>	<ol style="list-style-type: none"> 1. Boundary wall Painting work need to be done. 2. Kesco cable fault on 14.03.2022 after that IPS was running on DG power. 	15-12-2021		Pending

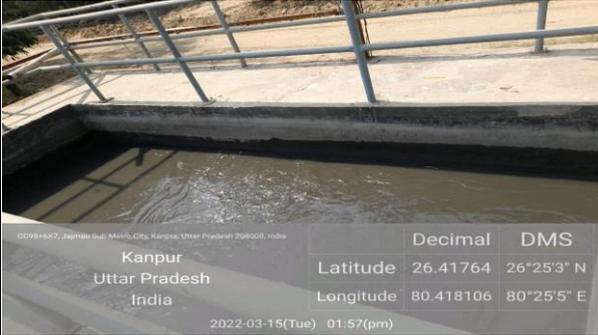
S. No.	Equipment	Assessment of Current Condition	Assessment of Current Condition Photo	Corrective Action Suggested by STC	Original Date of Issue	Proposed Date to Resolve by KRMPL	Current Status of Compliance
A	Inlet Chamber	1.Intel chamber painting for internal and external surfaces are not satisfactory. 2.Lubrication of sluice gate not done. 3.Cleaning work of chamber is pending.

CCPR-667, Jajmau Sub Merit City, Kanpur, Uttar Pradesh 208009, India Kanpur Uttar Pradesh India Decimal DMS Latitude 26.41764 26°25'3" N Longitude 80.418106 80°25'5" E 2022-03-15(Tue) 01:57(pm)	1. Chamber and hand railing painting work need to be done. 2. Sluice gate need to be lubrication 3. Cleaing of inlet chamber need to be done.	21.09.2021		Pending.
1	Fine Screen No.1(Mecahnical)	Non-operated and not proper alignment

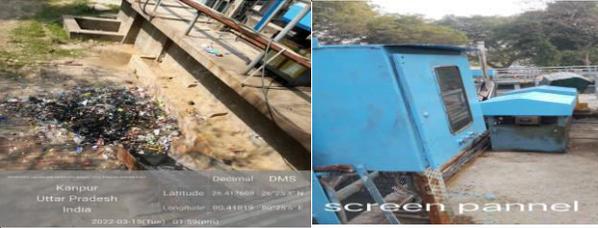
CCPR-667, Jajmau Sub Merit City, Kanpur, Uttar Pradesh 208009, India Kanpur Uttar Pradesh India Decimal DMS Latitude 26.41766 26°25'3" N Longitude 80.41808 80°25'5" E 2022-03-15(Tue) 01:58(pm)		21.09.2021		Pending.
3	Fine Screen No.3(Manual)	Opertaional

Kanpur Uttar Pradesh India Decimal DMS Latitude 26.41766 26°25'3" N Longitude 80.41808 80°25'5" E 2022-03-15(Tue) 01:58(pm) screen pannel		16.12.2021		Pending.

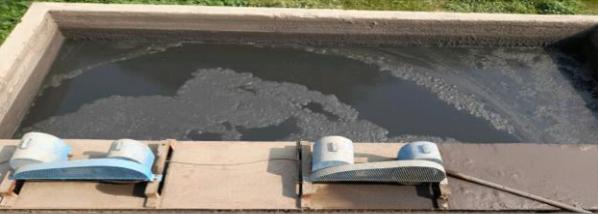
5	Centrifuge thickened sludge sump + Agitator 2 Nos.	1 - Operated 1- Operated

<p>Unnamed Road, Jajmau Sub Metro City, Kanpur, Uttar Pradesh 208008, India</p> <table border="1"> <thead> <tr> <th></th> <th>Decimal</th> <th>DMS</th> </tr> </thead> <tbody> <tr> <td>Kanpur</td> <td></td> <td></td> </tr> <tr> <td>Uttar Pradesh</td> <td>Latitude</td> <td>26.416087 26°24'57" N</td> </tr> <tr> <td>India</td> <td>Longitude</td> <td>80.418841 80°25'7" E</td> </tr> </tbody> </table> <p>2022-03-15(Tue) 02:48(pm)</p>		Decimal	DMS	Kanpur			Uttar Pradesh	Latitude	26.416087 26°24'57" N	India	Longitude	80.418841 80°25'7" E	<ol style="list-style-type: none"> 1. Sludge cleaning work need to be done. 2. Need to be overhauled & servicing as required. 3. Log book need to be maintained. 	16.12.2021		Pending
	Decimal	DMS																	
Kanpur																			
Uttar Pradesh	Latitude	26.416087 26°24'57" N

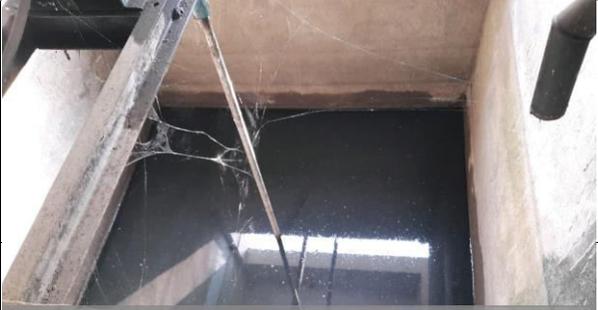
India	Longitude	80.418841 80°25'7" E																	
6	Poly Dosing(No.1 & 2)	Operational

<ol style="list-style-type: none"> 1. Need to be Overhauled & Servicing. 2. Log book need to be maintained. 	21.09.2021		Pending												
7	Agitator No.1	Non-Operational

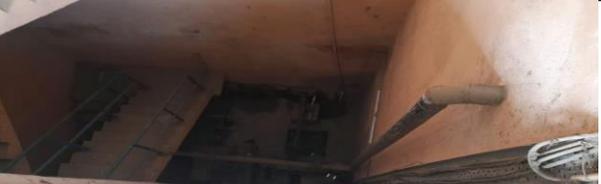
10	Digester feed Pump(No.1 & 2)	Non-Operated

<p>CC08+SJA_ Japnau Sub Metro City, Kanpur, Uttar Pradesh 208008, India</p> <table border="1"> <thead> <tr> <th></th> <th>Decimal</th> <th>DMS</th> </tr> </thead> <tbody> <tr> <td>Kanpur Uttar Pradesh India</td> <td>Latitude 26.416166 Longitude 80.41826</td> <td>26°24'58" N 80°25'5" E</td> </tr> </tbody> </table> <p>2022-03-15(Tue) 02:37(pm)</p>		Decimal	DMS	Kanpur Uttar Pradesh India	Latitude 26.416166 Longitude 80.41826	26°24'58" N 80°25'5" E	<ol style="list-style-type: none"> 1. Need to be overhall and servicing. 2. Lubrication of pump need to be done. 	21.09.2021		Pending
	Decimal	DMS											
Kanpur Uttar Pradesh India	Latitude 26.416166 Longitude 80.41826	26°24'58" N 80°25'5" E											
G	Sludge Thickner No.1	Non-Operated

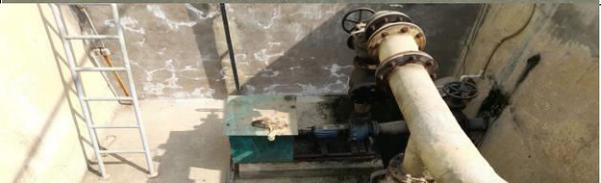
Decimal	DMS											
Kanpur Uttar Pradesh India	Latitude 26.417354 Longitude 80.418536	26°25'2" N 80°25'6" E											
1	Supertanant pump no 1 & 2	Operational

<p>CC08+SJA_ Japnau Sub Metro City, Kanpur, Uttar Pradesh 208008, India</p> <table border="1"> <thead> <tr> <th></th> <th>Decimal</th> <th>DMS</th> </tr> </thead> <tbody> <tr> <td>Kanpur Uttar Pradesh India</td> <td>Latitude 26.416169 Longitude 80.418244</td> <td>26°24'58" N 80°25'5" E</td> </tr> </tbody> </table> <p>2022-03-15(Tue) 02:36(pm)</p>		Decimal	DMS	Kanpur Uttar Pradesh India	Latitude 26.416169 Longitude 80.418244	26°24'58" N 80°25'5" E	<ol style="list-style-type: none"> 1. We have found heavy viberation at Pump no 2 during visit.KRMPL need to be repair. 2. Pipe support need to be replace as required . 3. Viberation and Temperature need to be measure on regular basis. 4. Pump log book has not maintained by KRMPL. 5. Dewatering from the sump need to be required. 	16.12.2021		Pending
