SITE INSPECTION REPORT FOR 42 MLD Sajari STP

SAJARI STP

Date:
08.06.2022

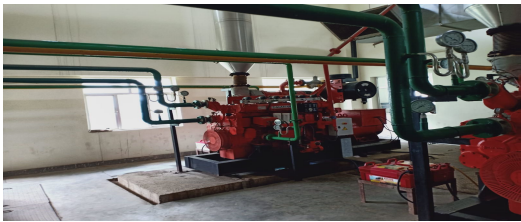
8	Gas engine -1	Operational
