National Mission for Clean Ganga- Development, Rehabilitation with
Operation & Maintenance of STPs at Kanpur under Hybrid Annuity based PPP mode

Ref. STC / PE / KNP /1679 / Jajmau Phase I & II

Date : 29.06.2022

Sub: HAM KANPUR: Inspection Report of 130 MLD & 43 MLD IPSs and STP Jajmau facilities,
Inspection done on 06.06.2022 and 07.06.2022 and 20.06.2022.

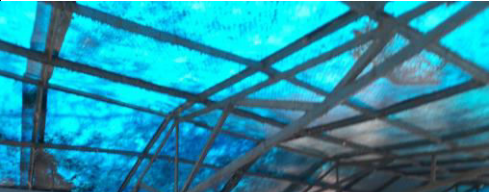
4	Mechanical Fine Screen no. 1	Functional

<ol style="list-style-type: none"> 1. Mechanical Fine Screen are need to be installed as per approved drawing. 2. Mechanical screen of teeth are damaged , KRMPL has not been repaired. 3. Screen erection/ installation work is not verified by STC . 4. Mechanical Screen not working with auto system and without sensor, need to be fixed the auto system immediately. 5. Procedure of screens has not been submit by KRMPL. 6. Without getting approval for shut down and charging the Raw sewage for the same work. KRMPL has not been submitted any approval. 7. Autosystem and level sensor meter has not been installed by KRMPL till date. 	23.11.2021		Pending

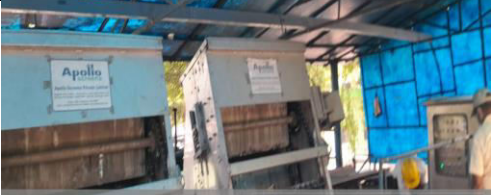
S. No.	Equipment	Assessment of Current Condition	Assessment of Current Condition Photo	Current defects and Corrective Action Suggested by STC, PE	Original Date of Issue	Proposed Date to Resolve by KRMPL	Current Status of Compliance
5	Mechanical Fine Screen no. 2	Functional

1. Mechanical screen of teeth are damaged , KRMPL has not been repaired. 2. Mechanical Fine Screen are need to be installed as per approved drawing. 3. Screen needs to be clean periodically depends on the sewage. 4. Mechanical Screen is not working with auto system and without sensor .Need to be fixed the auto system immediately. 5. New Cables should be laid properly in cable trays. 6. Autosystem and level sensor meter has not been installed by KRMPL till date.	23.11.2021		Pending
6	Mechanical Fine Screen no. 3	Functional

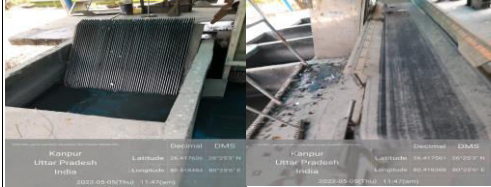
7	Manual Screen no. 1	Operated

1. KRMPL has been installed GI anchor fasteners in submergence condition for screen. Need to be replaced SS316/SS304 anchor fastener. 2. KRMPL without getting approval for shut down and charging the Raw sewage for the same work. KRMPL has not been submitted any approval.	23.11.2021		Pending

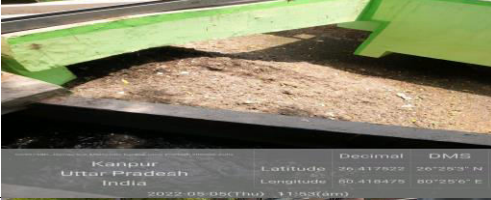
S. No.	Equipment	Assessment of Current Condition	Assessment of Current Condition Photo	Current defects and Corrective Action Suggested by STC, PE	Original Date of Issue	Proposed Date to Resolve by KRMPL	Current Status of Compliance
C	Grit Chamber						
8	Grit Chamber	Renovation work done by KRMPL.

1. Outer side painting work in progress in Grit Chamber 03. 2. Log Book need to be maintained. 3. Handrails need to be provided by KRMPL. 4. Flooring need to be done by KRMPL.	01.03.2021		Lond pending
9	Grit Mechanism-1	Operational

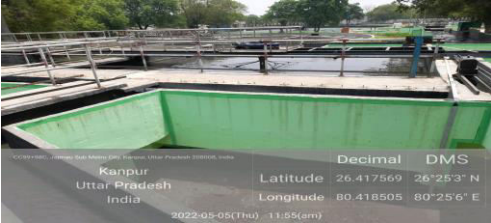
1. KRMPL need to provide proper excess to Grit mechanism platform. 2. Renovation in screw conveyor channel is pending. 3. KRMPL without getting approval for shut down and charging the Raw sewage for the same work. KRMPL has not been submitted any approval. 4. KRMPL has not been submitted installation procedure for Grit Mechanism System. 5. KRMPL has not submitted any RFI's (Request for Inspection).	01.03.2021		Lond pending

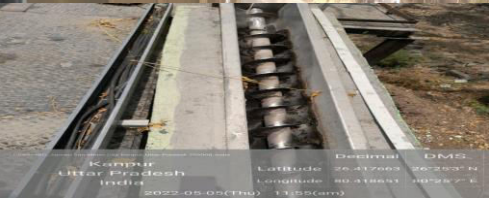
S. No.	Equipment	Assessment of Current Condition	Assessment of Current Condition Photo	Current defects and Corrective Action Suggested by STC, PE	Original Date of Issue	Proposed Date to Resolve by KRMPL	Current Status of Compliance
13	Grit Classifier -2	Non-operational

1. Not in working due to foundation damage. 2. Need to be repaired immediately and to be replaced as per the CA 3. Grit Classifier alignment has not been done by KRMPL as per approved drawing. 4. Organic pump needs to be replaced as per approved drawing.	01.03.2021		Long pending
14	Grit Classifier -3

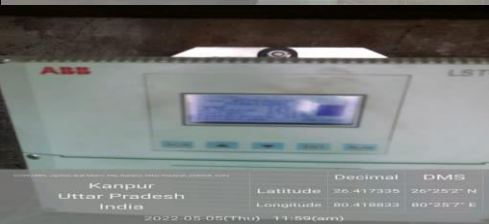
18	Flow meter	Operational

1. Power backup arranged by KRMPL 19.02.2022. 2. Flow meter found working and under trial run. 3. Glass door needs to be installed for Flow meter 4. Commissioning has not been completed yet. 5. Cable needs to be laid properly in cable tray and conduit pipe. 6. Log Book needs to be maintained. 7. Factory calibration report has not been submitted by KRMPL.	23.11.2021		Pending
E	Distribution Chamber -1

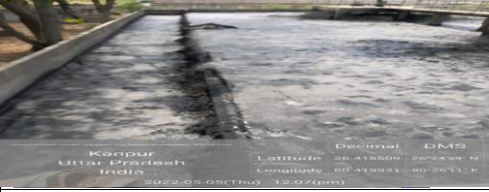
S. No.	Equipment	Assessment of Current Condition	Assessment of Current Condition Photo	Current defects and Corrective Action Suggested by STC, PE	Original Date of Issue	Proposed Date to Resolve by KRMPL	Current Status of Compliance
41	Aerator no. 13	Operational

1. Aerators need to be replaced. 2. Canopies to be installed on the top of motors. 3. Cable need to be laid in cable tray. 4. LPBS system to be install at site	01.03.2021		Long Pending
42	Aerator no. 14	Operational					
43	Aerator no. 15	Non-operational					
44	Aerator no. 16	Operational					
45	Aerator no. 17	Operational					
46	Aerator no. 18	Operational					
I	Distribution Chamber -3						
47	Civil works	To be renovated

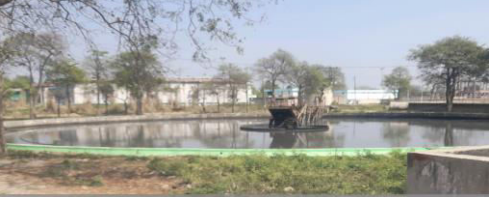
S. No.	Equipment	Assessment of Current Condition	Assessment of Current Condition Photo	Current defects and Corrective Action Suggested by STC, PE	Original Date of Issue	Proposed Date to Resolve by KRMPL	Current Status of Compliance
K	Treated Effluent Pump House	Operational

1. KRMPL need to arrange sufficient power backup to operate all TEPH pumps. 2. New Treated effluent pump house has already been proposed in CA and needs to keep this pump house in working condition till the renovation period. 3. Civil Drawing of pump foundation not submitted by KRMPL for Renovation work. 4. Out of 11 pumps only 4 Nos. pump has been supplied at site and 2 Nos. Pump with motor has been installed. 5. Log Book need to be maintained.	01.03.2021		Long Pending
52	Treated Effluent sump (Civil)	Structure is in damaged condition

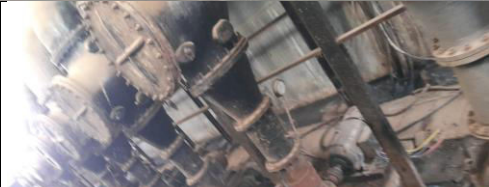
1. New TEPH cum Sump has already been proposed in CA and needs to keep this sump in working condition till the renovation period.	01.03.2021		Long Pending

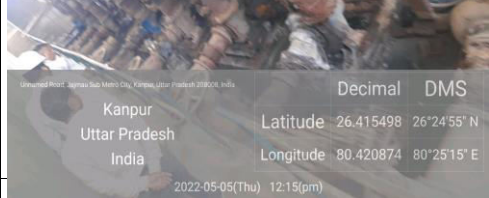
53	Treated Effluent Pump House (Civil)	Structure is in bad condition.

<p>Unrecorded Report - Jajmau Sub Metro City, Kanpur, Uttar Pradesh 208006, India</p> <p>Decimal DMS</p> <p>Kanpur Uttar Pradesh India</p> <p>Latitude 26.415498 26°24'55" N Longitude 80.420874 80°25'15" E</p> <p>2022-05-05(Thu) 12:15(p.m)</p>	1. New TEPH cum Sump has already been proposed in CA and needs to keep Pump house in working condition till the renovation period. 2. Pump foundation are found in damaged condition. 3. Hand railing to be repaired and installed.	01.03.2021		Long Pending
54	TEPH Pump no.1	Operational

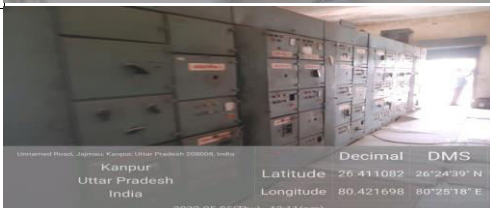
67	Return Sludge Pump no. 1	Pump no 03-Non functional

<div><div>Kanpur Uttar Pradesh India</div><div>Latitude 26.411082 26°24'39" N Longitude 80.421698 80°25'18" E</div><div>2022-05-05(Thu) 12:11 (pm)</div></div>	1.KRMPL need ro arrange sufficient power backup during any brekdown from Keso. 2.Cables to be arranged in proper manner and should be laid in cable tray. 3.Leakage has been detected in the pipes connecting to the Pumps. 4.All panel found non-operational. 5. 2 Nos new pumps has been installed by KRMPL without get any prior approval from UPJN/PE and KRMPL has not submitted any erection procedure as per CA schedule 11. 6.Erection and commissioning of pumps have been done by KRMPL.KRMPL has not complied the complainece raised by PE officials . 7. Thermometer and vibration meter should be at site.Vibration and Temperature reading has not mention in the daily log book.	10.12.2021		Pending

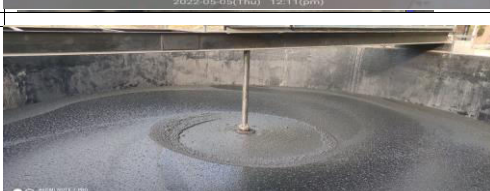
1. Sludge disposal work done from dated 04.02.2022 to 22.02.2022 from common sludge chamber. 2. Belding tank commisioned on 31.05.2022	31.05.2022		
	Blending Tank Agitator	New Replacement as per BEPI

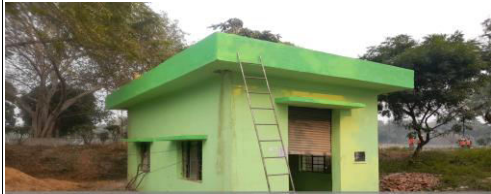
<ol style="list-style-type: none"> Sump to be clean and renovate. Installation of the railing on the boundary of the sump. Precast cover to be replaced or constructed on the sump. Stairs at the pump house to be renovate. Plastering work and finishing work to be done in the pump house. Foundation of the pumps to be repaired. Railing to be repair in the Pump house. LPBS System to be installed for GST-1. Cable need to be laid in cable tray. Dewatering pump to be installed. Log Book need to be maintained. 	01.03.2021		Long Pending

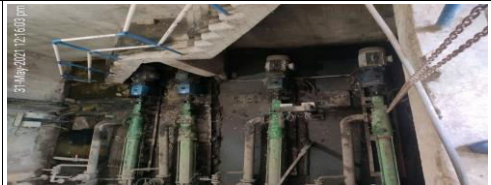
84	Digested Sludge Pump no.1	2 nos out of 4 Nos.

<ol style="list-style-type: none"> KRMPL need to arrange sufficient power backup to operate the pumps and panels. As per CA 4 nos. of screw pumps need to be replaced. Required repair work for pump no.3 & 4 	01.03.2021		Long Pending
85	Digested Sludge Pump no.2						
86	Digested Sludge Pump no.3						
87	Digested Sludge Pump no.4

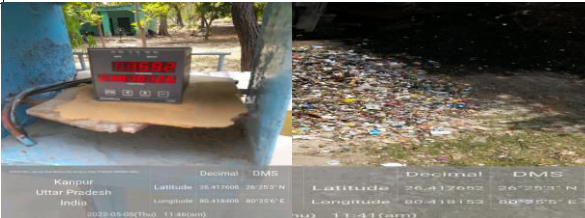
2	Fine Screen No.2 (Mecahnical)				21.09.2021		Pending.
3	Fine Screen No.2(Manual)	Operational

CC0846X7, Jajmau Sub Metro City, Kanpur, Uttar Pradesh 208008, India Kanpur Uttar Pradesh India Latitude 26.41758 Longitude 80.418209 2022-05-05(Thu) 11:40(am)		16.12.2021		Pending.

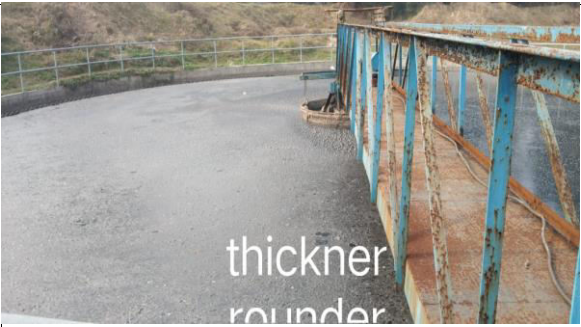
G	Sludge Thickner No.1	Non-Operated

<p>1. Need to be painted.</p> <p>2. Need to be Clean wier plates.</p> <p>3. Sludge cleaning need to be done.</p> <p>4. Need to be Overhaul and servicing.</p> <p>5. Sludge thickener operation needs immediate attention since supernatant from the thickener is discharging heavy solids into the PST inlet distribution chambers overloading the PST system.</p>	21.09.2021		Pending
1	Thickened Sludge Sump (Feed pump no 1 & 2)	Operational

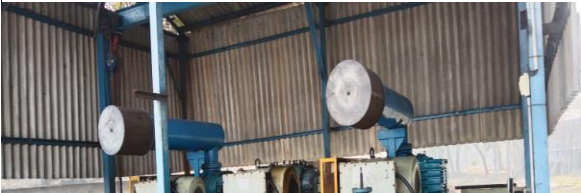
H	Blower Room						
1	Air Blower No.1	Operated

<ol style="list-style-type: none"> 1. Air Blower remote system cable need to be dressed properly. 2. Air blower no.1 need to be rectified . 3. Acoustic hood need to be installed . 4. Vibration and Temperature need to be measure on regular basis. 5. Log book need to be maintained. 6. Pressure guages need to be installed. 7. PRV need to be checked. 8. Insulation work in discharge line needs to be done by KRMPL. 	21.09.2021		Pending
3	Air Blower No.3	Operated

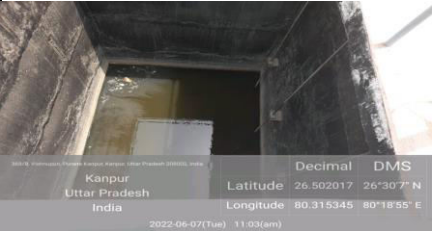
<p>2022-06-07(Tue) 11:01(am)</p> <p>Kanpur Uttar Pradesh India</p> <p>Decimal DMS Latitude 26.50205 26°30'7" N Longitude 80.315295 80°18'55" E</p>	Over flow condition found since handover. Upjn need to take action in this regards.	25.08.2021		Action to be taken by UPJN
2	Inlet Chamber	Epoxy coating found improper in inlet chamber.

<p>2022-06-07(Tue) 11:03(am)</p> <p>Kanpur Uttar Pradesh India</p> <p>Decimal DMS Latitude 26.502017 26°30'7" N Longitude 80.315345 80°18'55" E</p>	1. Finishing of wall need to be done. 2. Epoxy coating work need to be done.	15.12.2021		Pending
3	Coarse bar Screen Chamber(Manual)	Garbages and rusted MS stair and handrailing found

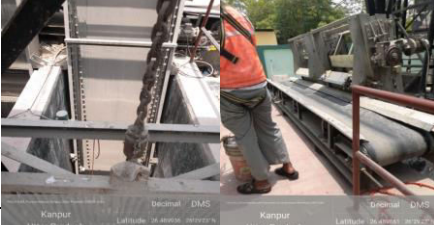
1. Cleaning need to be done. 2. Epoxy Coating need to be done.	15.12.2021		Pending
3	Coarse bar Screen Chamber(Manual)	Civil work is in satisfactory condition

1. Mechanical Screen no. 1 repaired on 07.05.2022 and in working condition ,Mechanical screen no. 2 are not in working condition since long time. 2. Electrical hoist need to be repaired for Manual screen. 3.Manual screen was in overflow condition. 4.Level Indicator is not working condition. 5. Panel cover need to be installed.	15.12.2021		Pending

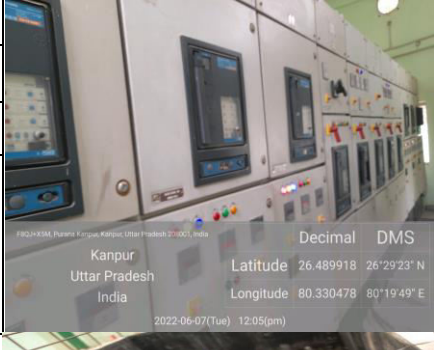
iii	Pump no 3 Capacity(1080 cum/hr)	Operational		7. Monorail painting work and load certification of manual Chain pulley block didn't done by KRMPL. 8. Stud bolt lubrication has not done by KRMPL. 9. KRMPL has not conducted any submitted schedule maintenance plan at Site.		
iv	Pump no 4 Capacity(1080 cum/hr)	Operational				
v	Pump no 5 Capacity(1080 cum/hr)	Operational				
vi	Pump no 6 Capacity(1080 cum/hr)	Non operational

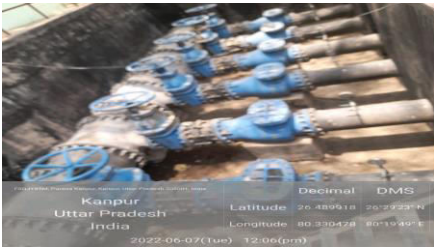
6	Common headerChamber	Operational

<p>1. Pressure guage of pump no 2 is not in woking condition.</p> <p>2. Pump No 2 and Pump No 5 line leakages found.</p> <p>3. Valve and NRV directions are not visualize during operation. So KRMPL has shown the direction on as stated above.</p>	15.12.2021		Pending
7	DG set	Both DG set found operational but diesel fuel found short.

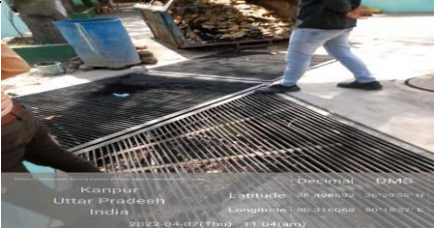
8	Open Channel and Sluice Gate	Civil Structure in unsatisfactory Condition

<p>1. KRMPL has not submitted and approval of fabrication work.</p> <p>2. Sluice gate need to be replace under renovation.</p>	23.11.2021		Pending
9	Boundary wall, Valve chambers and landscaping area	Civil Structure in unsatisfactory Condition

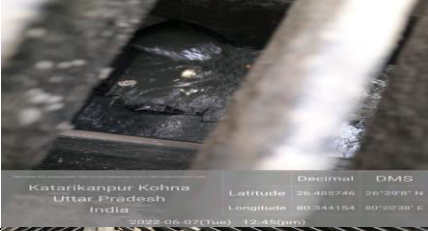
<p>Katarikanpur Kohna Uttar Pradesh India</p> <p>Decimal DMS Latitude 26.485246 26°29'6" N Longitude 80.344164 80°20'38" E</p> <p>2022-06-07(Tue) 12:45(pm)</p>	1. Renovation work need to done with all respect in inlet chamber. 3. Cleaning and landscaping need to be done. 5. KRMPL need to deploy a security guard for this IPS.	23.11.2021		Pending
2	Screen Chamber	Civil Structure is in satisfactory condition

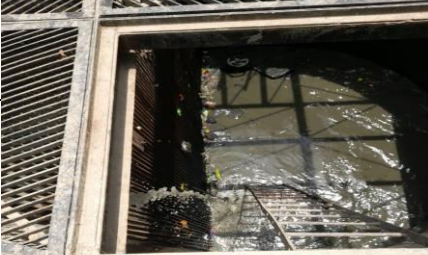
<p>Katarikanpur Kohna, Uttar Pradesh 208001, India</p> <p>Decimal DMS Latitude 26.485436 26°29'7" N Longitude 80.34379 80°20'37" E</p> <p>2022-06-07(Tue) 12:48(pm)</p>	1. Renovation required inner and outer surface of this chamber. 2. Plaster work need to be done. 3. Cleaning and landscaping need to be done. 4. MS frame cover should be painted.	23.11.2021		Pending

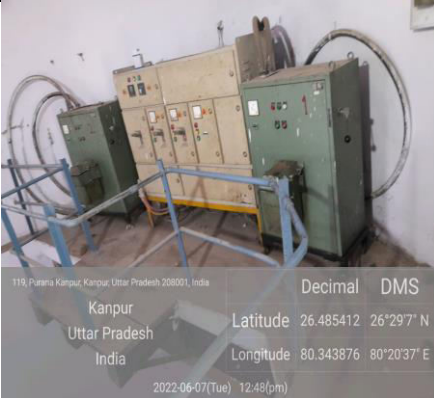
4	Pump house No. 1	Civil Structure is in unsatisfactory condition

<p>1. Painting work carried out by KRMPL for Outer and inner surface of Pump house but workmanship found very poor. These all are represent improper quality of painting work. 3.Replacement of damaged Door,window,louvers and ventilators. 3. Outdoor lightening 10 Nos are available at site and only 4 Nos lights are in working condition. 4. DG set is not working for Pump house 01. 5. Flow meter need to be installed by KRMPL. 6. Dewatering pumps need to be arrange at bottom of Pump house. 7. Flooring work need to be carried out by KRMPL. 8. Internel lightening arrangement need to be replaced for DG set room of Pump house 01. 9. Operators are non technical person. They are not understanding the Pump Capacity , Flow of Discharge, Peak Flow and maintain the records. 10. Pipeline and all type valves need to be replaced.</p>	23.11.2021		Pending

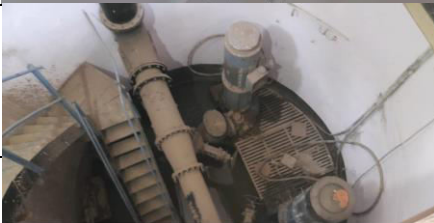
i	Pump No.1(pump capacity =900 m3/hr)	Pump found operational

<p>New pump has been installed at 15.03.2022. But installation of new valves, pipeline and fittings are still pending.</p>	23.11.2021		Pending
ii	Pump No.2(pump capacity =900 m3/hr)	Pump found operational

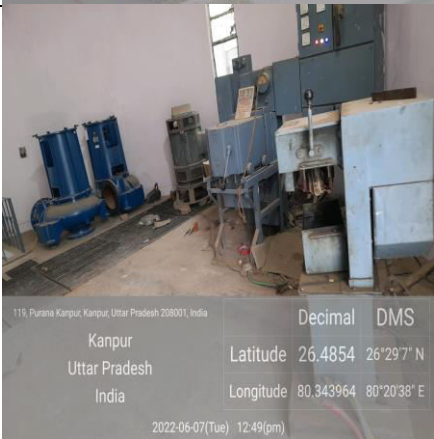
<p>1. No labour egagaged by KRMPL for renovation work. 2. Painting work need to be rework with proper workmanship and material as per recommended by UPJN and PE. 3. KRMPL did not submit any work plan, Methodology and material approval form PE / UPJN. 4. Required repairing the cracks, Finishing activity painting work, Replacement of damaged Door,window,louvers and ventilators. 5.All indoor lightening need to be replaced. 6.Dewatering pumps need to be arrange at bottom of Pump house. 7. Flooring work need to be carried out by KRMPL 8. Flow meter need to be installed by KRMPL. 9. Operators are non technical person. They are not understanding the Pump Capacity , Flow of Discharge, Peak Flow and maintain the records. 10. Pipeline and all type valves need to be replaced.</p>	15.12.2021		Pending

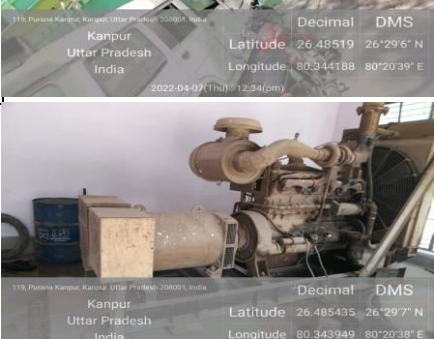
i	Pump No.1(pump capacity =1320 m3/hr)	Non operational	 	1. During site visit it was found that pump no 1 was not in working condition since handover of this IPS. 2. Need to be replaced as per Renovation Plan	23.11.2021		Pending
ii	Pump No.2(pump capacity =1320 m3/hr)	Operational	 	1. Need to be replaced as per Renovation Plan	23.11.2021		Pending
iii	Pump No.3(pump capacity =1320 m3/hr)	Non operational

1. Need to be replaced as per Renovation Plan	23.11.2021		Pending
6	Pump House No. 3	Civil Structure is in unsatisfactory condition	 	1.Required repairing the cracks, Finishing activity painting work, Replacement of damaged Door,window,louvers and ventilators. 2. Pump 3 Nos found not in working condition. 3. Design and drawing for E&M shall be submitted by KRMPL. 4. Outside and inside painting work done by KRMPL under renovation.	23.11.2021		Pending
7	DG room	Civil Structure is in unsatisfactory condition	 	1.Required repairing the cracks, Finishing activity painting work, Replacement of damaged Door,window,louvers and ventilators. 2. KRMPL had completed surface roof treatment without any approval of construction methodology of surface roof treatment. 4. KRMPL is not maintaining the log book of DG set. 5. Smog exhaust pipe length is not sufficient as per CPCB/CPHEO guidelines. It must be replaced on urgent basis.	23.11.2021		Pending

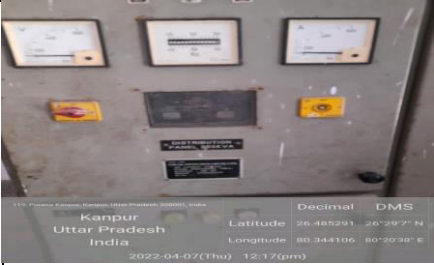
9	Panel Room	Civil Structure is in unsatisfactory condition

<p>136/A, Purana Kanpur, Kanpur, Uttar Pradesh 208001, India</p> <p>Kanpur Uttar Pradesh India</p> <p>Latitude 26.485291 26°29'7" N Longitude 80.344106 80°20'39" E 2022-04-07 (Thu) 12:17 (pm)</p>	<p>1. Inside and outside painting work done by KRMPL under renovation.</p> <p>2. Replacement of damaged Door,window,louvers and ventilators.</p> <p>2. Panel Volt meters and Ammeters need to be replaced.</p> <p>3.All Phase Indicator need to be replaced.</p>	23.11.2021		Pending
10	Loahank	Log book of pump house 01 and pump house no. 02 has not

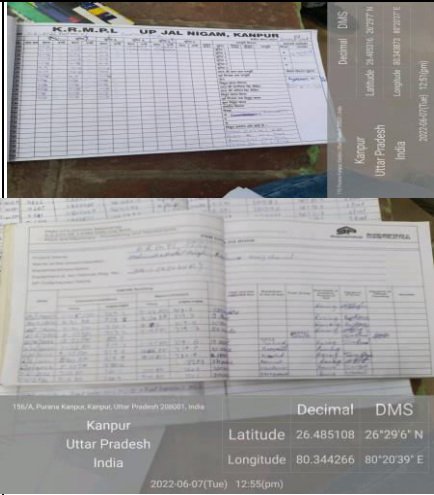
<p>K.R.M.P.L. UP JAL NIGAM, KANPUR</p> <p>136/A, Purana Kanpur, Kanpur, Uttar Pradesh 208001, India</p> <p>Kanpur Uttar Pradesh India</p> <p>Latitude 26.485108 26°29'6" N Longitude 80.344266 80°20'39" E 2022-06-07 (Tue) 12:55 (pm)</p>	<p>1. Log book of pumps and DG set are not being maintained by KRMPL.</p> <p>2. KRMPL has not arranged adequate number of staff (Operators, Sweepers and relievers) for proper O&M of IPS and attendance register manipulated staff details. Operators are non technical person. They are</p>	23.07.2021		Pending

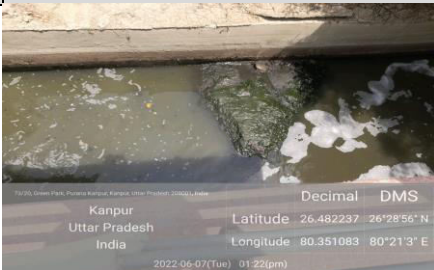
1. During site visit it was found that there are no Overflow or Bypass of sewage found. 2. Raw sewage by-pass sluice gate need to be replaced. Design,drawing need to be submitted by KRMPL.	4.01.2022		Pending

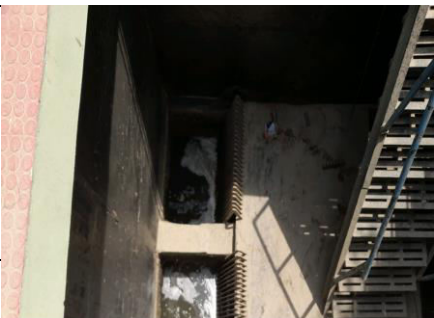
2	Inlet Chamber (Civil)	Civil Structure is in satisfactory condition

<ol style="list-style-type: none"> 1. All gates need to be lubrication. 2. Sludge need to be remove from inlet part of IPS. 	23.11.2021		Pending
3	Screen Chamber	Civil Structure is in satisfactory condition

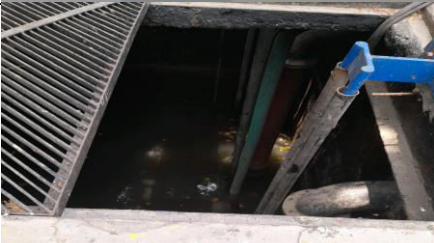
<ol style="list-style-type: none"> 1. Chamber need to be clean and cover properly. 2. All valves need to be replace. 3. All stud bolts and gasket need to be replace. 4. Lubrication for valves and pumps ,sluice gates need to be done by KRMPL. 5. Pressure guage need to be provided by KRMPL. 	15.12.2021		Pending

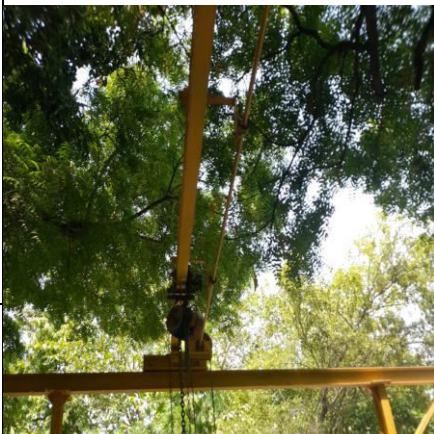
<ol style="list-style-type: none"> 1. Exposure of steel in staircase bottom slab need to be renovate. 2. Inside the pump house, Light is not working. 3. EOT load test required by KRMPL. 4. Flow meter need to be installed by KRMPL. 5. Log book is not proper maintaing by KRMPL staff at site with all details. 6. Staircase is in bad condition and need to be renovate. 7. Cable dressing need to be done properly. 8. Operators are non technical person. They are not understanding the Pump Capacity , Flow of Discharge, Peak Flow and maintain the records. 	23.11.2021		Pending
i	Pump no.1(Capacity=309cum/hr)	Non-operatioal		<ol style="list-style-type: none"> 1. New pump has been installed at 14.03.2022 to 20.03.2022. 2. KRMPL has not submitted any RFI during installation of new pumps. 3. Pump no. 01 found damaged from 02.06.2022, KRMPL needs to be repair on urgent basis 	15.12.2021		Pending

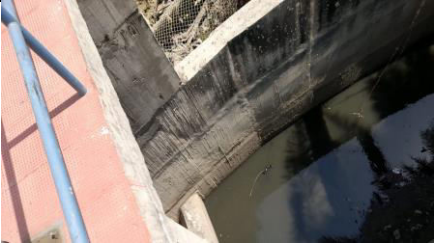
1	Inlet Over Flow Condition	No over flow

During site visit it was found that there are no Overflow/Bypass of sewage .	02.03.2022		Pending
2	Inlet Chamber	Civil Work is in satisfactory Condition

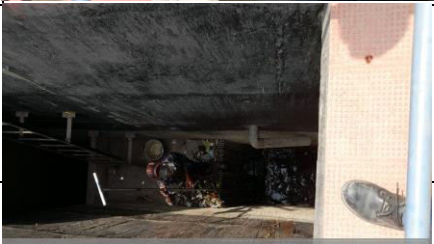
1. All gates need to be lubrication.	15.12.2021		pending
3	Manual bar Screen Chamber	Civil Work is in satisfactory Condition

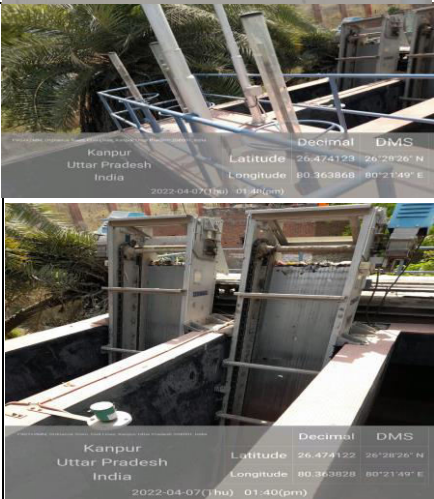
1. Both mechnical screen and conveyor belt found non-operational at the time of inspection.It was started when asked by UPJN/STC representative. 2. Mechanical screen no. 1 is working only in auto mode. 3. Auto System and level sensor meter is not in woking condition. 4. Screen panel On/Off main power selector switch has been found in not working properly. 5. Screen No. 2 is in working condition. 6. Conveyor belt is in working condition. 7. Garbages need to be remove on regularly. 8. Garbage trouly need to be available at Site. 9. All leakages of Oil need to be repair. 10. Conveyor belt is not working in auto mode. 11. Screen No 1 is not working in manual mode. 12. Chain in conveyor belt is not available.	15.12.2021		pending

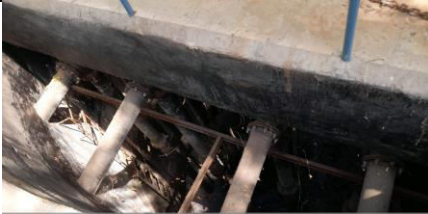
5	Pump House	Civil Work is in satisfactory Condition

<p>1. Pump No 1,2,3 and 4 are in working condition. 2. EOT crane painting work is pending and Test certificate of load test also required. 3. Only 3 Nos of light is in woking condition out of 7 Nos in IPS campus. 4. Operators are non technical person. They are not understanding the Pump Capacity , Flow of Discharge, Peak Flow and maintain the records. 5. Flow meter is not in working condition.</p>	23.11.2021		pending
6	Panel room	Civil Work is in satisfactory Condition

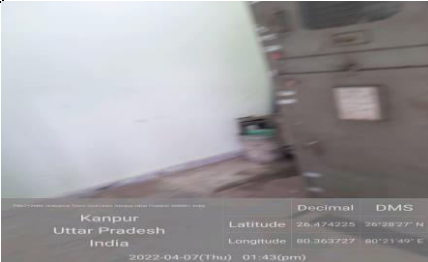
<p>1. Meter room need to be clean with proper facility of Electric switch and light inside the room.</p>	23.11.2021		pending
8	DG yard	Civil Work is in satisfactory Condition

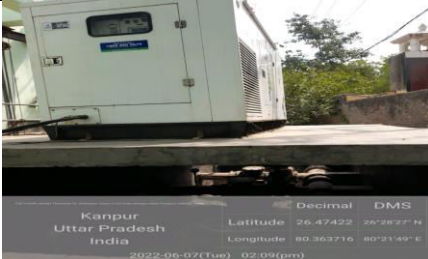
<p>1. DG set is in working condition. 2. Log book of DG set is not maintain by KRMPL properly. 3. Smog exhaust pipe length is not sufficientr as per CPCB/CPHEEO guidelines.It must be replaced on urgent basis.</p>	23.11.2021		pending

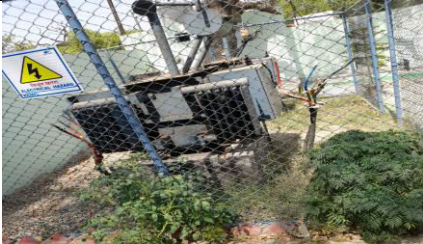
9	Transformer yard	Civil Work is in satisfactory Condition

<p> Kanpur Uttar Pradesh India 2022-04-07(Thu) 01:38(pm) </p> <p> Decimal DMS Latitude 26.481766 26°28'54" N Longitude 80.349842 80°20'59" E </p>	1. Transformer No 1 received at site on 08.03.2022 but their termination work is still pening. 2. Transformer yard area need to clean. 3. All earthing chamber need to be cover.	13.12.2021		pending
10	Handrailing work	satisfactory Condition		1. Installation of handrails need to be done by KRMPL properly. 2. Security guard need to be arrange by KRMPL	23.11.2021		pending

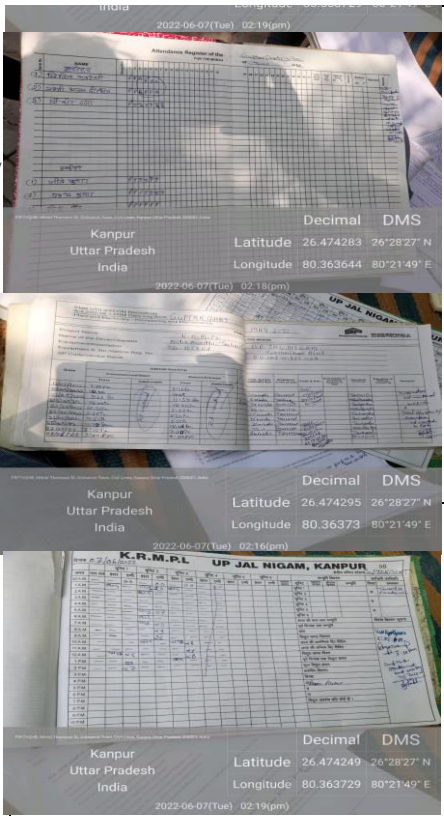
11	Logbook/Records/Documentation	Logbooks are not maintain properly by KRMPL

<ol style="list-style-type: none"> 1. Log book of pumps and DG set are not being maintained by KRMPL. 2. KRMPL has not arranged adequate number of staff (Operators, Sweepers and relievers) for proper O&M of IPS and attendance register manipulated staff details. Operators are non technical person. They are not understanding the Pump Capacity , Flow of Discharge, Peak Flow and maintain the records. 3. KRMPL need to maintain Visitor Register. 4. Security guard need to be deploy. 5. No labour available by KRMPL for renovation work. 	23.07.2021	Pending
----	-------------------------------	---------------------------------------------	-----------------------------------------------------------------------------------	--------------------------------------------------------------------------------------------------------------------------------------------------------------------------------------------------------------------------------------------------------------------------------------------------------------------------------------------------------------------------------------------------------------------------------------------------------------------------------------------------------------------------------------------------------------------------------------------------------------	------------	---------

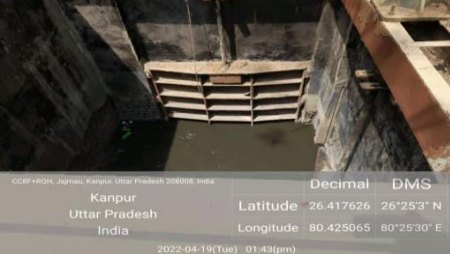
<p>CCSF-HQKH, Jajmau, Kanpur, Uttar Pradesh 208008, India Kanpur Uttar Pradesh India Decimal DMS Latitude 26.417626 26°25'3" N Longitude 80.425065 80°25'30" E 2022-04-19(Tue) 01:43(pm)</p>	1. Proper barricade required. 2. Cleaning work need to be done. 3. Balance renovation work need to be done by KRML. 4. 2 Nos gate to be replaced as per CA schedule 11. 5. Bypass gate gear system is in working condition.	16.12.2021		Pending
1	Receiving chamber-1	Civil work is in satisfactory condition

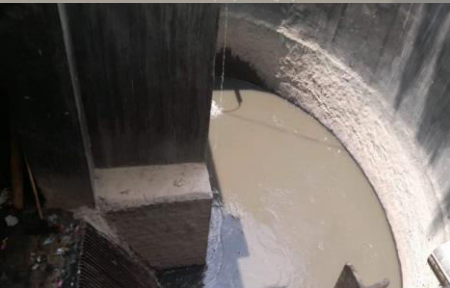
1. Cleaning work need to be done. 2. Balance renovation work need to be done by KRML. 3. Hand rail need to be repair. 4. Level marking work need to be done by KRML.	23.11.2021		Pending

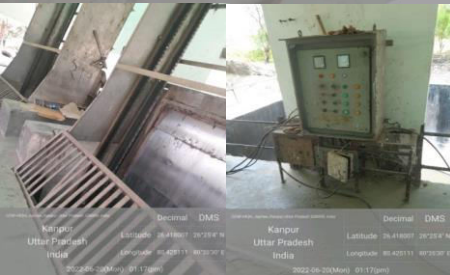
<p>CCSF-HQKH, Jajmau, Kanpur, Uttar Pradesh 208009, India Kanpur Uttar Pradesh India Decimal DMS Latitude 26.414897 26°25'8" N Longitude 80.425111 80°25'9" E 2022-06-20(Mon) 01:17(pm)</p>	1. Both mechanical screen and conveyor belt found non-operational at the time of inspection. It was started when asked by UPJN/STC representative. It was found screens operated by sweeper during UPJN/STC site inspection. 2. Sluice gate at Inlet and Outlet need to be replaced. 3. Garbage need to be remove regularly. 4. Painting work need to be done with proper workmanship for inside and outside of building. 5. Electric switch board need to be repair. 6. Drain water pipe need to be fixed. 7. Cleaning and landscaping work need to be done. 8. Conveyor belt chute need to be replaced by KRML.	23.11.2021		Pending

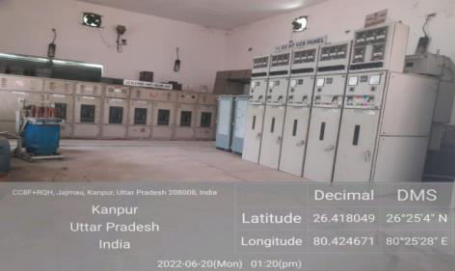
6	Substation building	Operational

<p>CCBP-HQH, Jajmau, Kanpur, Uttar Pradesh 208008, India</p> <p>Decimal DMS Latitude 26.418049 26°25'4" N Longitude 80.424671 80°25'28" E</p> <p>2022-06-20(Mon) 01:20(p.m)</p>	<ol style="list-style-type: none"> 1. 11KV HTVCB panel to be replaced. 2. LT A.C.B panel 440 V found non functional. 3. All light to be replaced in sub station. 4. All store material dumped in substation building. 	16.12.2021		Pending
7	DG yard	Operational
