SITE INSPECTION REPORT FOR 43 MLD JAJMAU PHASE-II STP

JAJMAU PHASE-II
STP - 43 MLDDate: 13.10.2022
17.10.2022INSPECTED BY:
UPJN,STC and KRMPL team

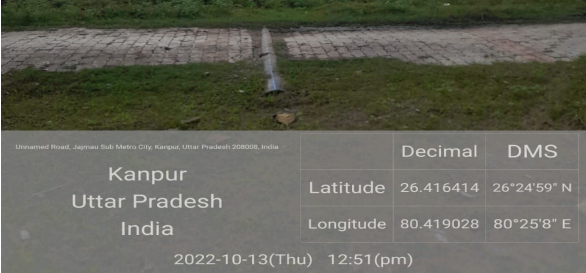
1. Need to be overhauled & servicing. 2. Dosing of PACL in sludge feed line not properly tapping according to design .Therefore dosing line tapping from upword to downward direction.KRMPL has not taken action as same. 3.Pipe support shall be installed properly for sludge feed line and dosing line. 4. Electrical cables need to be lineup properly. 5. 1 CCTV need to be arranged for sludge removal from Trolley on urgent basis. 6. The quality of dewatered sludge is not adequate since liquid is being noticed during site visit. 7. 2 nos centrifuges operated by KRMPL, 12 Hrs.each due to non-availability of VFD, only one at a time operated	21.09.2021		Pending
4	Centrifuge No.2	Operational

<div><div>Unmanned Road, Jajmau Sub Metro City, Kanpur, Uttar Pradesh 208008, India</div><div><div>Kanpur Uttar Pradesh India</div><div><div>Latitude</div><div>26.416414</div><div>26°24'59" N</div></div><div><div>Longitude</div><div>80.419028</div><div>80°25'8" E</div></div></div><div>2022-10-13(Thu) 12:51(pm)</div></div>	1. Need to be overhauled & servicing. 2. Dosing of PACL in sludge feed line not properly tapping according to design .Therefore dosing line tapping from upword to downward direction.KRMPL has not taken action as same. 3. Dosing line has not been connected with sludge feed line of centrifuge No 2. 4. Pipe support shall be installed properly for sludge feed line and dosing line. 5 The quality of dewatered sludge is not adequate since liquid is being noticed during site visit. 6. 2 nos centrifuges operated by KRMPL, 12 Hrs.each due to non-availability of VFD, only one at a time operated	21.09.2021		Pending
