SITE INSPECTION REPORT				Jajmau STP - 130 MLD	Date: 13.10.2022 17.10.2022	INSPECTED BY: UPJN ,STC and KRMPL team	
S. No.	Equipment	Assessment of Current Condition	Assessment of Current Condition Photo	Current defects and Corrective Action Suggested by STC, PE	Original Date of Issue	Proposed Date to Resolve by KRMPL	Current Status of Compliance
A	Collection Chamber	Renovation work need to be done by KRMPL.

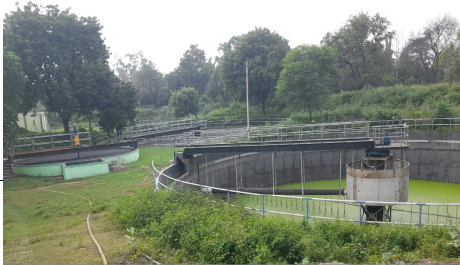
1. Sludge disposal work done from dated 04.02.2022 to 22.02.2022 from common sludge chamber. 2. Belding tank commisioned on 31.05.2022	31.05.2022		
	Blending Tank Agitator	New Replacement as per BEPI					
72	Gravity Sludge Thickeners						
73	Gravity Sludge Thickener no. 1	Operational but non-functional

<small>Unnamed Road, Jajmau Sub Metro City, Kanpur, Uttar Pradesh 208006, India</small> Decimal DMS Kanpur Latitude 26.416206 26°24'58" N Uttar Pradesh Longitude 80.418949 80°25'8" E India 2022-10-13(Thu) 12:58(pm)	1. Mechanical bridge has installed of sludge thickener No. 02 on 26.02.22 and commisioned on 04.06.2022. Recommissioned on 08.08.2022 without any approval from STC and UPJN	04.06.2022

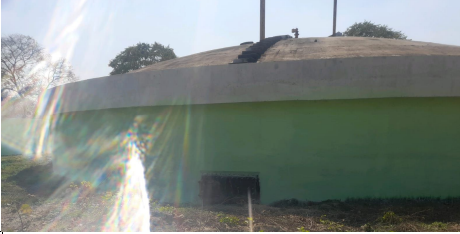
01.03.2021		Long Pending
81	Primary Sludge Digester no. 2	Not operational

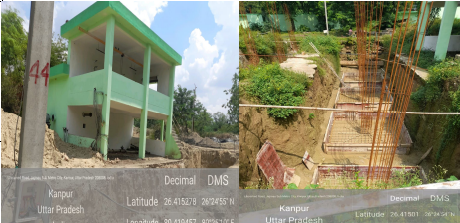
01.03.2021		Long Pending
85	Digested Sludge Pump no.2					
86	Digested Sludge Pump no.3					
87	Digested Sludge Pump no.4					
S	Centrifuge					
88	Centrifuge Building (Civil Works)	Not operational

01.03.2021		Long Pending
89	Centrifuge Pump no.1	All centrifuge were in dilapidated condition and dismantling work is completed
