SITE INSPECTION OF JAJMAU ASSOCIATED IPS REPORT

Nawabganj IPS 32
MLD

Date: 29.12.2022

Parmat IPS

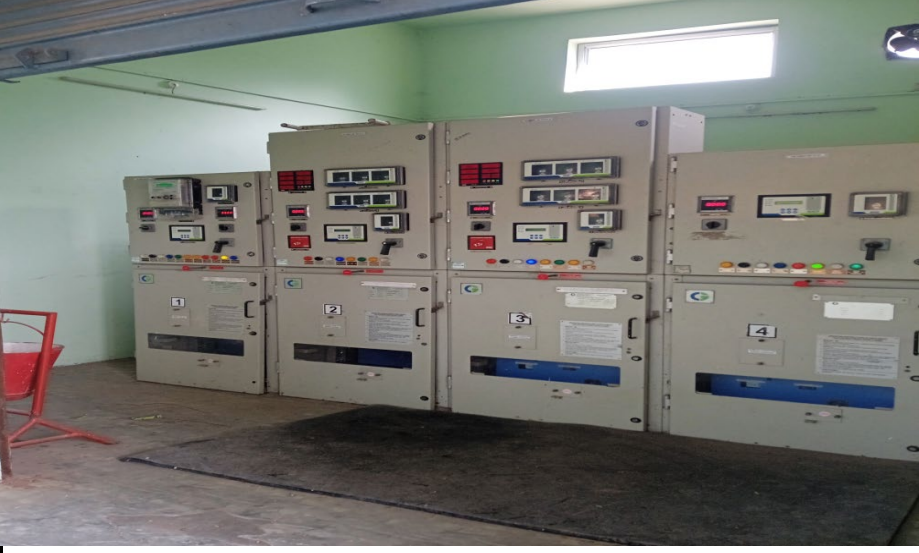
7	HT/Metering Room	Civil Work is in satisfactory Condition

23.11.2021		pending
8	DG yard	Civil Work is in satisfactory Condition
