<div>STC</div> <div>SITE INSPECTION OF JAJMAU ASSOCIATED IPS REPORT</div>					Nawabganj IPS 32 MLD	Date: 22.02.2023	INSPECTED BY: STC Team 1. Mr Ajay Kumar Goyal, Support Engineer, Mechanical, STC Kanpur 2. Mr. Karam Veer Singh, Support Site Supervisor, STC Kanpur

<div>STC</div> <div>SITE INSPECTION OF JAJMAU ASSOCIATED IPS REPORT</div>					Parmat IPS	Date: 22.02.2023	INSPECTED BY: STC Team 1. Mr Ajay Kumar Goyal, Support Engineer, Mechanical, STC Kanpur 2. Mr. Karam Veer Singh, Support Site Supervisor, STC Kanpur

<div> <div>STC</div> <div> <div></div> <div>SITE INSPECTION OF JAJMAU ASSOCIATED IPS REPORT</div> </div> </div>					Baba Ghat -7 MLD	Date: 29.11.2022	INSPECTED BY: STC Team 1. Mr Ajay Kumar Goyal,Support Engineer, Mechanical, STC Kanpur 2. Mr. Karam Veer Singh, Support Site Supervisor, STC Kanpur

<div> <div>STC</div> <div> <div></div> <div>SITE INSPECTION OF JAJMAU ASSOCIATED IPS REPORT</div> </div> </div>					Guptar Ghat	Date: 22.02.2023	INSPECTED BY: STC Team 1. Mr Ajay Kumar Goyal,Support Engineer, Mechanical, STC Kanpur 2. Mr. Karam Veer Singh, Support Site Supervisor, STC Kanpur

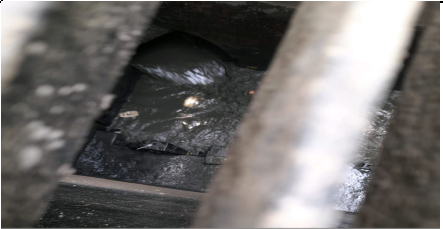
1. KRMPL should arrange informatory sign board for Parmat IPS.	07.04.2022		Pending
1	Inlet Chamber	Civil Structure is in unsatisfactory condition

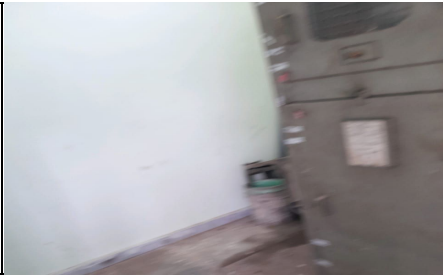
7	Metering Room	Civil Work is in satisfactory Condition
