National Mission for Clean Ganga- Development, Rehabilitation with
Operation & Maintenance of STPs at Kanpur under Hybrid Annuity based PPP mode

Sub: HAM KANPUR – Joint Site Inspection for Progress of 15 MLD STP Unnao

An Inspection of 15 MLD Unnao STP construction site and I&D facilities was jointly conducted by PE and UPJN officials in the presence of KRMPL Representatives, and our findings are noted below:

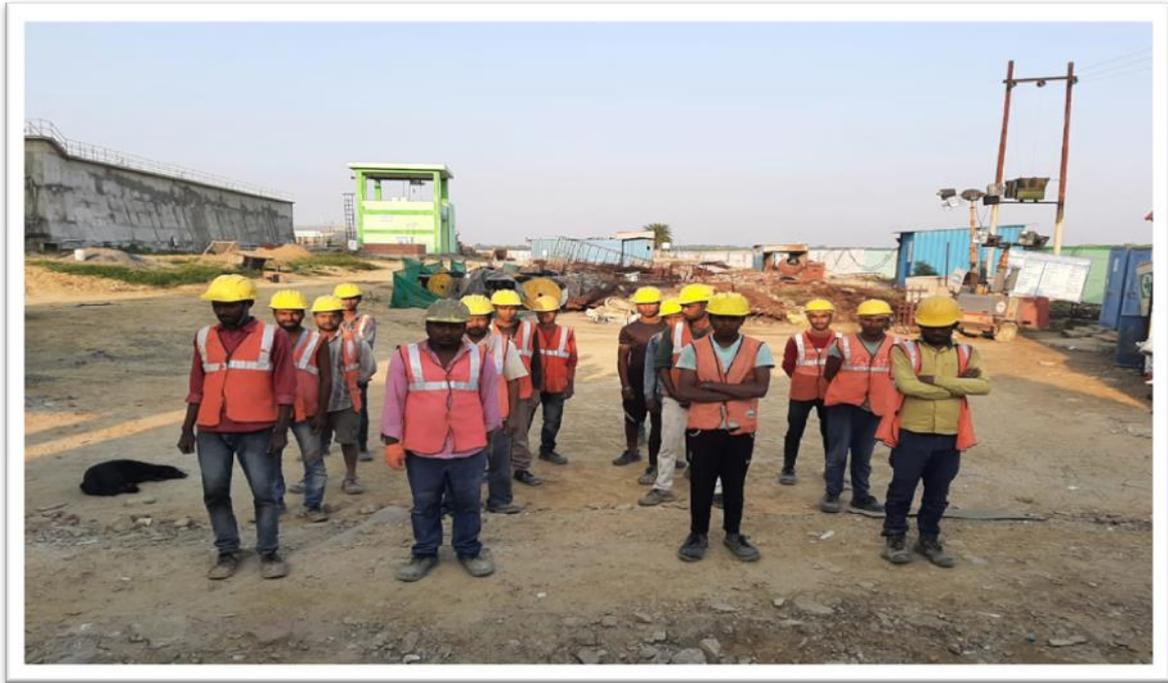
5. Manpower Deployed at the site was found to be low. PE & UPJN Team inspected the site on 15.11.2022, and during site inspection it was observed that only 15 nos. manpower (Civil, E&M) were deployed at the site. It seems that with the present manpower

Fig 1: Total manpower deployed at 15 MLD STP Unnao on 15.11.2022

deployed at the site the Concessionaire would not be able to complete the work and meet the target dates noted above. Therefore, it was recommended to increase the manpower for completing the work with all respects and also as per above mentioned schedule.

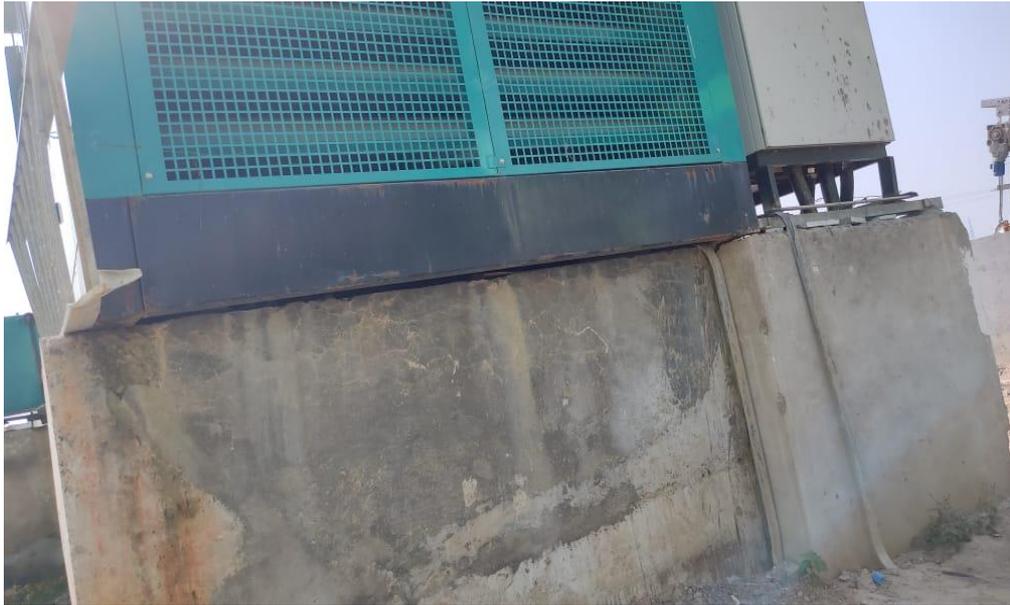
- i. DG Set not placed centrally on Foundation, so overhang of DG portion appears on one side of foundation.
- ii. There is also no walking platform around DG Set for periodically maintenance & repairing. KRMPL instructed to provide at least 1 m wide walking RCC/Fabrication platform at periphery of DG Foundation & placed DG exactly central part of foundation.
- iii. Walkway & extension of foundation are still pending.
- iv. KARMPL has not start yet of Chimney work.

Overhang of DG portion appears on one side of foundation.
