SITE INSPECTION REPORT

Inspection note of 20 MLD Sundar Nagar IPS construction site and facilities by Mr. Anil Seth Kumar, Team Leader and KRMPL Representative as given below.

Date of site visit	15/04/2023
Visit Team & Persons met	Mr. Anil Kumar Seth – Team Leader (I/C), STC Kanpur Mr. Rahul- Support Engineer- Electrical, STC Kanpur Mr. Ajay Kumar Goyal, Mechanical Engineer, STC Kanpur
LOCATION	20 MLD Sundar Nagar IPS

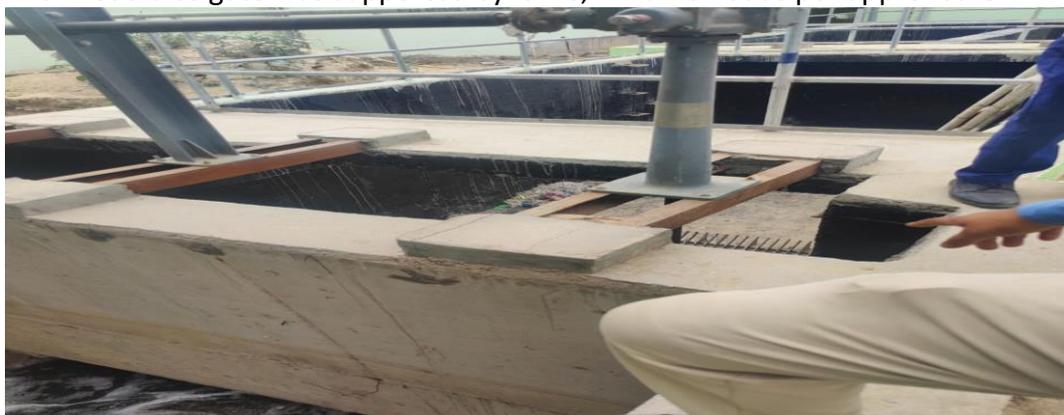
- The inlet Sluice gate was supported by ISMC, which is not as per approved GAD.

Fig: I&D Sluice Gate

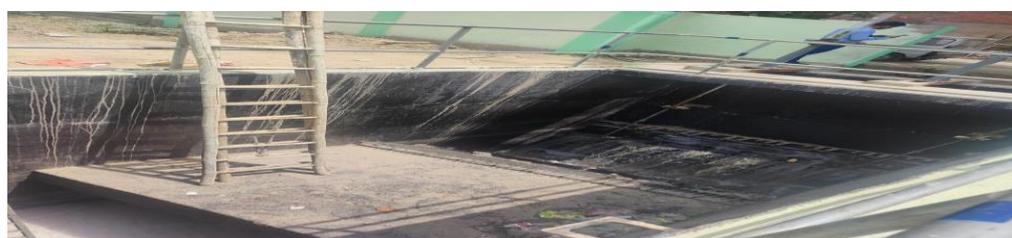
- Accessway is not provided for gate operation.
- The installation of Manual screen at site is not as per approved GAD (Drawing no. 183261003). As per the approved drawing, distance from I&D gate to manual screen should be 1085 mm but only 500 mm was provided. This will make the inlet flow fall directly into the bar screen and push the screenings through the bar spacings causing inefficient removal of debris.
- Provide safe access with stair or appropriate ladder for labour for removal and disposal of screenings.

Fig: Manual Screen

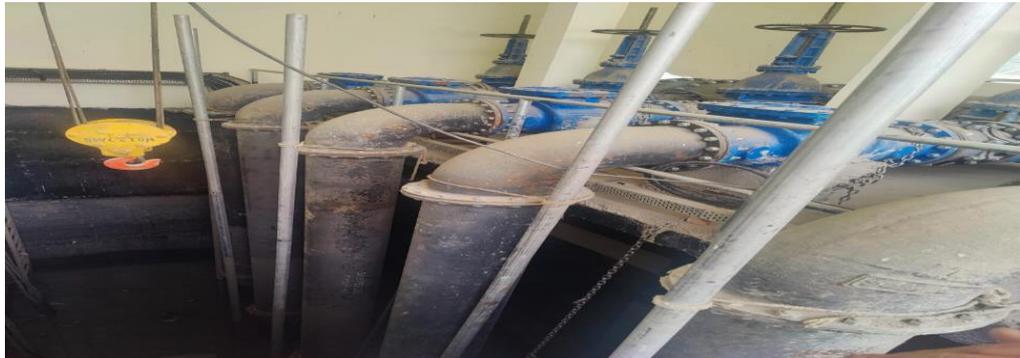
- It was observed that Electrical hoist termination work still pending.
- All Mechanical equipment are fixed without levelling & proper alignment. Additionally Grouting work is pending

Fig: Raw Sewage Pump House

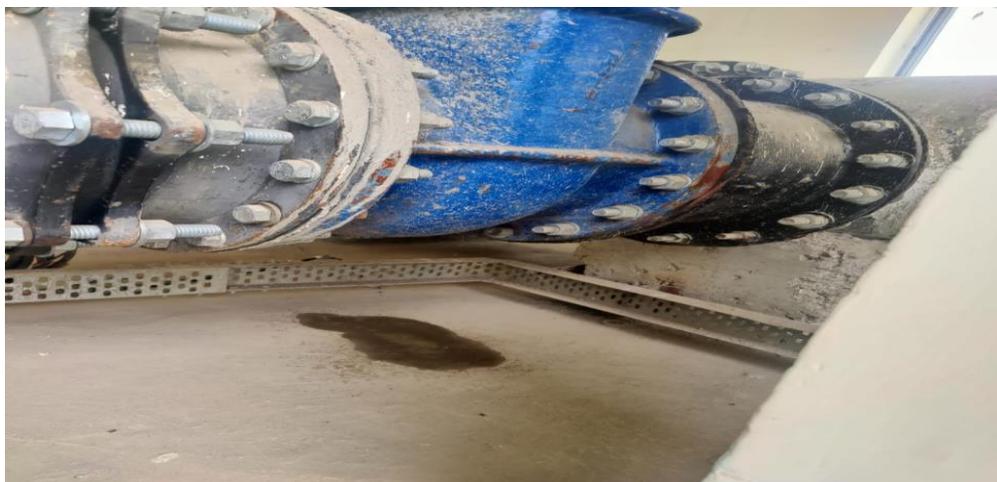
- It was observed that leakage f in pipe lines. KRMPL needs to rectify.

Fig: Leakage found in pipe line.
