Site Inspection Report of 5 MLD Shuklaganj

Date of Inspection	07/02/2024
STP Site inspection Team	Mr. Anil Kumar Seth- Team Leader Mr. Indra Deo Pandey- Support Engineer
KRMPL Personal	Mr. Rajpal Singh Gill Construction Manager

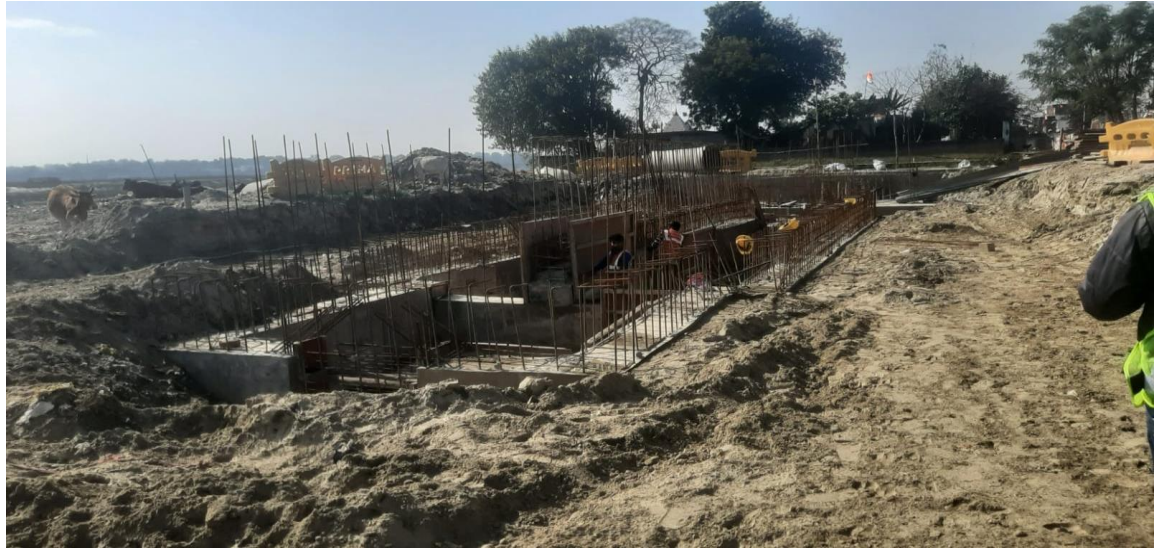
- i. **I&D Structure-** Work of I&D structure is very slow. Reinforcement work of wall in

progress for second lift. The casting of the first lift of the wall was done without informing UPJN and STC. In Approach channel, inlet channel and screen channel finishing and hydro test is pending. KRMPL has not used proper Clear cover exactly as per design. Due to use of wide range of cover blocks casting of wall by the Concessionaire is not proper.

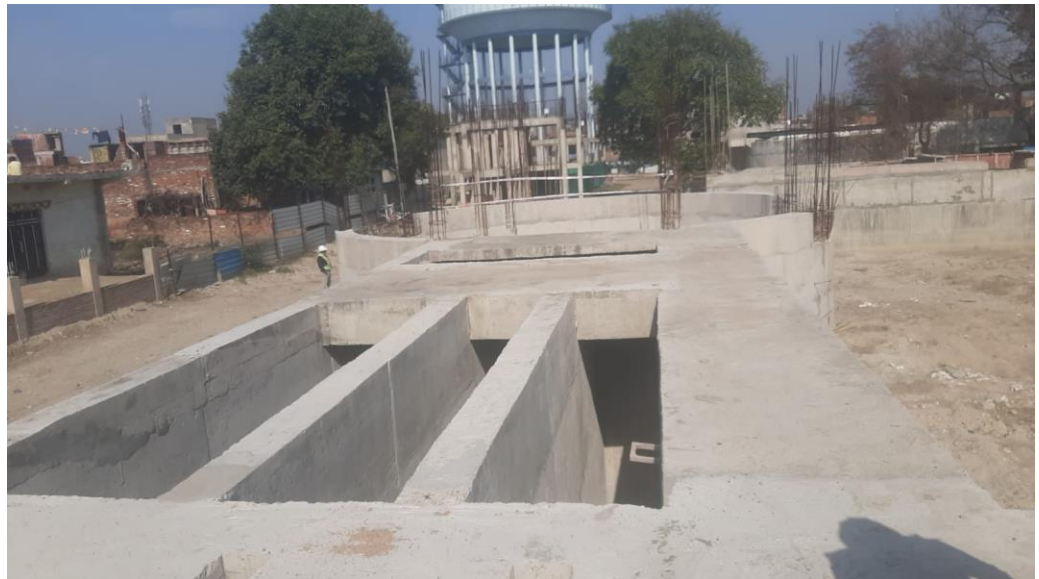
- ii. **MPS-** At inlet chamber step arrangement and proper footrest have not been provided. Column, beam and slab work is still pending. KRMPL needs to do hydro testing with clear water as per CEPHEEO MANUAL and IS code 3370 in presence of UPJN & STC, before grinding and tar coal epoxy work.

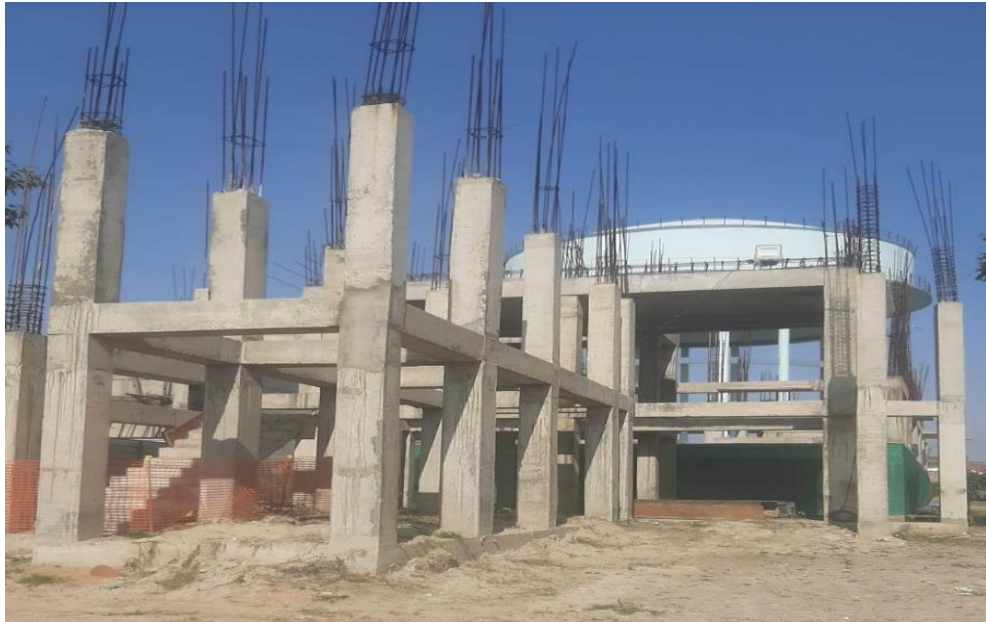
- iii. **PTU-** Most of Steel is corroded. PTU, Column work completed and slab

shuttering and reinforcement work is pending. In Inlet chamber area finishing work, hydro test is pending. In Grit chamber and parshall flume RCC wall, walk way, platform and hydro test pending.

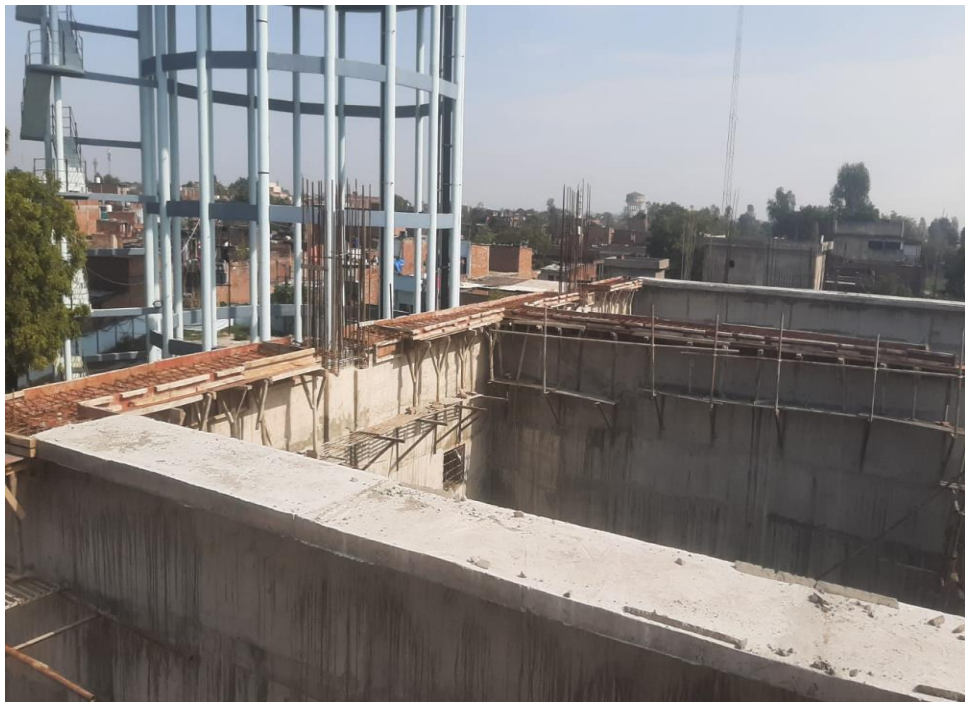
- iv. **SBR-** In SBR connecting channel, walkway platform, RAS and WAS pump column, Decanter foundation, finishing and hydro test are pending.

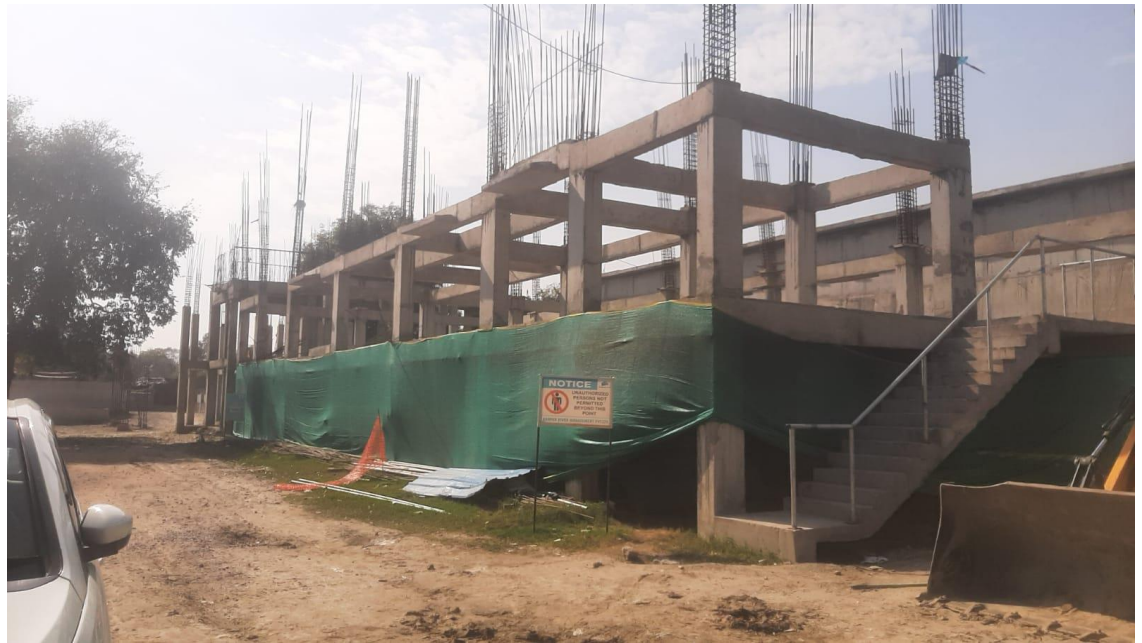
- v. **Admin building cum blower Room-** In admin Building first floor and second floor slab work, beam and column work is pending. In blower room roof slab and brick works are pending.

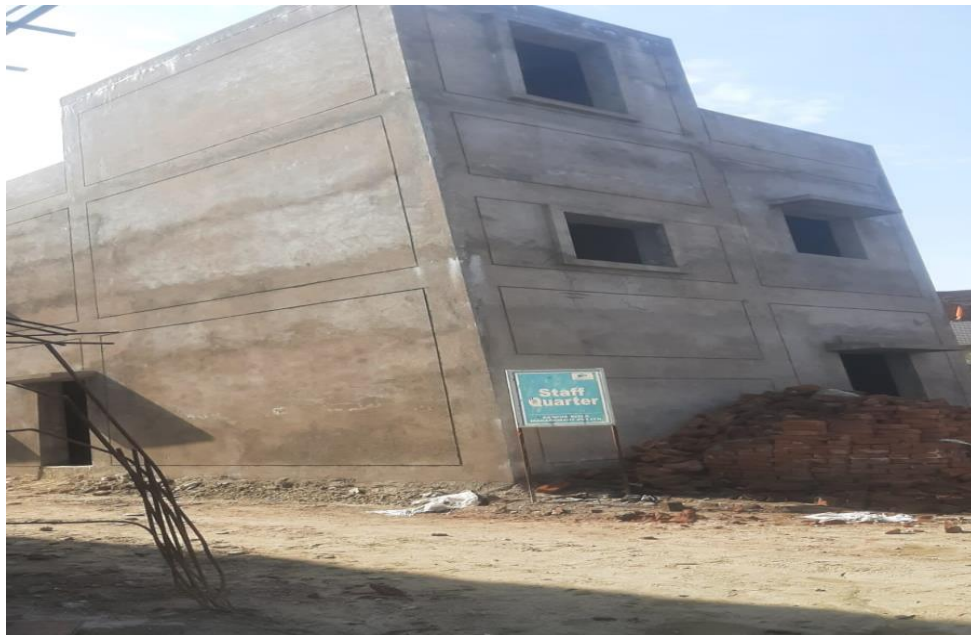
- vi. **Staff quarter-** Electric work, plumbing, sanitary fitting, floor, finishing and painting works are pending.

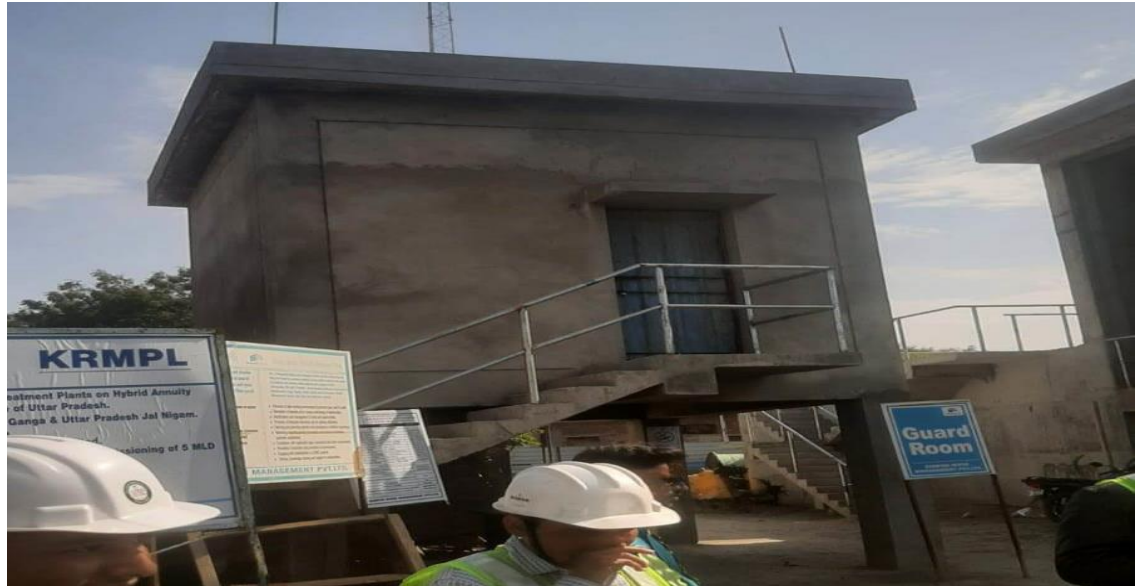
- vii. Guard Room-** Electric work, plumbing, sanitary fitting, floor, finishing and painting works are pending.

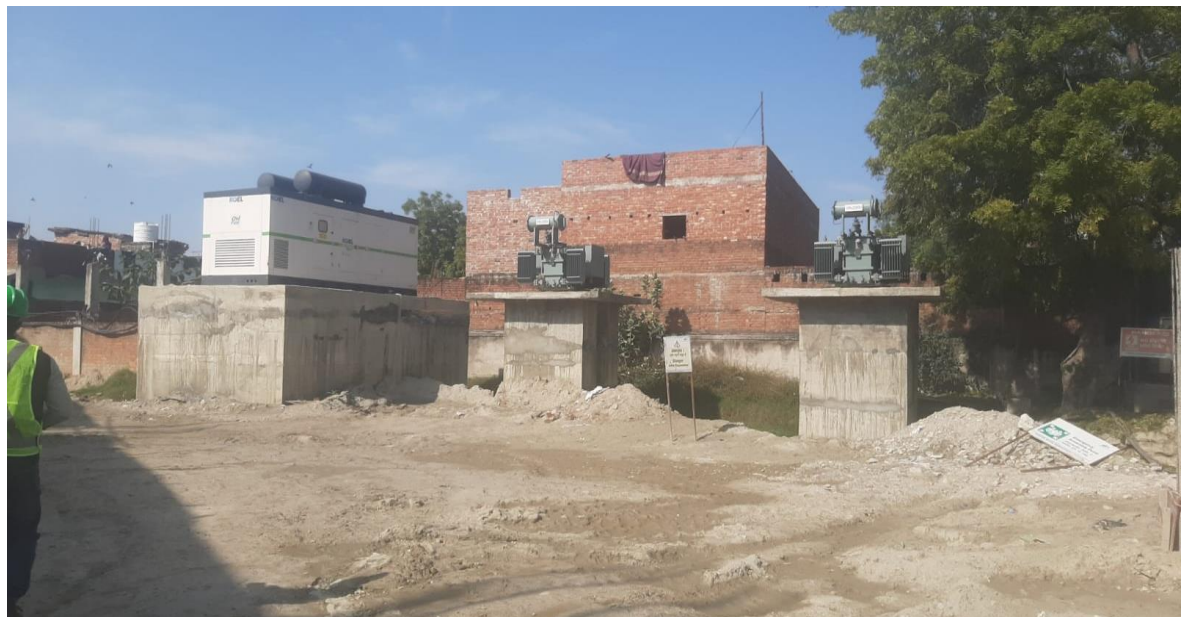
- viii. Transformer & DG Yard-** Staircase, finishing, approach and painting works are pending.

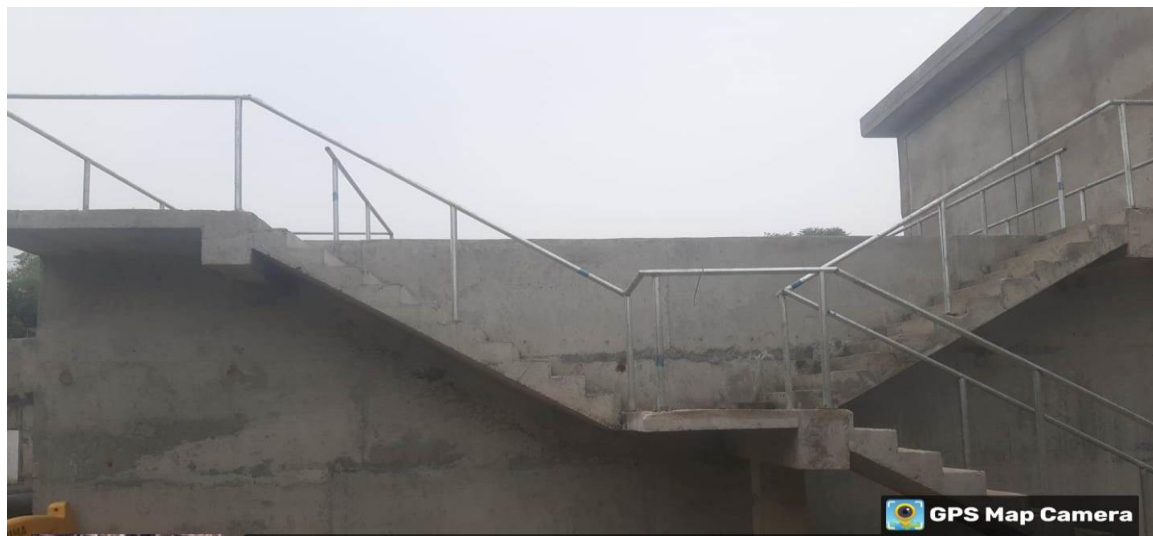
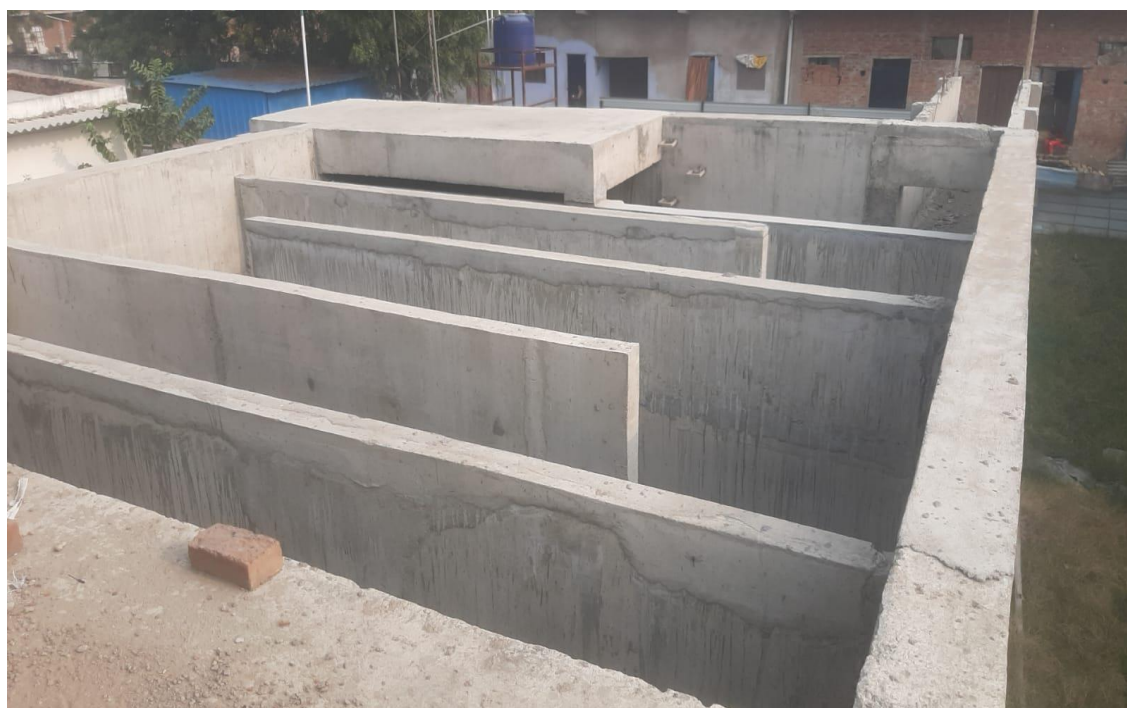
- ix. Chlorination building and CCT-** In CCT outlet channel work, finishing of outlet chamber, grinding, finishing and painting works are pending. In building

foundation of tonner, Electric work, plumbing, floor, finishing and painting works are pending. Booster pump and fitting pump can be install.

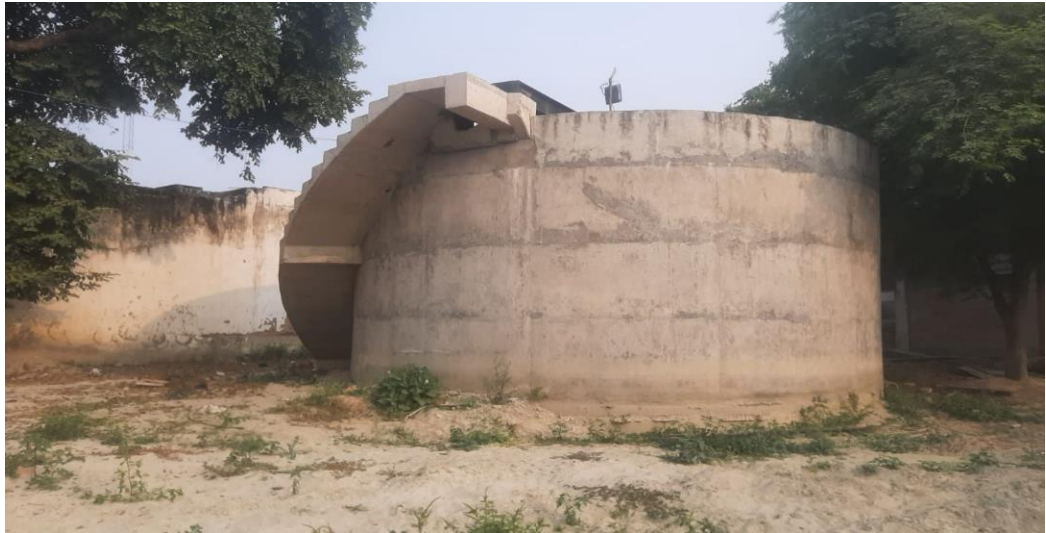
- x. **Sludge thickener and Supernatant sump**- Finishing, painting and hydro testing are pending. Scrapper in thickener and pump in supernatant can be install as

there is no hindrance.

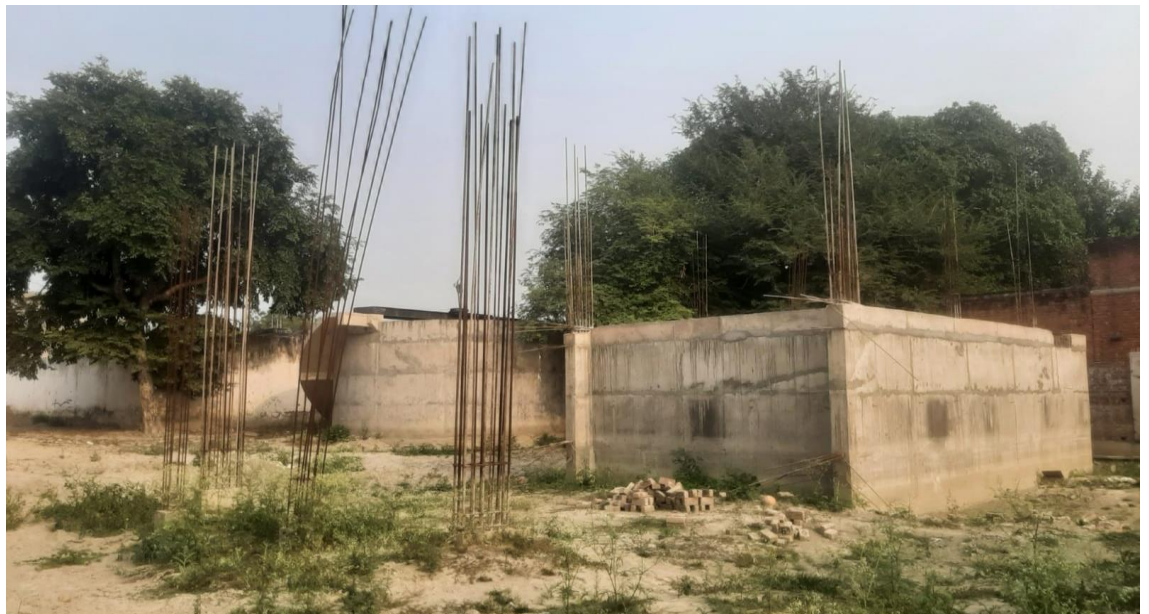
- xi. Centrifuge building-** First and second floor slab work, column and beam works are pending.
