Joint Site Inspection Report of 5 MLD Shuklaganj

Date of Inspection	08/04/2024
STP Site inspection Team	Mr. Anil Kumar Seth- Team Leader Mr. Subhash A.E. UPJN Mr. Ankur Saxena J.E. UPJN Mr. Indra Deo Pandey- Support Engineer
KRMPL Personal	Mr. Rajpal Singh Gill Construction Manager

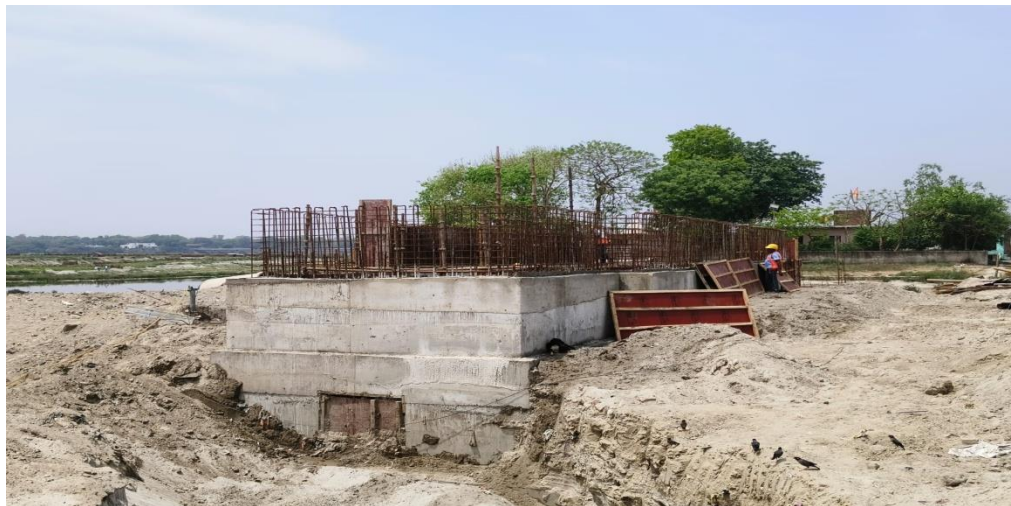
- i. Work of I&D structure is in progress. Reinforcement & shuttering work of wall in progress. The casting of the all lift of the wall was done without informing UPJN and STC. In Approach channel, inlet channel and screen channel finishing and hydro test is pending. KRMPL.

- ii. KRMPL has not used proper Clear cover exactly as per design. Due to use of wide range of cover blocks casting of wall by the Concessionaire is not proper.

- iii. Joint inspection conducted by Uttar Pradesh Jal Nigam and PE STC on 8th April 2024, it was found that the quality of steel being used in the I&D structure was rusted, for which KRMPL has been instructed several times by UPJN & STC through letters 4088/WS-97/253 dated 30/12/23, 240/WS-97/19 dated 18/01/24, 373/WS-97/27 dated 08/02/24, 508/WS-97/27 dated 08/02/24, 547/WS-97/28 dated 12/02/24, 609/WS-97/29 dated 18/02/24, 1084/WS-97/44 dated 20/03/24, STC/PE/KNP/2166 dated 15/03/24 and STC/PE/KNP dated 2168 to replace it, but KRMPL is not taking action to replace the steel and using the same steel, earlier instructions were given to KRMPL to work as per the approved drawing, but non compliance is being done continuously, which is not appropriate, in such a situation, it will not be possible to measure and make payment for the said work done by KRMPL.

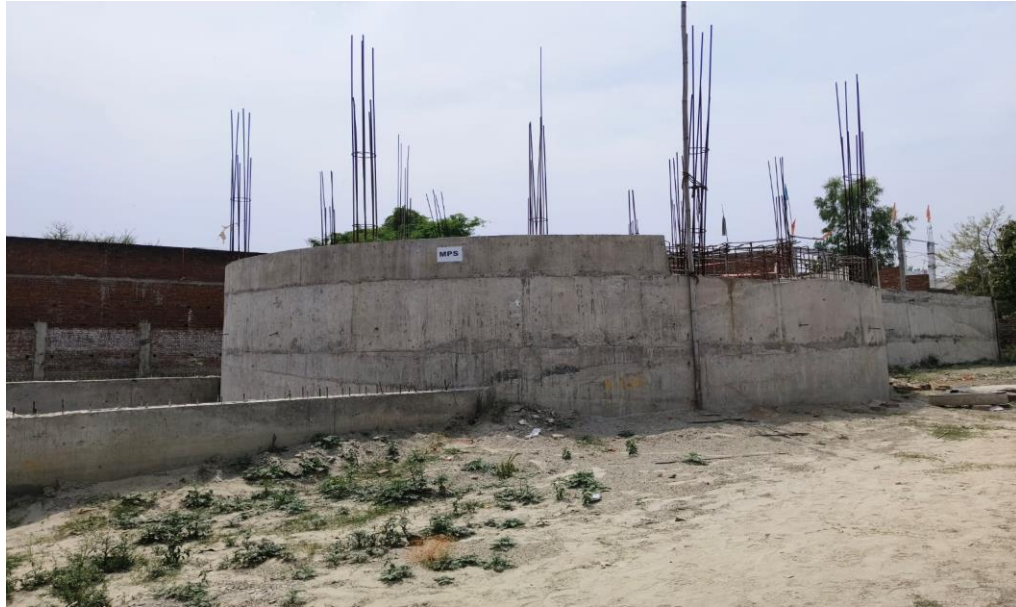
- B. MPS-** At inlet chamber step arrangement and proper footrest have not been provided. Column, beam and slab work is still pending. KRMPL needs to do hydro testing with clear water as per CEPHEEO MANUAL and IS code 3370 in presence of UPJN & STC, before grinding and tar coal epoxy work. During inspection there is no

manpower on MPS.

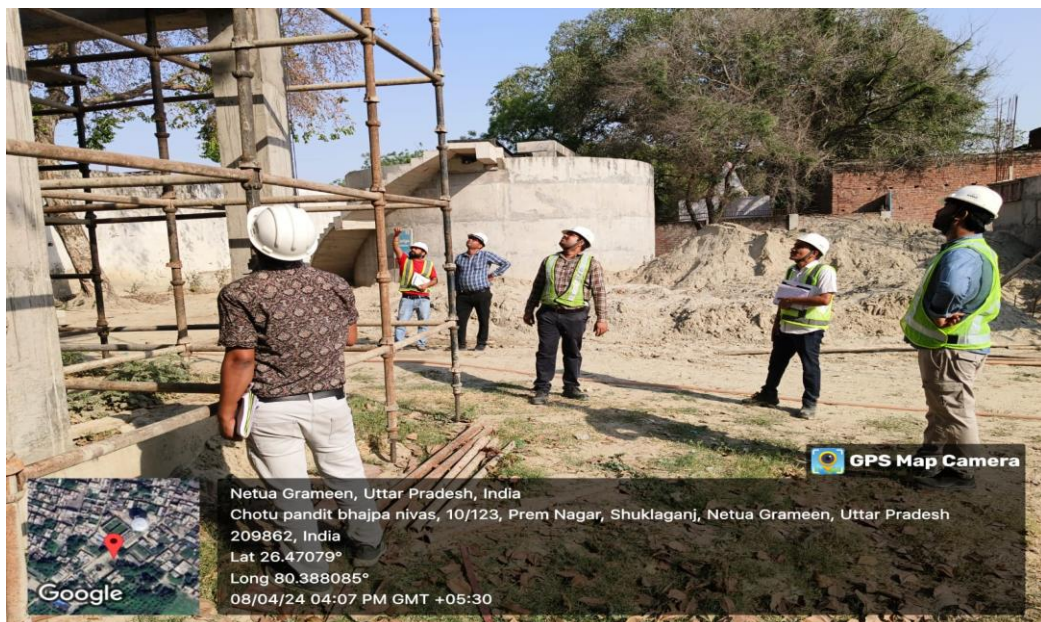
- C. **PTU-** Most of Steel found corroded. PTU, Column work completed and slab shuttering and reinforcement work is in progress. In Inlet chamber area finishing work, hydro test is pending. In Grit chamber and parshall flume RCC wall & slab, walk way, platform and hydro test pending.

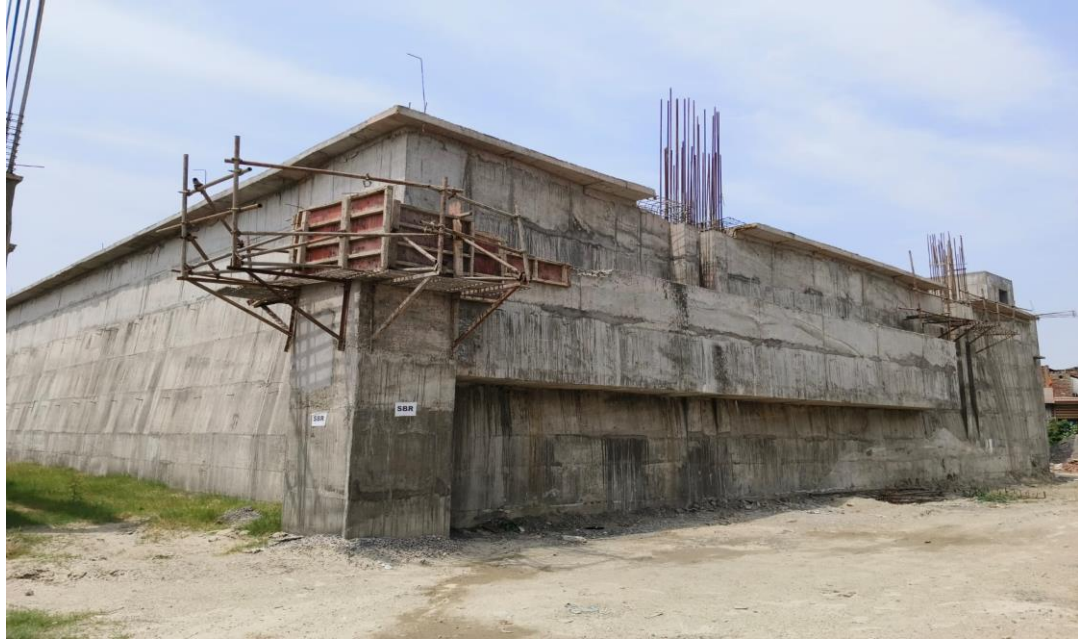
- D. SBR-** In SBR connecting channel, supporting column, walkway platform, RAS & WAS pump platform column, decanter foundation, finishing hydro test are pending. There is no manpower on SBR during inspection.

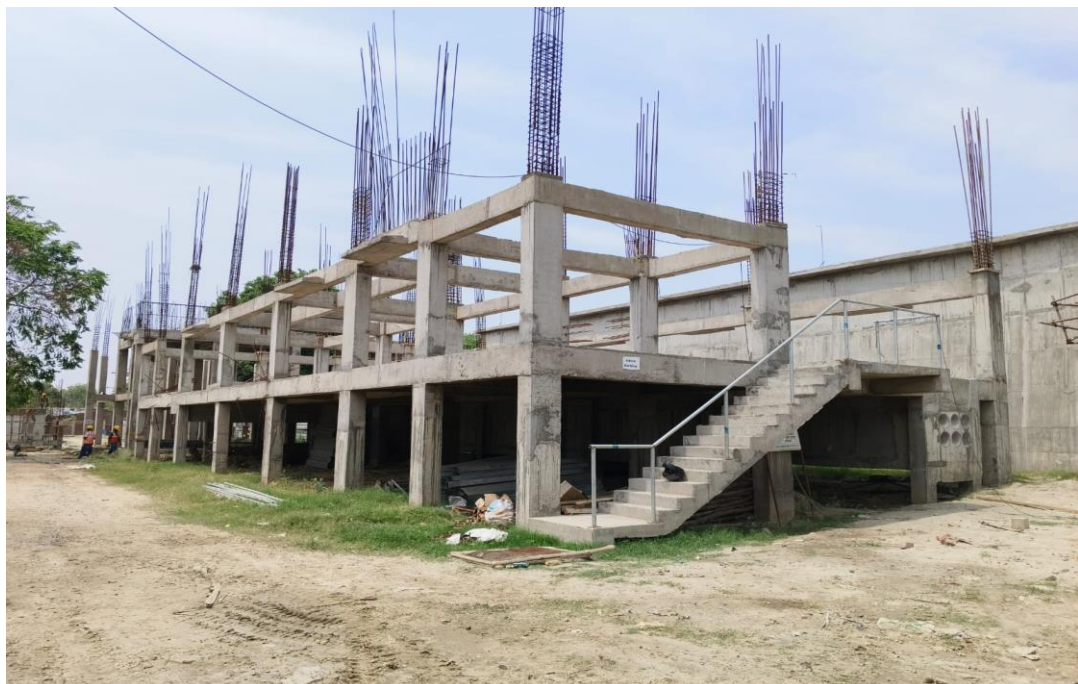
- E. Admin building cum Blower room-** In admin building room first floor and second floor slab work pending, brick work IPS flooring, electrification, sanitary fitting & plumbing, beam, column works are pending. In blower room roof slab, brick work, IPS flooring, roof treatment & finishing works are pending.

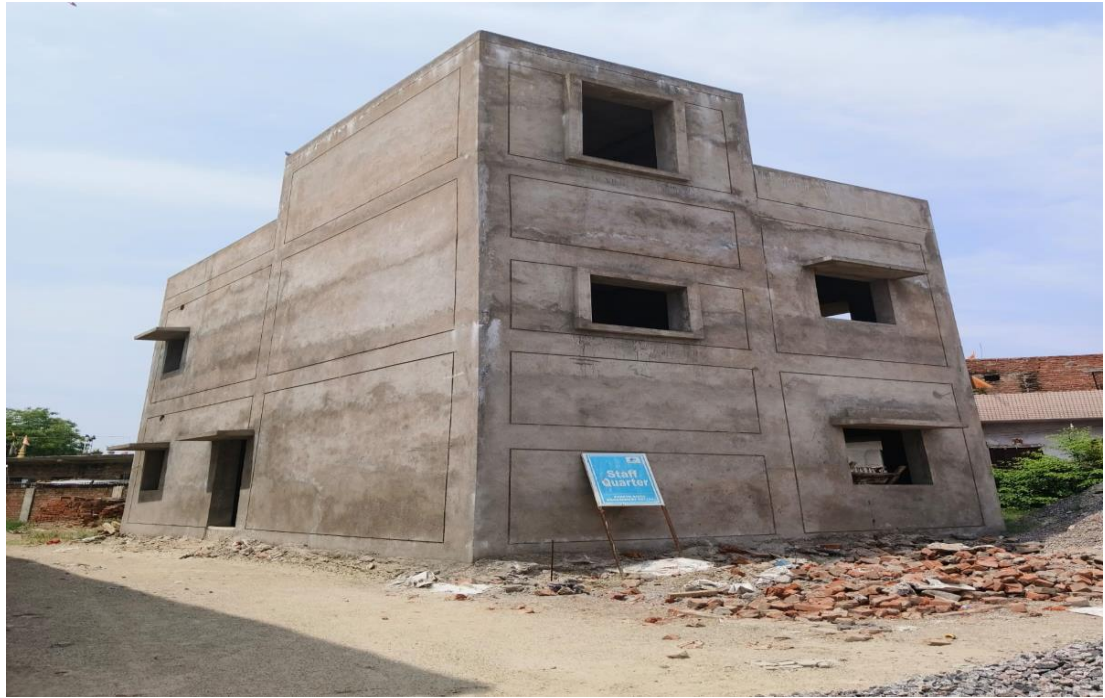
- F. Staff quarter-** Electric work, plumbing, sanitary fittings, floor, roof treatment, drainage, finishing and painting works are pending. There is no manpower on staff quarter during inspection.

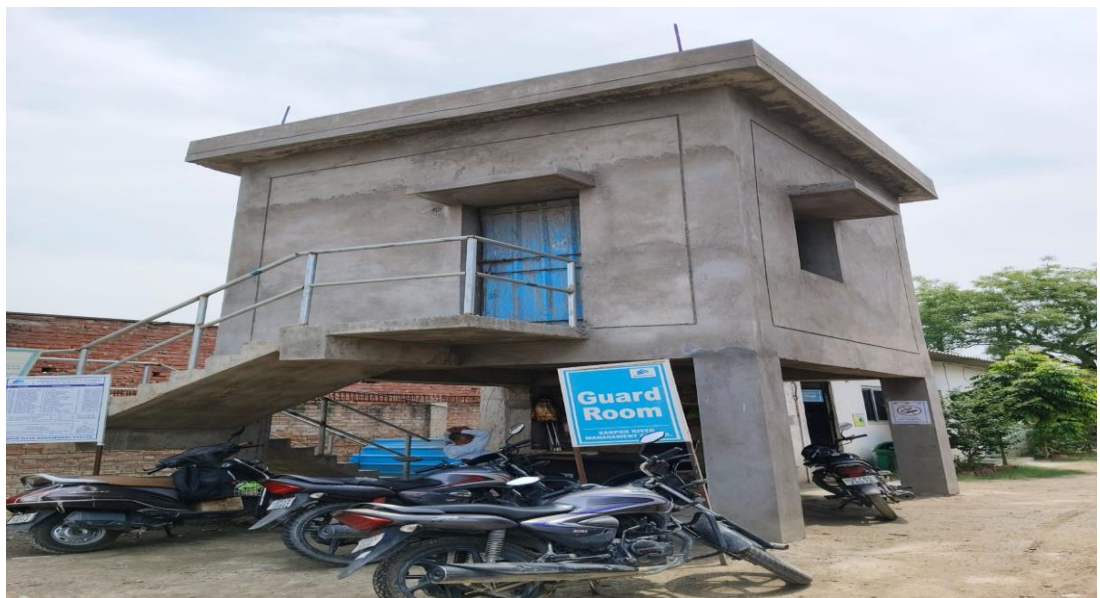
- G. Guard Room-** Electric work, plumbing, sanitary fittings, floor, roof treatment, drainage, finishing and painting works are pending. There is no manpower on staff quarter during inspection.

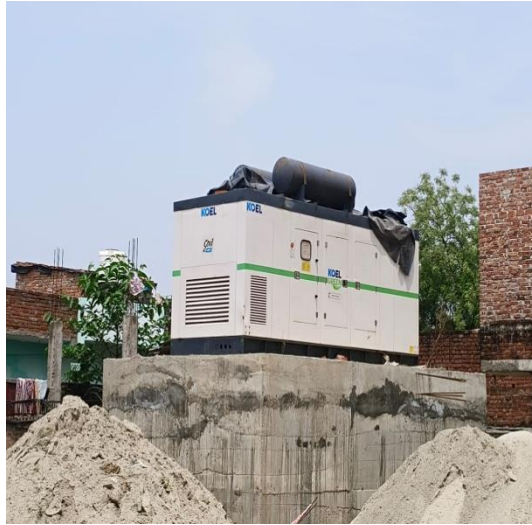
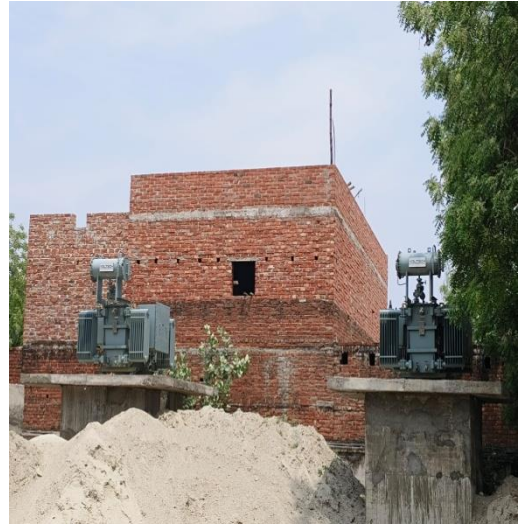
H. Transformer & DG Yard- Staircase, finishing, approach and painting works are pending.

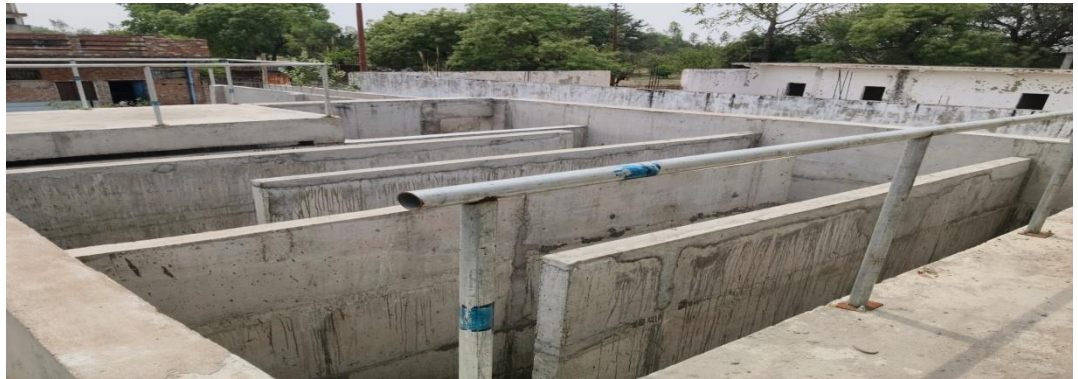
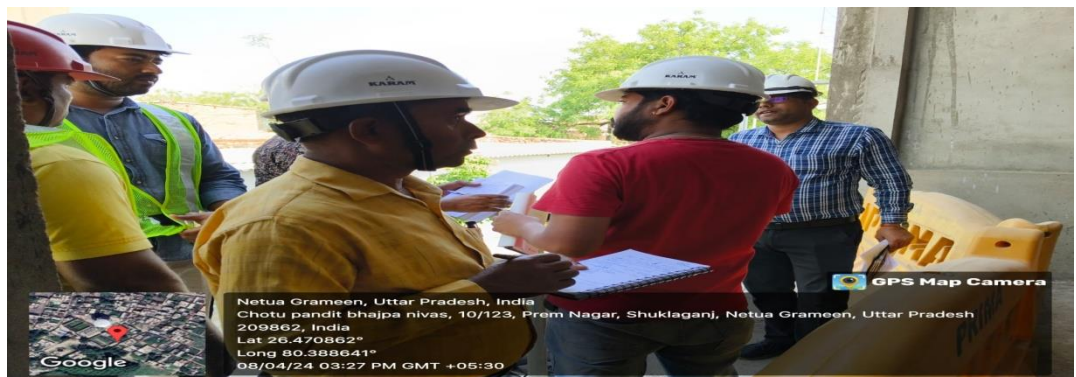
I. CCT & Chlorination building - In CCT outlet channel work, finishing of outlet chamber, grinding, finishing and painting works are pending. In building foundation of tonner, Electric work, plumbing, floor, finishing and painting works are pending. Booster pump and fitting pump can be install. During inspection there is no manpower on chlorination building & CCT.

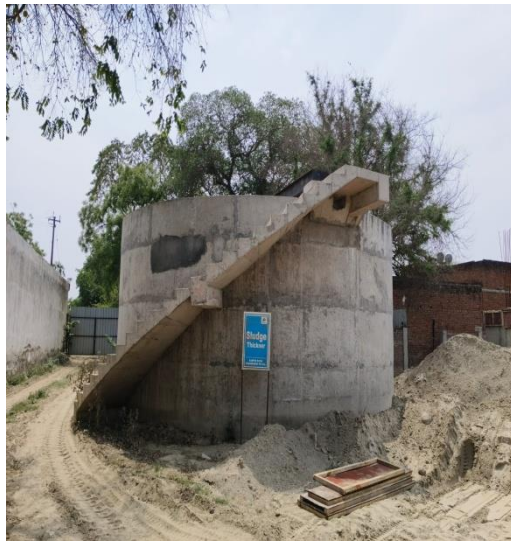
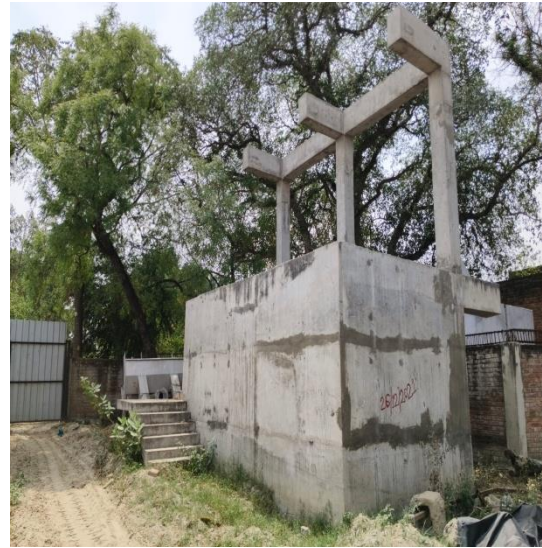
- J. **Sludge Thickener & Supernatant Pump**- finishing, painting and hydro testing are pending. Scrapper in thickener and pump in supernatant can be install as there is no hindrance.

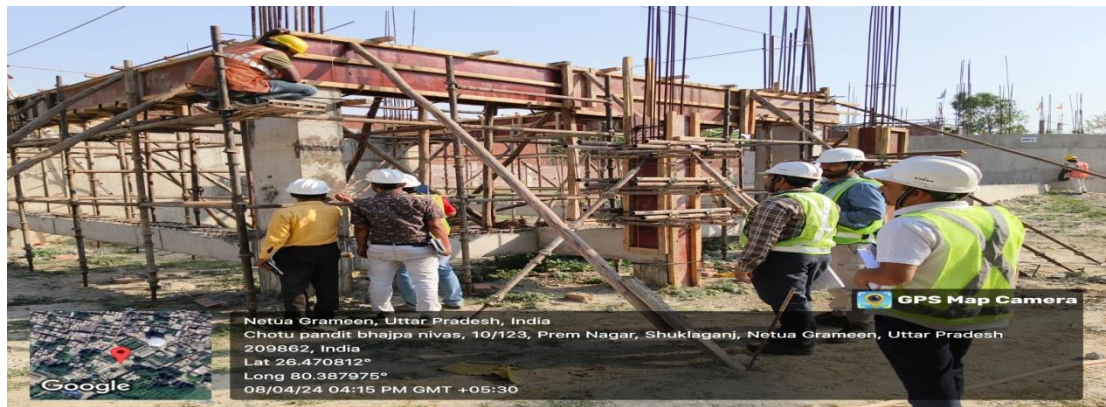
- K. **Centrifuge Building**- First and second floor slab work is pending, column and beam work is in progress.

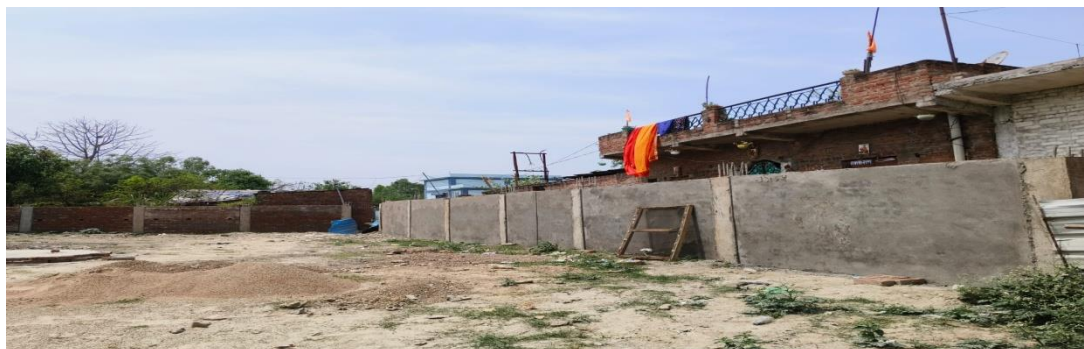
- L. **Boundary wall**- 60% work of boundary wall completed. Plaster work of boundary wall is in progress.

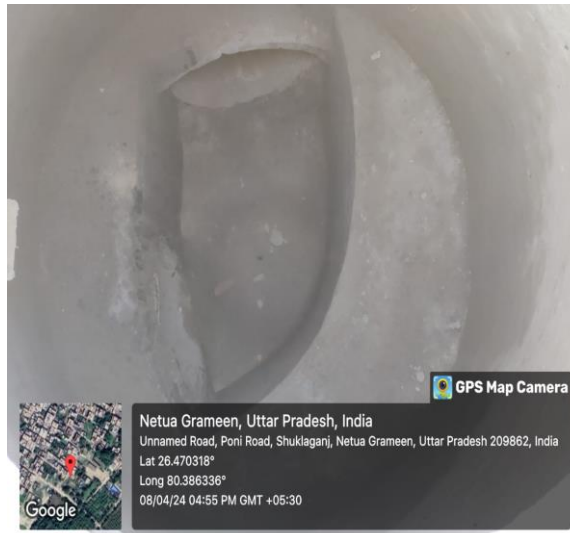
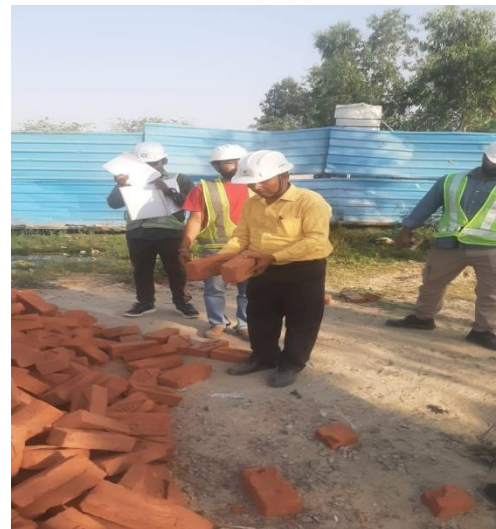
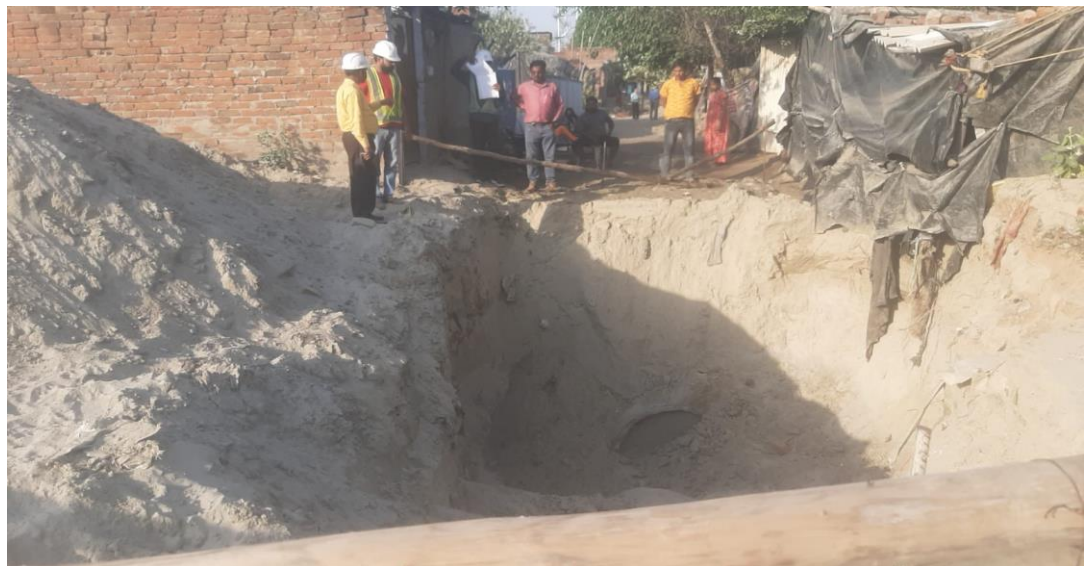
M. Manhole-During inspection it was found that the manhole work was being done without information to UPJN & STC and without approved drawings, in which the quality of bricks being used was found to be very poor which is not appropriate in the interest of work. In such a situation it would not be possible to measure and make payment for the work done by KRMPL and in view of the quality of the said work, it was also informed through letter **STC/PE/2165/Shuklaganj dated 11/03/24**, despite this KRMPL is getting the work done arbitrarily.

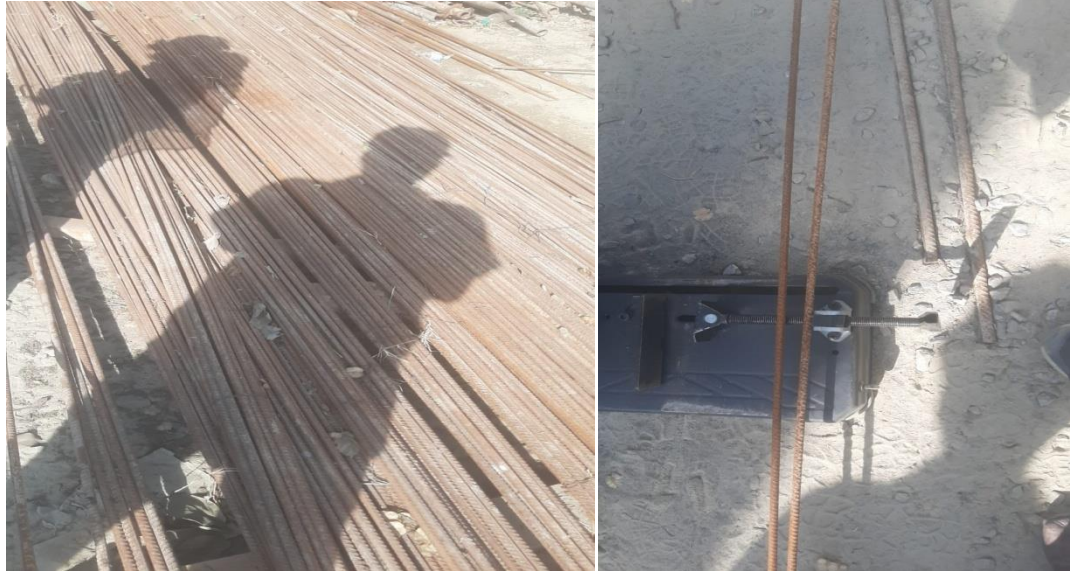
- N.** There is no any work progress in work of Rising Main, Effluent disposal system, sludge storage platform and HT panel & metering room.
- O.** During inspection UPJN & STC instructed KRMPL to cover the all excavated manhole places with proper safety signals.
- P. Note-** During the joint inspection, it was found that the steel used in grade chamber, collection chamber, screen chamber, approach channel and inlet chamber on the I&D structure is not as per the approved drawing design and the concerned Deputy Project

Manager of KRMPL, Mr. Rajpal Singh Gill, Site Engineer Mr. Sohan Vishwas are making aware of the fact that KRMPL does not have the availability of steel as per the approved design and drawing. KRMPL is not ensuring the availability of material in the execution of the works of the proposed scheme under an important program like Namami Gange, whereas KRMPL is also provided price acceleration money in relation to the invoice to complete the works with quality, in such a situation also not being able to complete the works as per the approved design and drawing shows negligence and indifference towards the works. In such a situation, it will not be possible to measure and make payment for the said work done by KRMPL.
