Site Inspection Report of 5 MLD Shuklaganj

Date of Inspection	21/08/2024
STP Site inspection Team	Mr. Anil Kumar seth Mr. Indra Deo Pandey- Support Engineer
KRMPL Personal	Mr. Soham vishwas. Mr. Saket singh

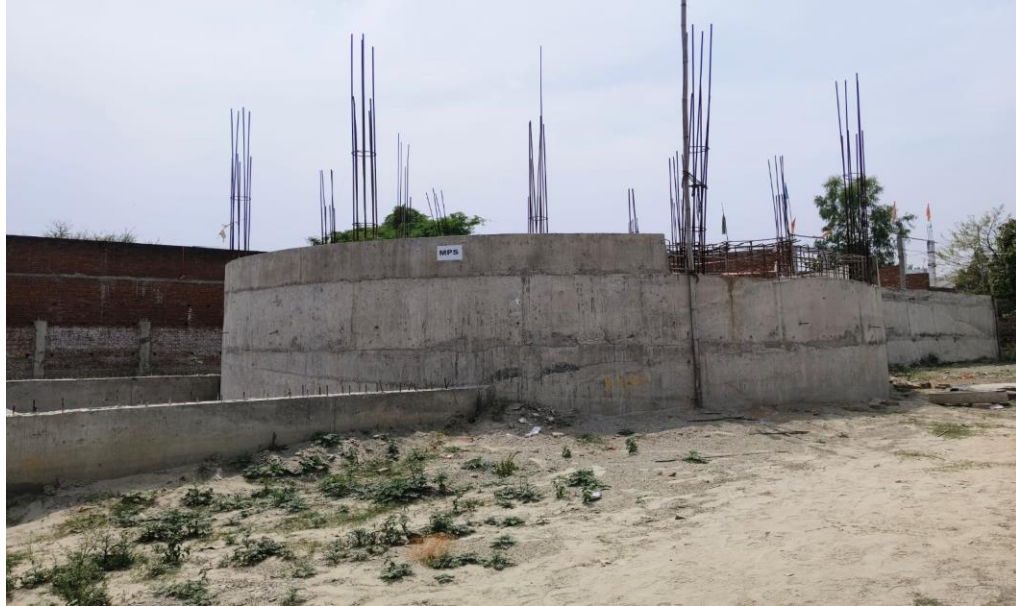
- B. MPS-** At inlet chamber step arrangement and proper footrest have not been provided. Column, beam and slab work is still pending. KRMPL needs to do hydro testing with clear water as per CEPHEEO MANUAL and IS code 3370 in presence of UPJN & STC, before grinding and tar coal epoxy work. During inspection there is no manpower on MPS. MPS staircase shuttering work on progress

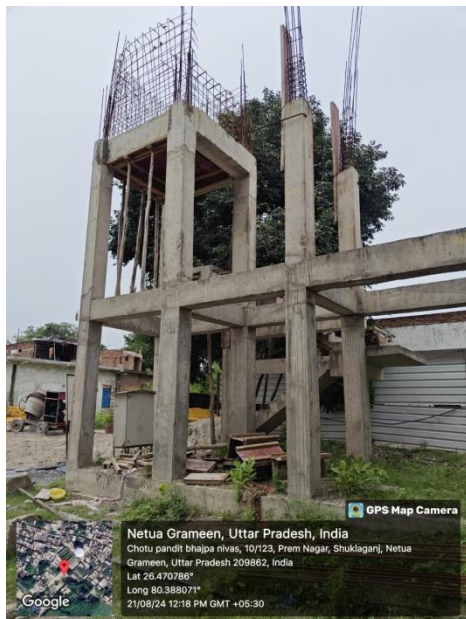
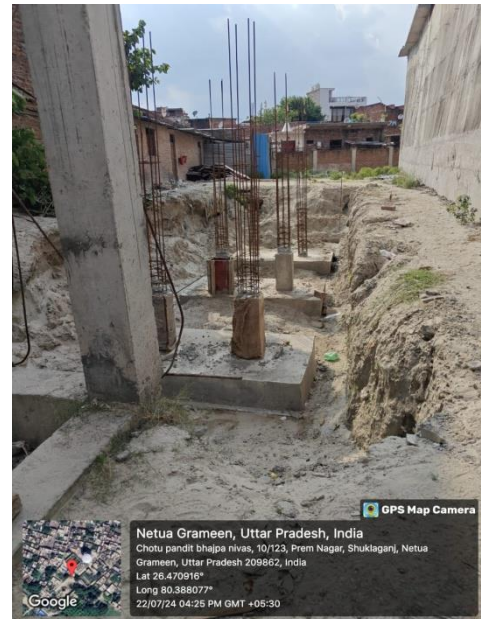
- C. PTU-** Most of Steel found corroded. PTU, Column work completed and slab shuttering and reinforcement work is in progress. In Inlet chamber area finishing work, hydro test is pending. In Grit chamber and parshall flume RCC wall & slab, walk way, platform and hydro test pending. Stair costing done and connecting channel column on progress.

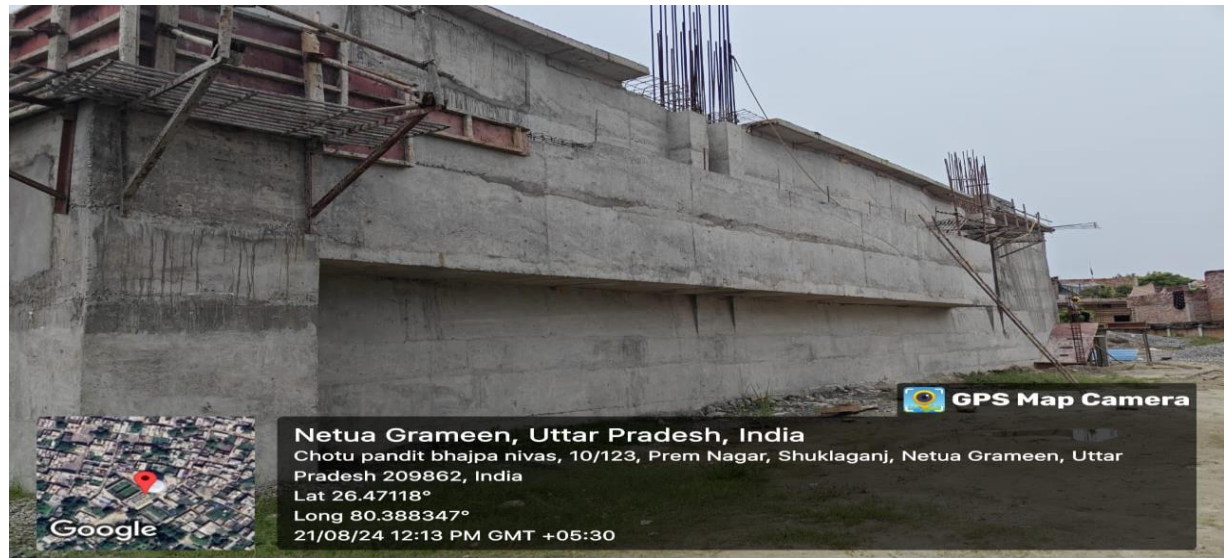
- D. SBR-** In SBR connecting channel, supporting column, walkway platform, RAS & WAS pump platform column, decanter foundation, finishing hydro test are pending.

Selector zone wall pipe support beam reinforcement on progress.

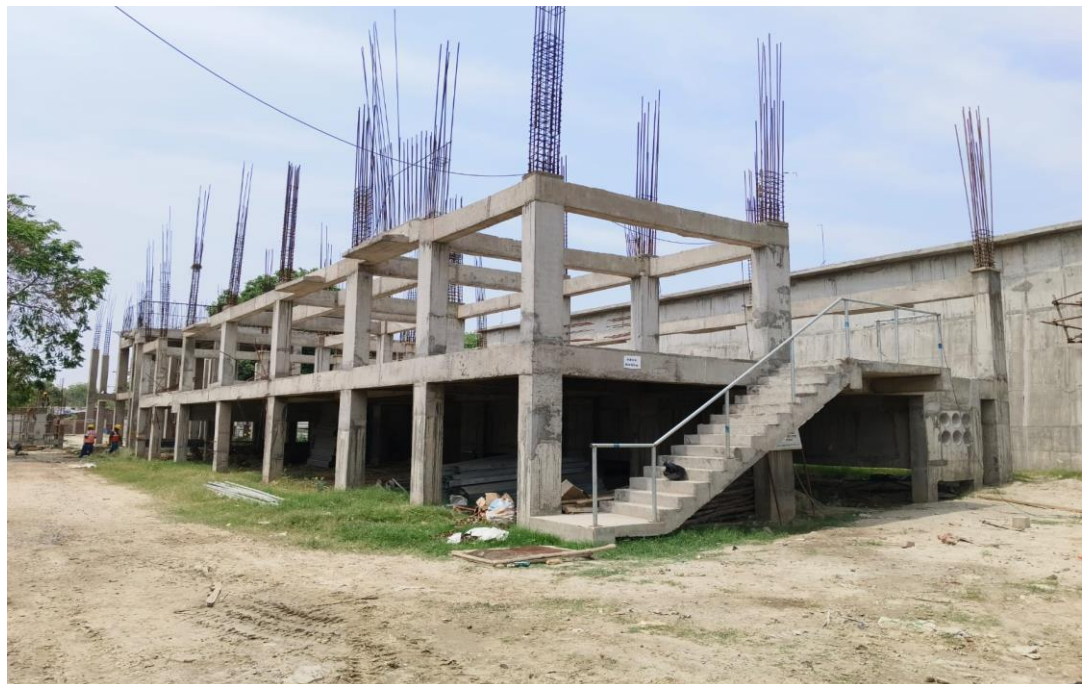
- E. Admin building cum Blower room-** In admin building room first floor and second floor slab work pending, brick work IPS flooring, electrification, sanitary fitting & plumbing, beam, column works are pending. In blower room roof slab, brick work, IPS flooring, roof treatment & finishing works are pending.

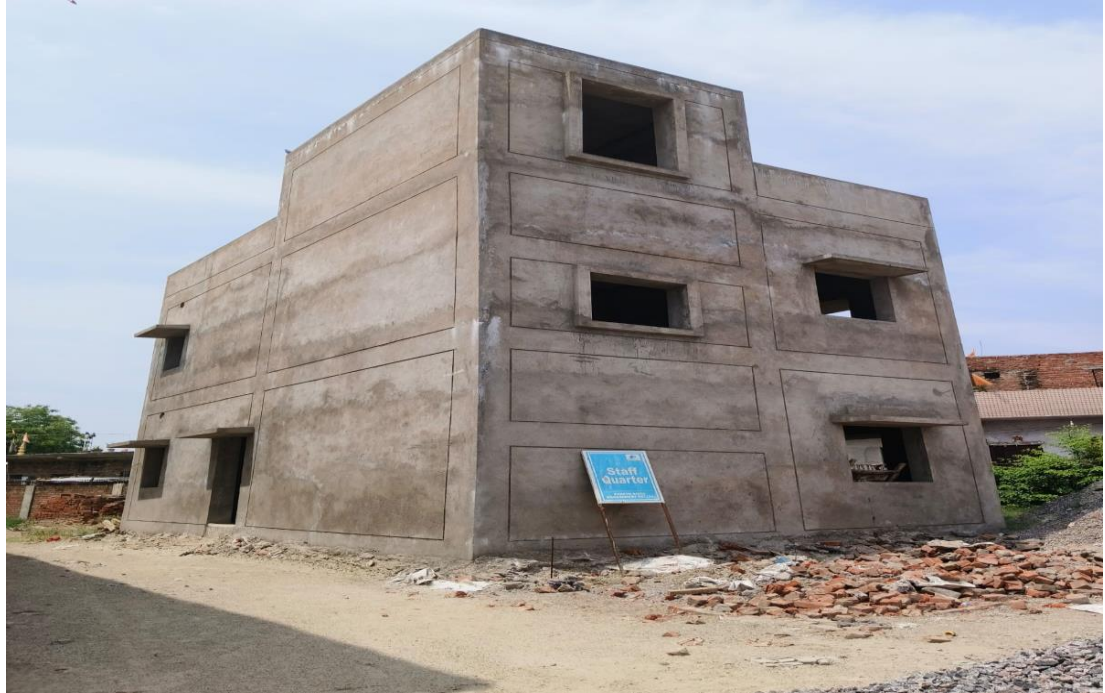
- F. Staff quarter-** Electric work, plumbing, sanitary fittings, floor, roof treatment, drainage, finishing and painting works are pending. There is no manpower on staff quarter during inspection.

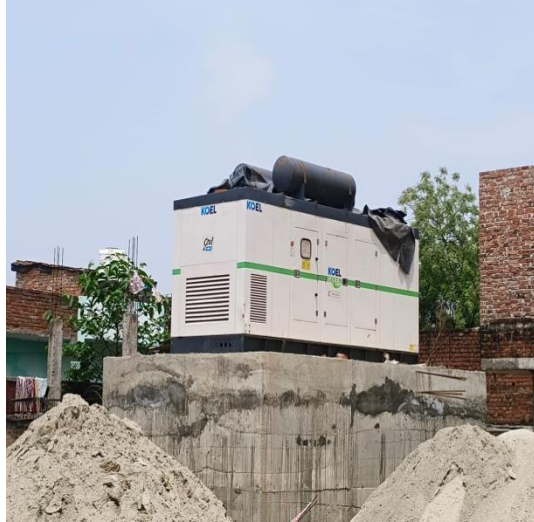
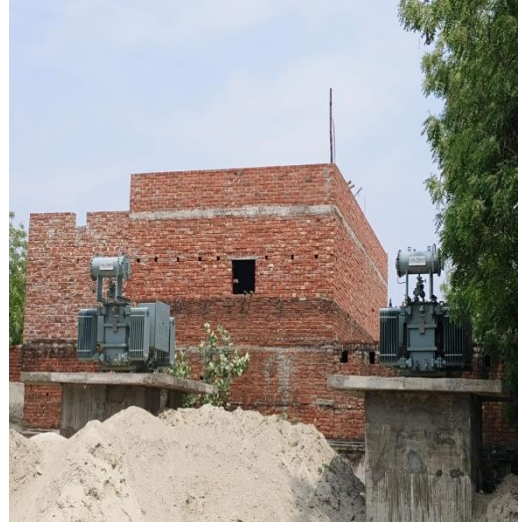
H. Transformer & DG Yard- Staircase, finishing, approach and painting works are pending.

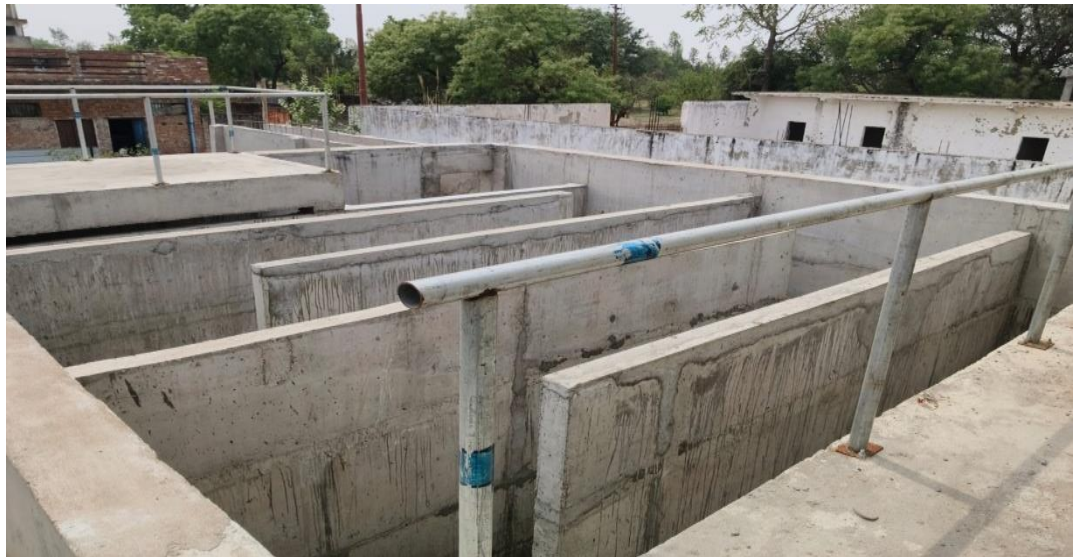
- I. **CCT & Chlorination building** - In CCT outlet channel work, finishing of outlet chamber, grinding, finishing and painting works are pending. In building foundation of tonner, Electric work, plumbing, floor, finishing and painting works are pending. Putty work on progress. Booster pump and fitting pump can be install. During inspection there is no manpower on chlorination building & CCT.

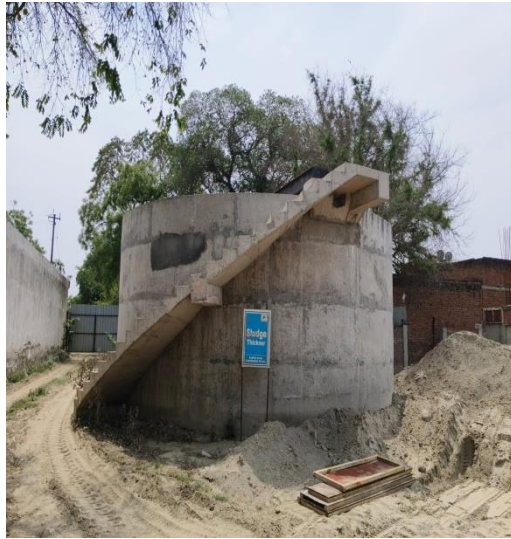
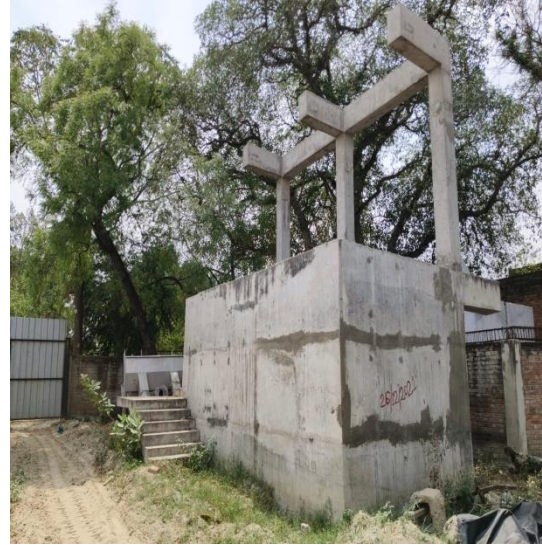
- J. **Sludge Thickner & Supernatant Pump**- finishing, painting and hydro testing are pending. Scrapper in thickener and pump in supernatant can be install as there is no hindrance.

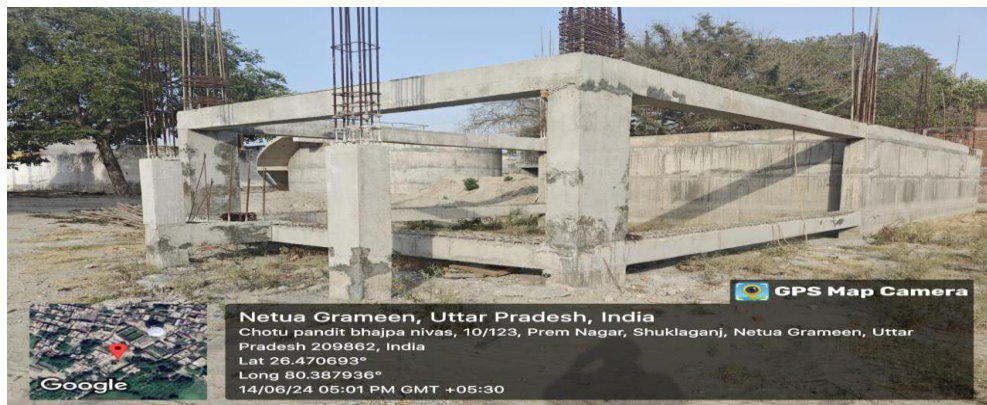
- K. Centrifuge Building-** First and second floor slab work is pending, column and beam work is in progress. Cracks found in the beam.

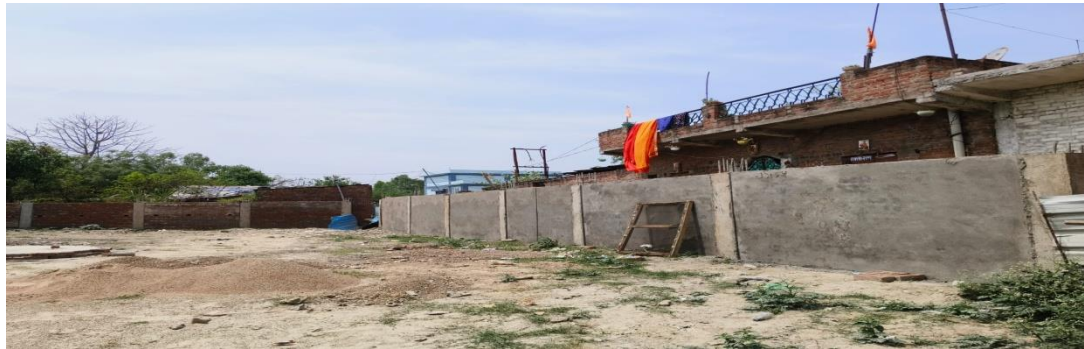
- L. Boundary wall-** 67% work of boundary wall completed. Plaster work of boundary wall is in progress.

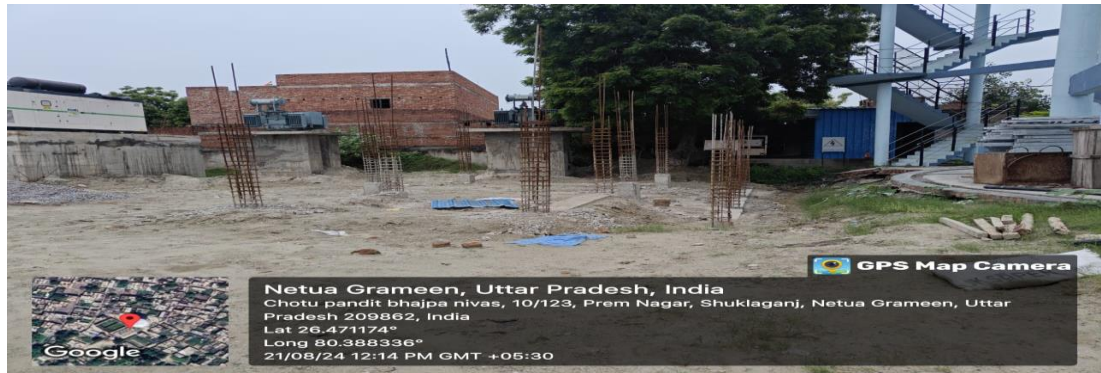
- N. There is no any work progress in work of Rising Main, Effluent disposal system, sludge storage platform and.
- O. During inspection UPJN & STC instructed KRMPL to cover the all excavated manhole places with proper safety signals.
- P. **HT panel & metering room**- Footing Reinforcement and shuttering work on progress.
