## **Inspection Report of 5 MLD STP Shuklaganj**

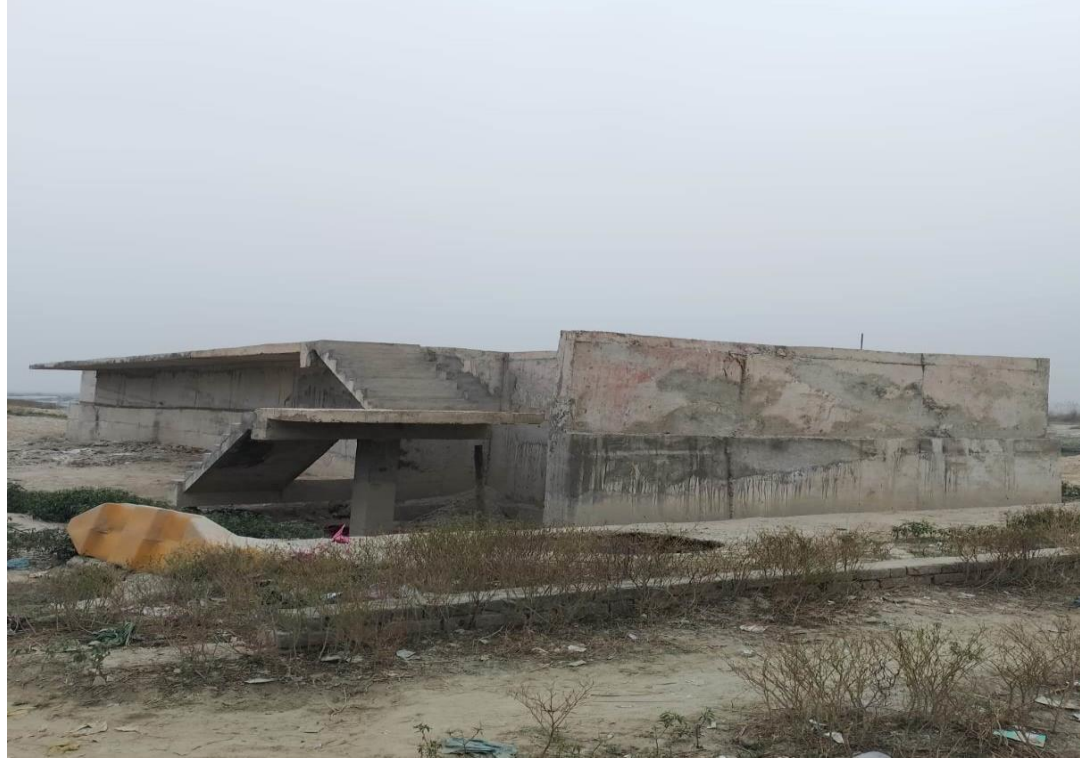
#### **A. I&D Structure-**

- i. Work of I&D structure is in progress. Reinforcement& shuttering work of wall is done. The casting of the all lift of the wall was done without informing UPJN and STC. In Approach channel, inlet channel and screen channel finishing and hydro test is pending.
- ii. During Site visit we found minor cracks are visible due to lack of curing.
- iii. Manual Screen's , Hand Rails are not installed.

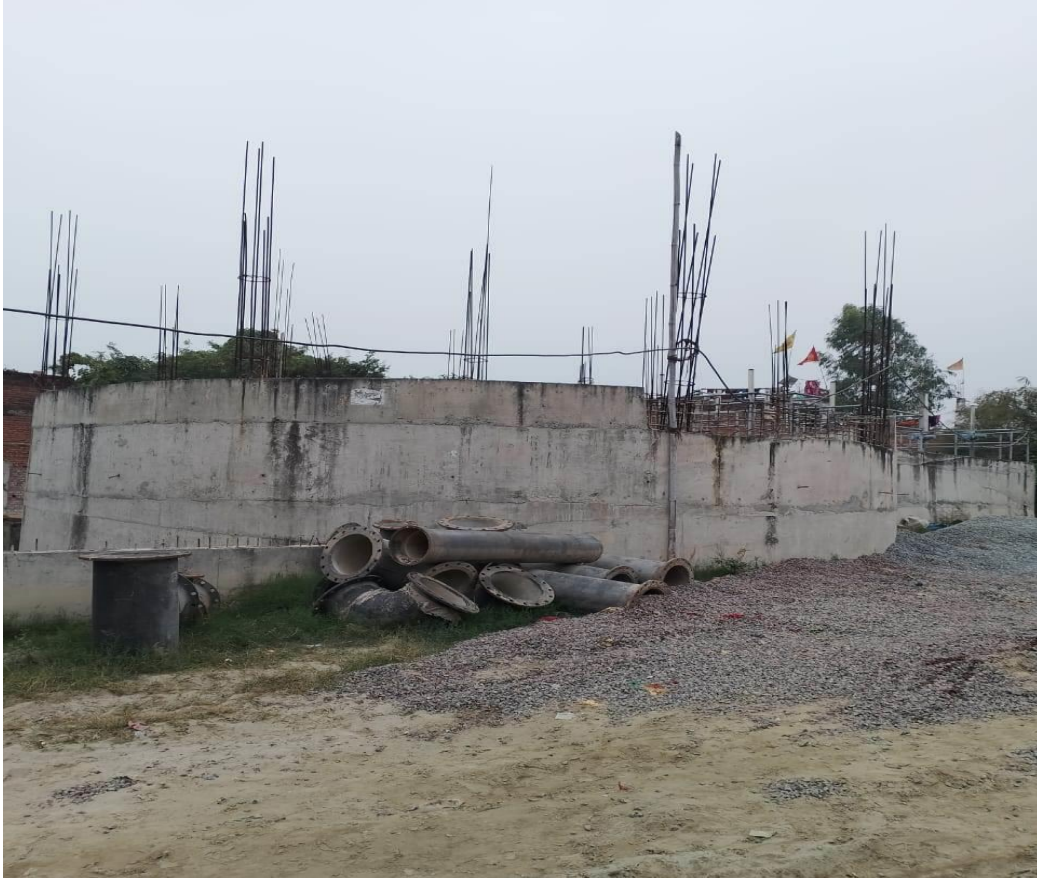
**B MPS-** At inlet chamber step arrangement and proper foot rest have not been provided. Column, beam and slab work is still pending. KRMPL needs to do hydro testing with clear water as per CEPHEEO MANUAL and IS code3370 in presence of UPJN & STC. It was advised to clean the open steel bar and coat with cement slurry.

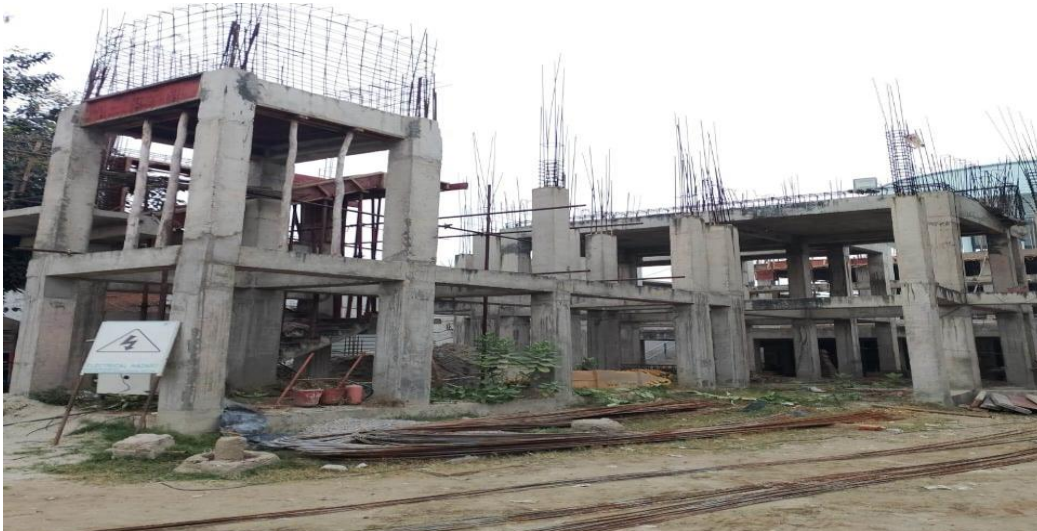
**C PTU-** PTU 2<sup>nd</sup> lift staircase shuttering work in progress. PTU, Column work completed and slab shuttering and reinforcement work is in progress. In Inlet chamber area finishing work, hydro test is pending. In Grit chamber and parshall flume RCC wall & slab, walk way, platform and hydro test pending.

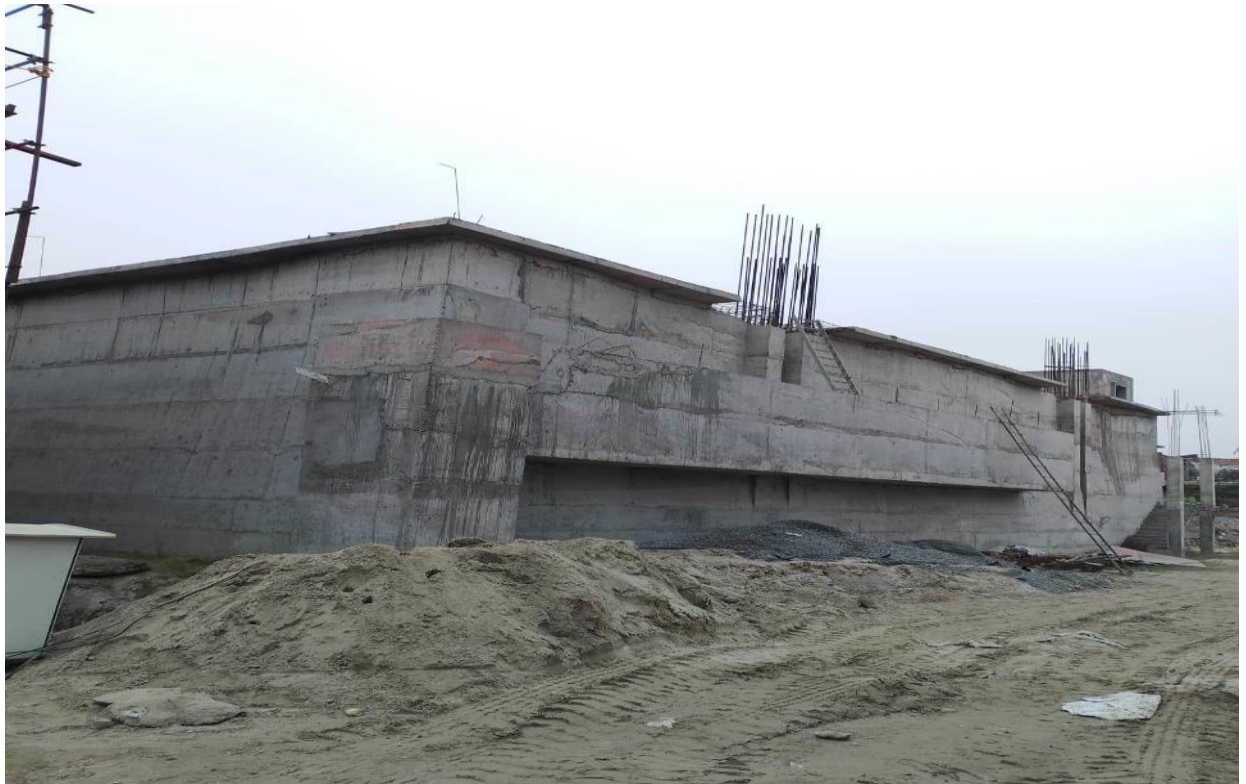
- B. SBR-** In SBR connecting channel, supporting column, walkway platform, RAS & WAS pump platform column, decanter foundation, finishing hydro test are pending. Selector zone wall pipe support beam reinforcement on progress.
- C. SBR Staircase** second lift is pending.

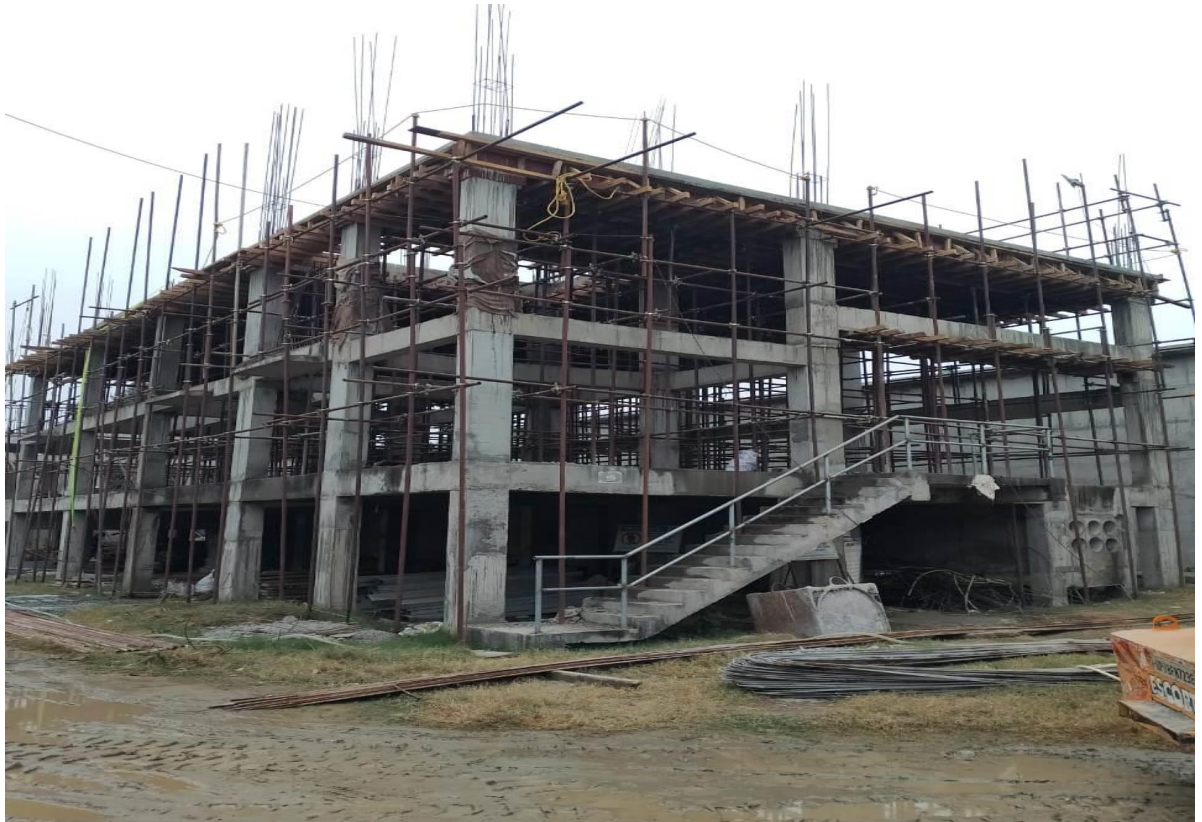
**Admin building cum Blower room-** In admin building room first floor Slab casting work is completed and second floor slab work pending, brick work IPS flooring, electrification, sanitary fitting & plumbing, beam, column works are pending. In blower room roof slab, brick work, IPS flooring, roof treatment & finishing works are pending.

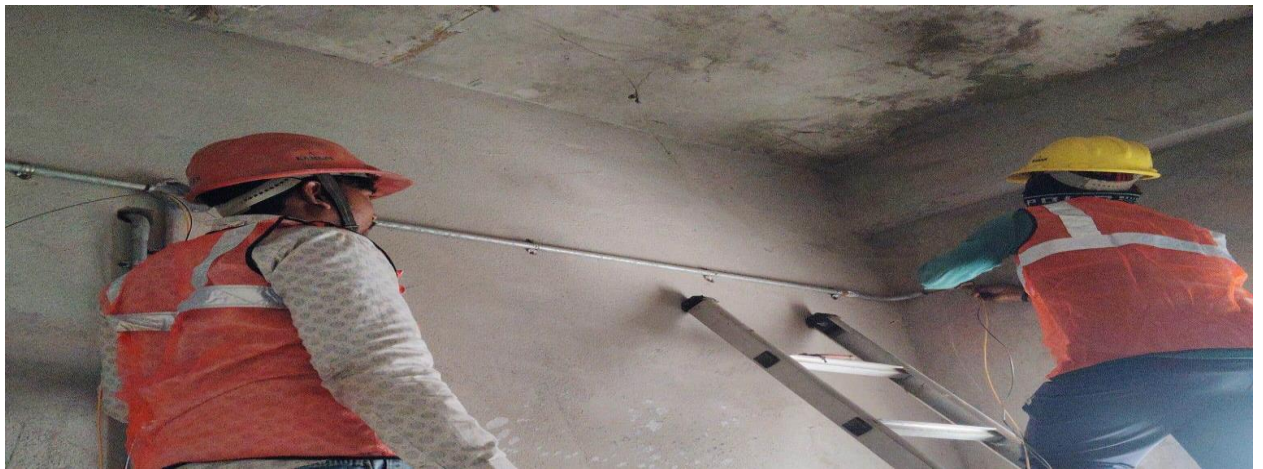
- D. Staff quarter-** Electric wiring work in progress. Plumbing, sanitary fittings, floor, roof treatment, drainage, finishing and painting works are pending. There is no manpower on staff quarter during inspection.

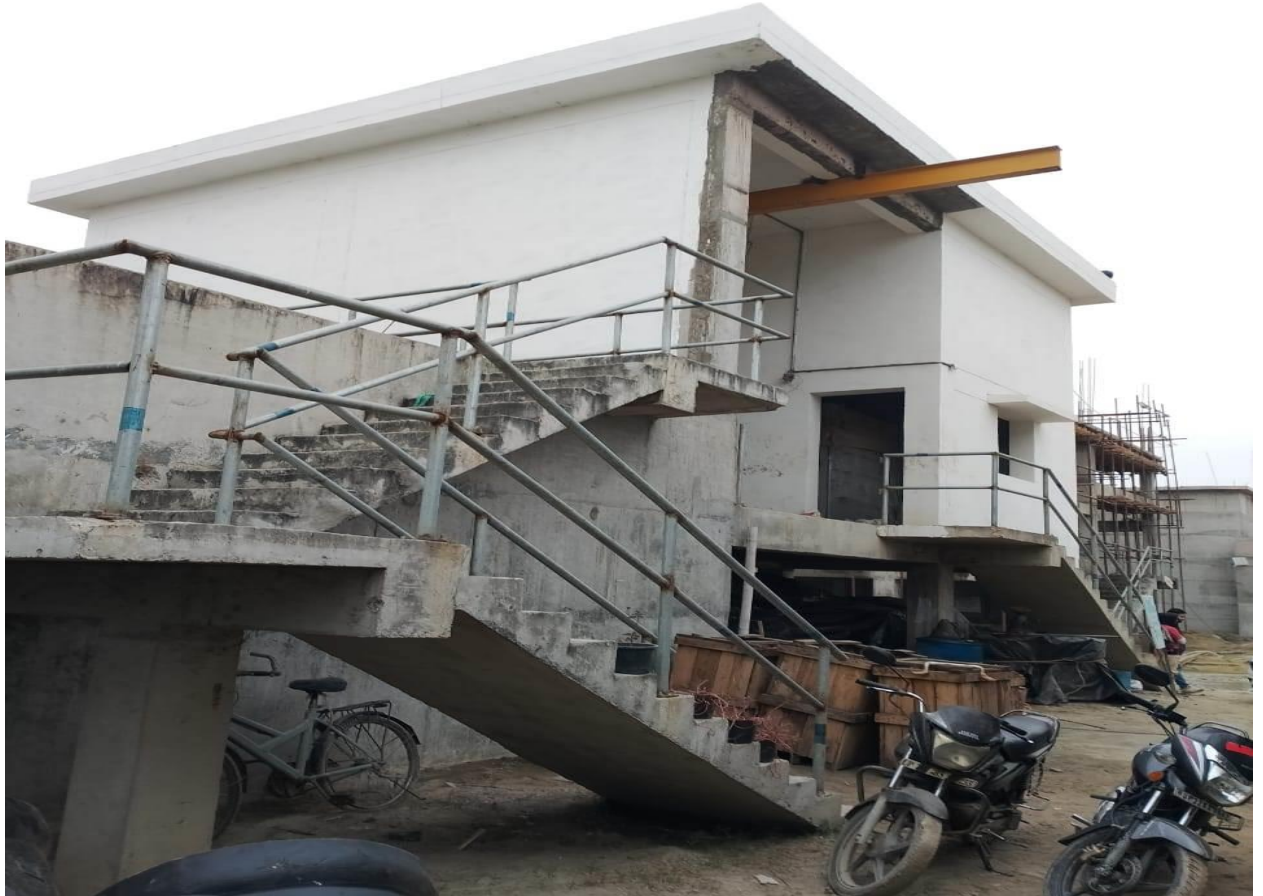
- E. Guard Room-** Electric work, plumbing, sanitary fittings, floor, roof treatment, drainage, finishing and painting works are pending.
- F. Transformer & DG Yard-** Staircase, finishing, approach and painting works are pending.
- G. CCT & Chlorination building -** In CCT outlet channel work, finishing of outlet chamber, grinding, finishing and painting works are pending. In building foundation

of tonner, Electric work, plumbing, floor, finishing and painting works are pending. Putty work on progress. Booster pump and fitting pump can be install. EE UPJN advice for better housekeeping.

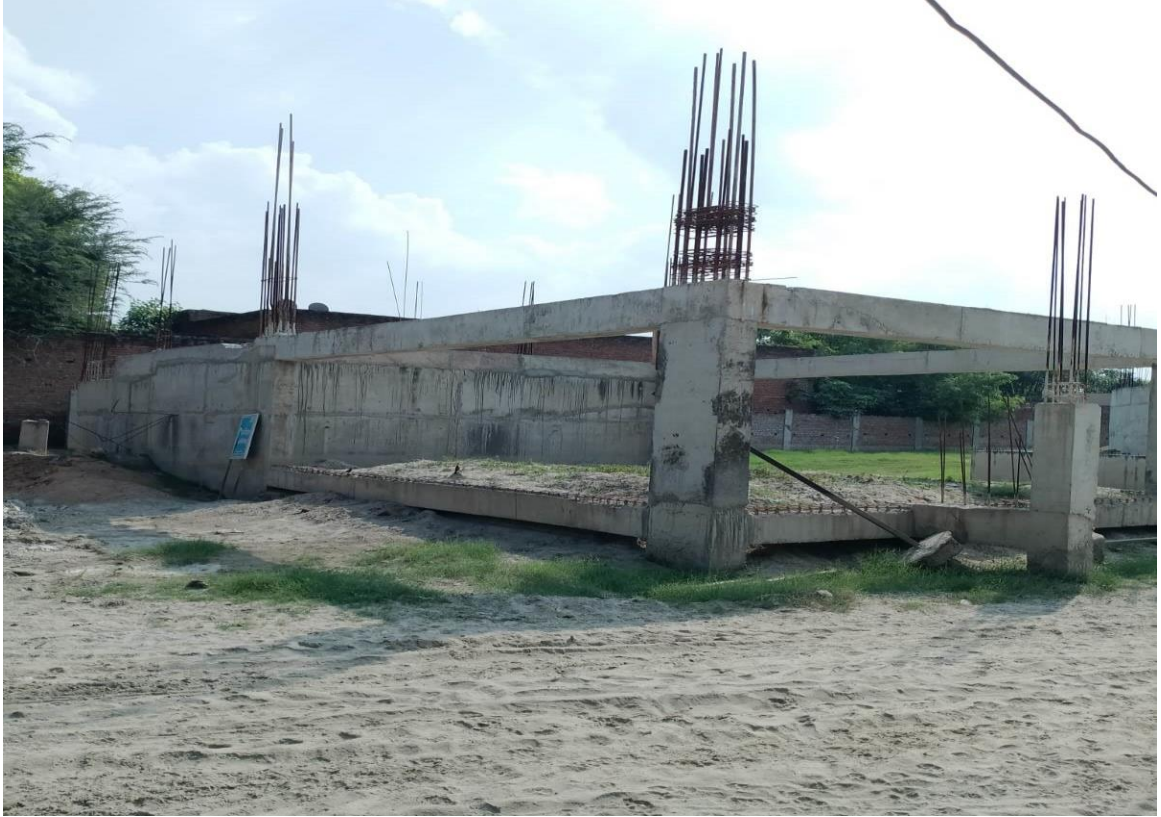
**I. Centrifuge Building-** PCC done Grade slab reinforcement work in progress. First and second floor slab work is pending, column and beam work is in progress. Cracks found in the beam.

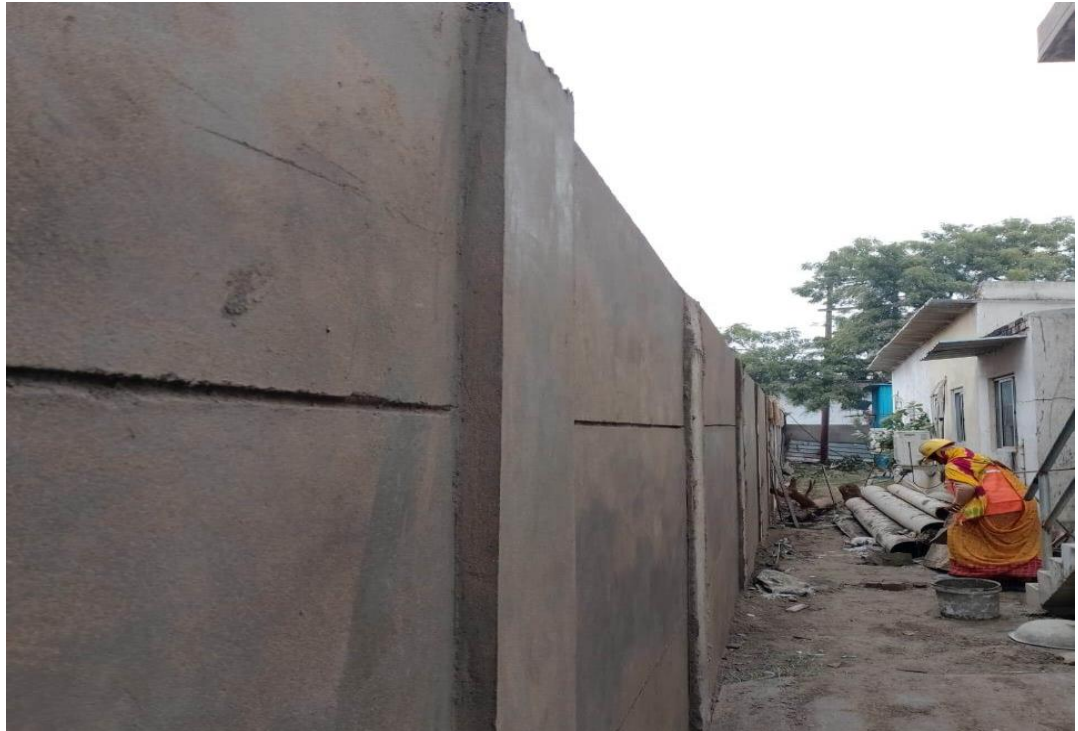
J. **Boundary wall-** 87% work of boundary wall completed. Plaster work of boundary wall is in progress.
