Inspection Report of 5 MLD STP Shuklaganj

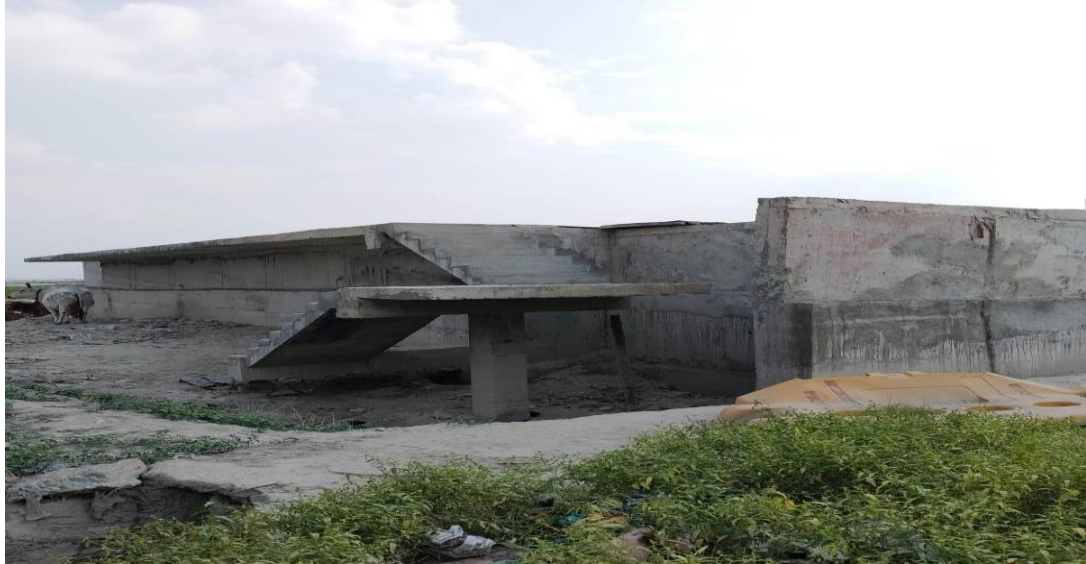
- i. Work of I&D structure is in progress. Reinforcement & shuttering work of wall is done. The casting of the all lift of the wall was done without informing UPJN and STC. In Approach channel, inlet channel and screen channel finishing and hydro test is pending.
- ii. During Site visit we found minor cracks are visible due to lack of curing.
- iii. Manual Screen's , Hand Rails are not installed.

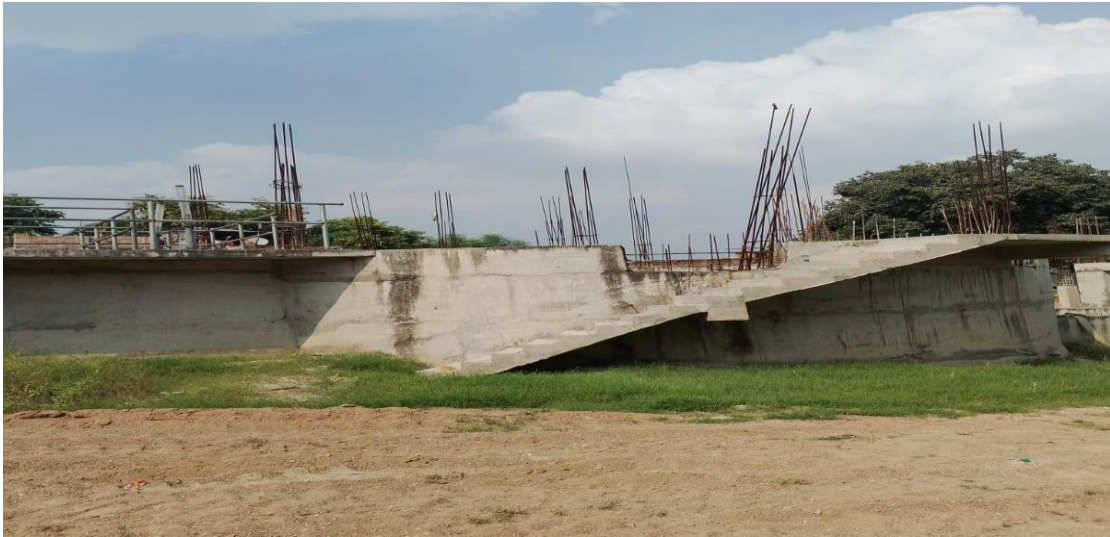
B MPS- At inlet chamber step arrangement and proper foot rest have not been provided. Column, beam and slab work is still pending. KRMPL needs to do hydro testing with clear water as per CEPHEEO MANUAL and IS code 3370 in presence of UPJN & STC. It was advised to clean the open steel bar and coat with cement slurry.

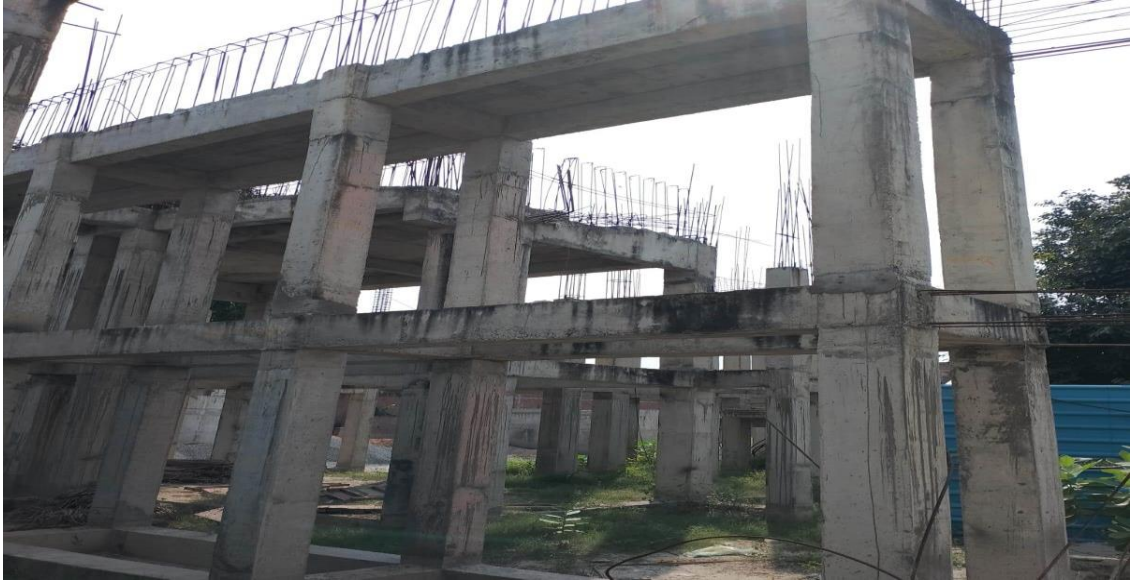
C PTU- Most of Steel found corroded. PTU, Column work completed and slab shuttering and reinforcement work is in progress. In Inlet chamber area finishing work, hydro test is pending. In Grit chamber and parshall flume RCC wall & slab, walk way, platform and hydro test pending. Stair casting done and connecting channel column on progress.

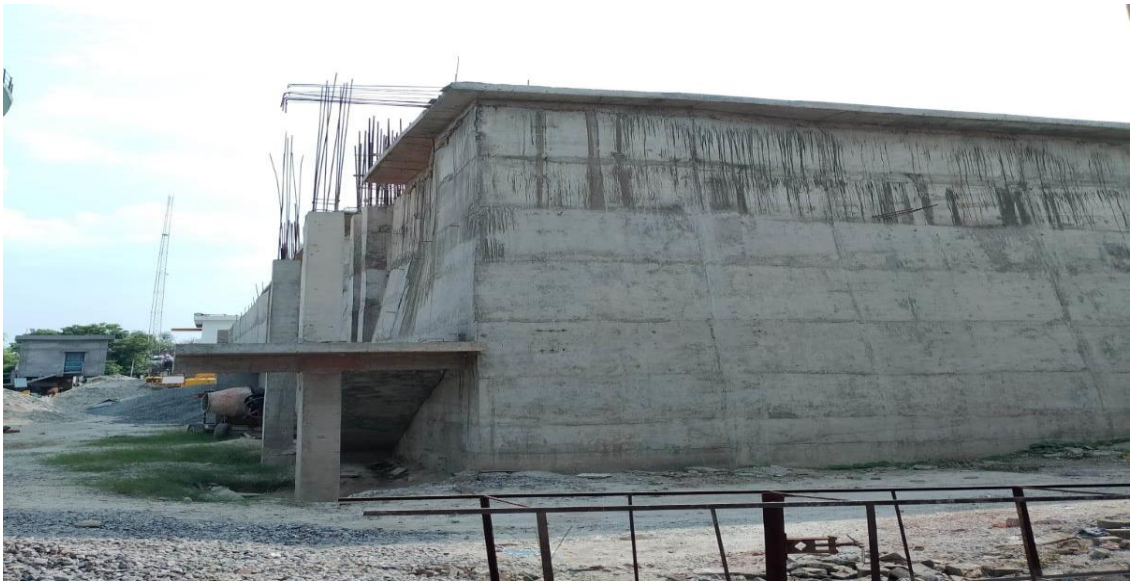
- B. **SBR-** In SBR connecting channel, supporting column, walkway platform, RAS & WAS pump platform column, decanter foundation, finishing hydro test are pending. Selector zone wall pipe support beam reinforcement on progress.
- C. SBR Staircase second lift is pending.

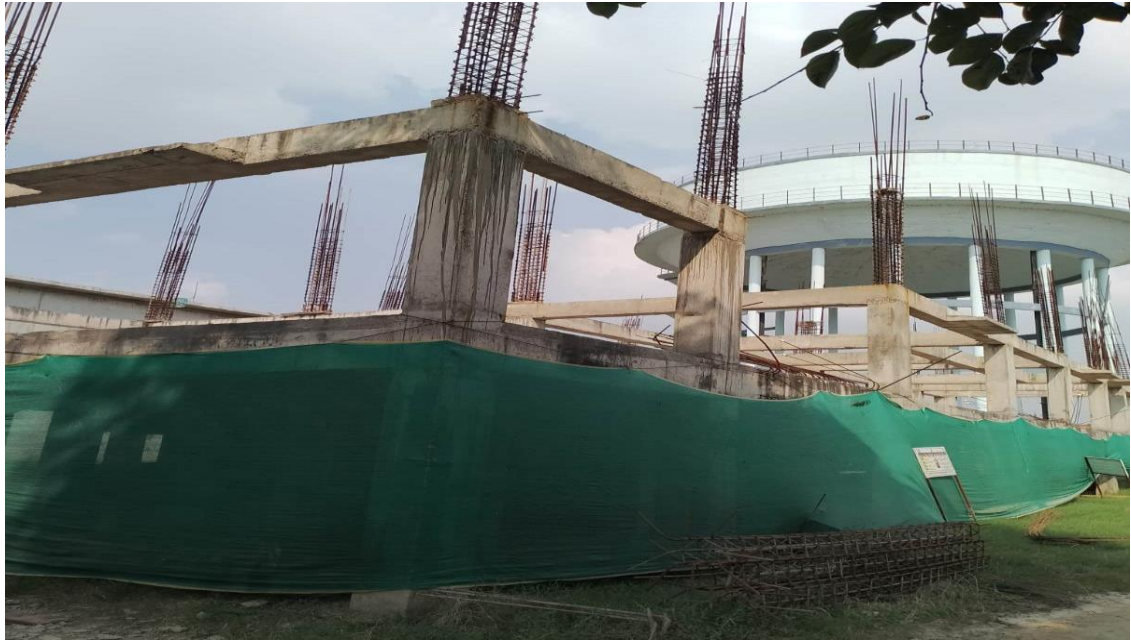
Admin building cum Blower room- In admin building room first floor and second floor slab work pending, brick work IPS flooring, electrification, sanitary fitting & plumbing, beam, column works are pending. In blower room roof slab, brick work, IPS flooring, roof treatment & finishing works are pending.

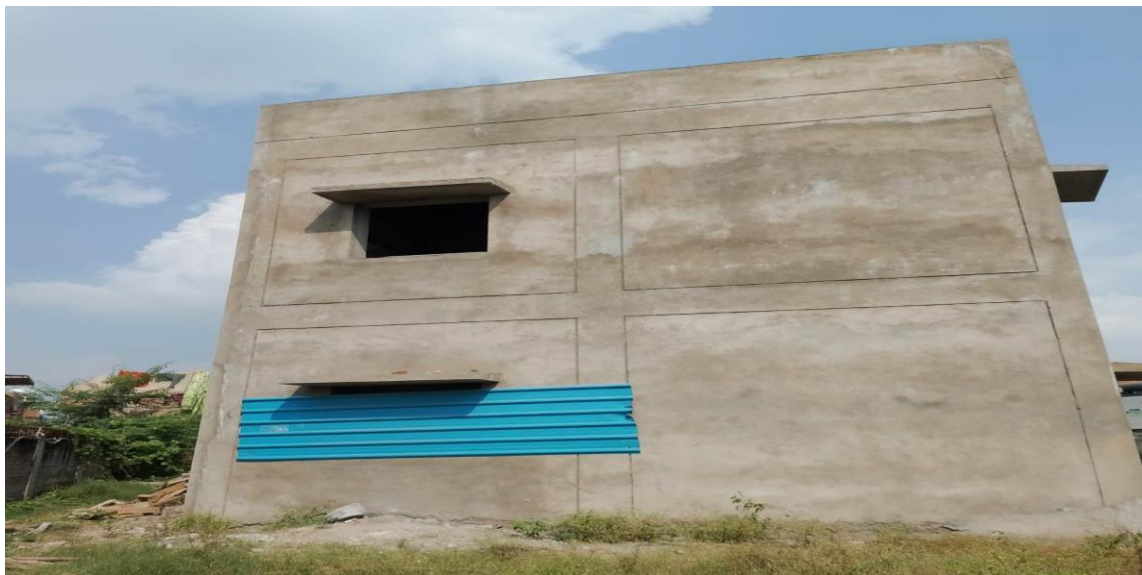
- D. Staff quarter-** Electric work, plumbing, sanitary fittings, floor, roof treatment, drainage, finishing and painting works are pending. There is no manpower on staff quarter during inspection.

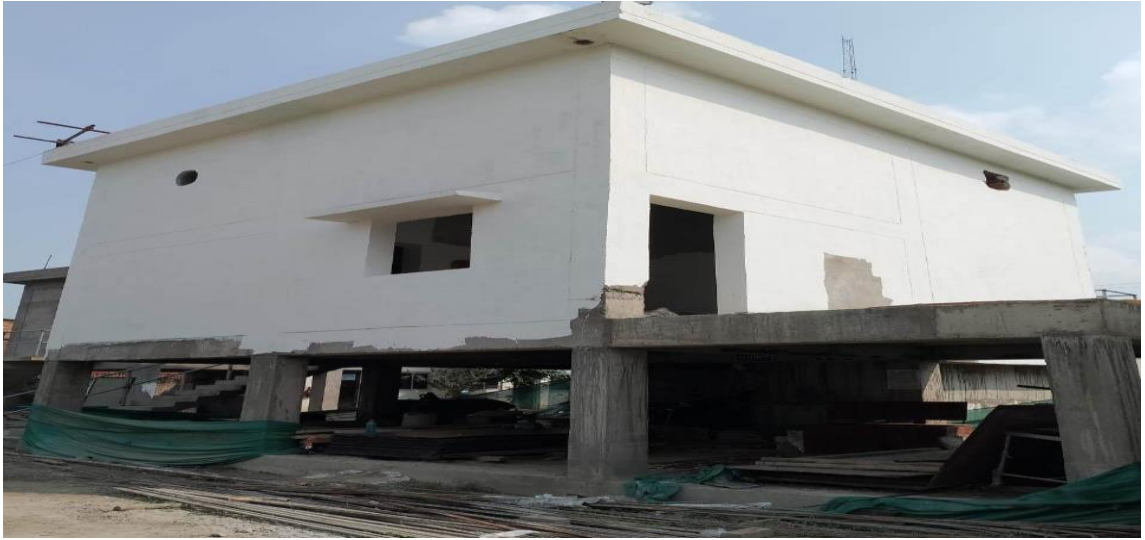
- E. Guard Room-** Electric work, plumbing, sanitary fittings, floor, roof treatment, drainage, finishing and painting works are pending.
- F. Transformer & DG Yard-** Staircase, finishing, approach and painting works are pending.
- G. CCT & Chlorination building** - In CCT outlet channel work, finishing of outlet chamber, grinding, finishing and painting works are pending. In building foundation of tonner, Electric work, plumbing, floor, finishing and painting works are pending. Putty work on progress. Booster pump and fitting pump can be install. EE UPJN

advice for better housekeeping. And also to advice to complete the casting of tonner foundation quickly.

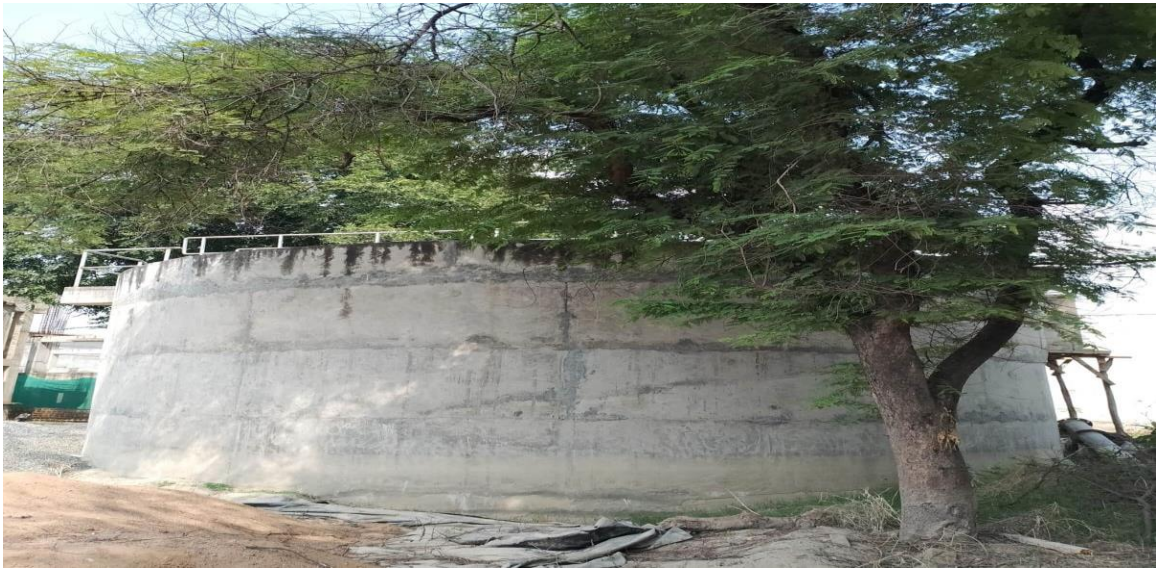
- H. Sludge Thickner & Supernatant Pump-** finishing, painting and hydro testing are pending. Scrapper in thickener and pump in supernatant can be install as there is no hindrance.

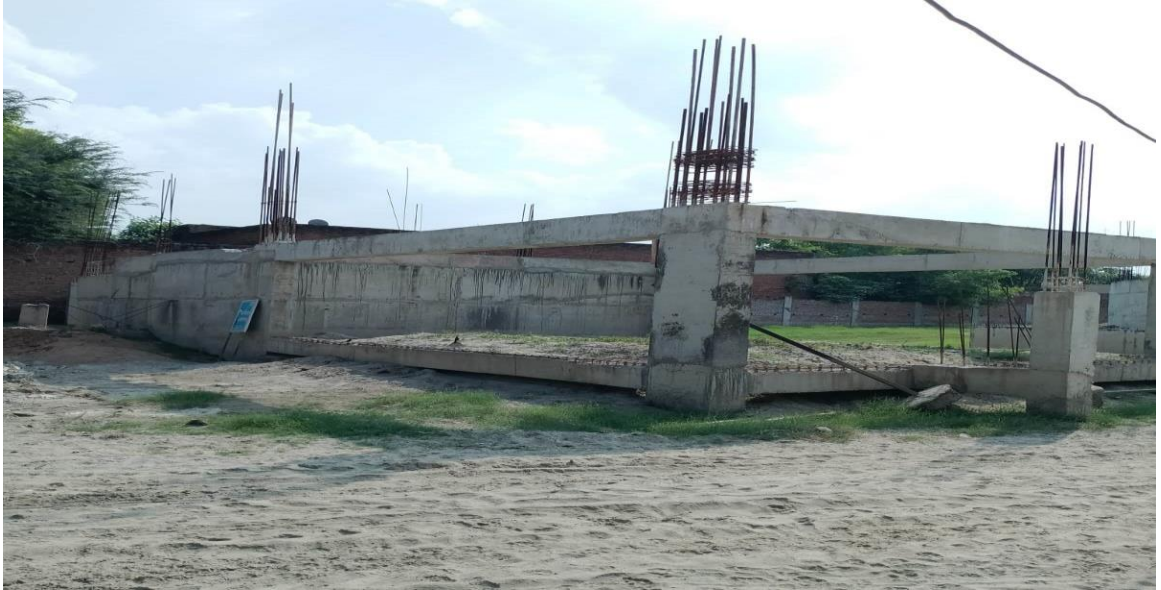
- I. Centrifuge Building-** First and second floor slab work is pending, column and beam work is in progress. Cracks found in the beam.

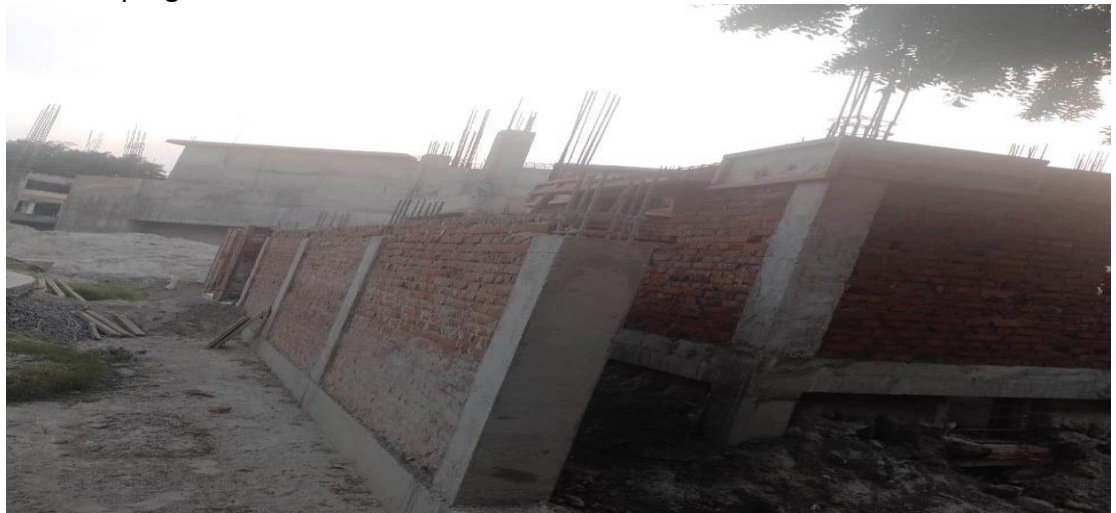
- J. Boundary wall-** 85% work of boundary wall completed. Plaster work of boundary wall is in progress.
